Investigation Report

Worker Fatally Pinned during Skid-Steer Maintenance

December 2, 2014

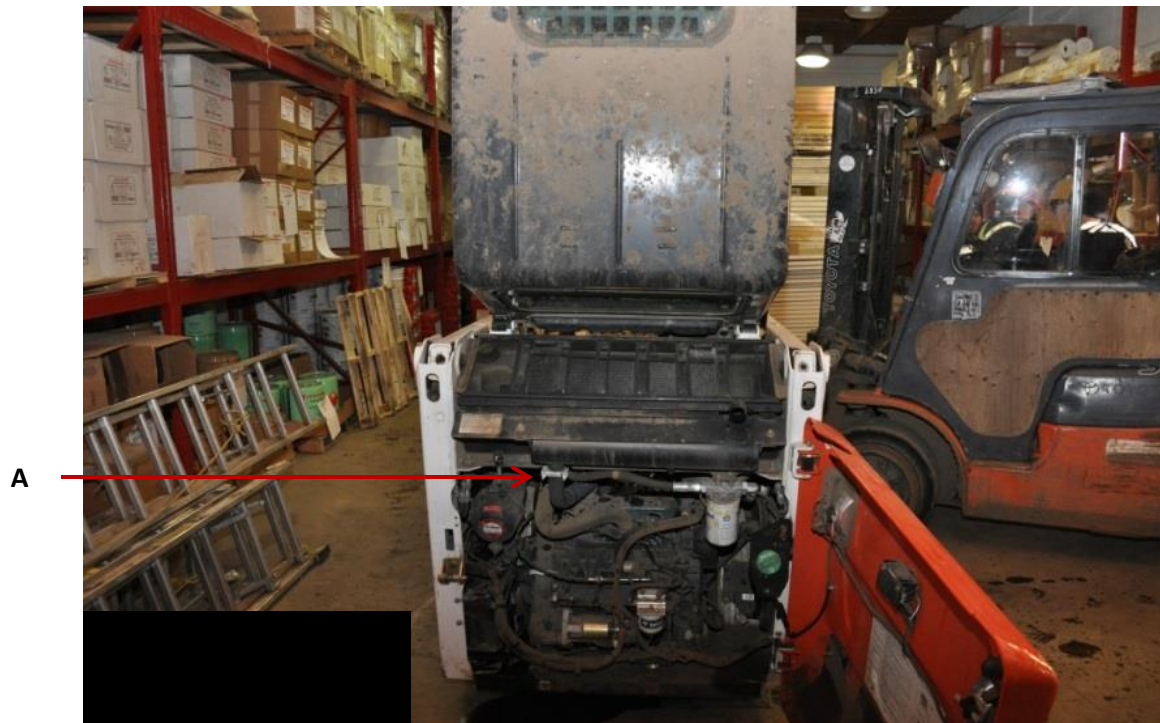
*Figure 2. The opened back door to the skid-steer.  
A: The loosened circuit hose.*

The mechanic had opened the back door to the skid-steer in order to loosen off the potentially leaking circuit hose. He did not completely remove the hose which allowed hydraulic oil pressure to remain in the circuit hose. He then raised the lift-arms with the bucket attached and the cab of the skid-steer (Figure 3) in order to access and remove the potentially leaking circuit hose from the control valve inside of the cab area. At this time, the lift arms were still under hydraulic pressure.

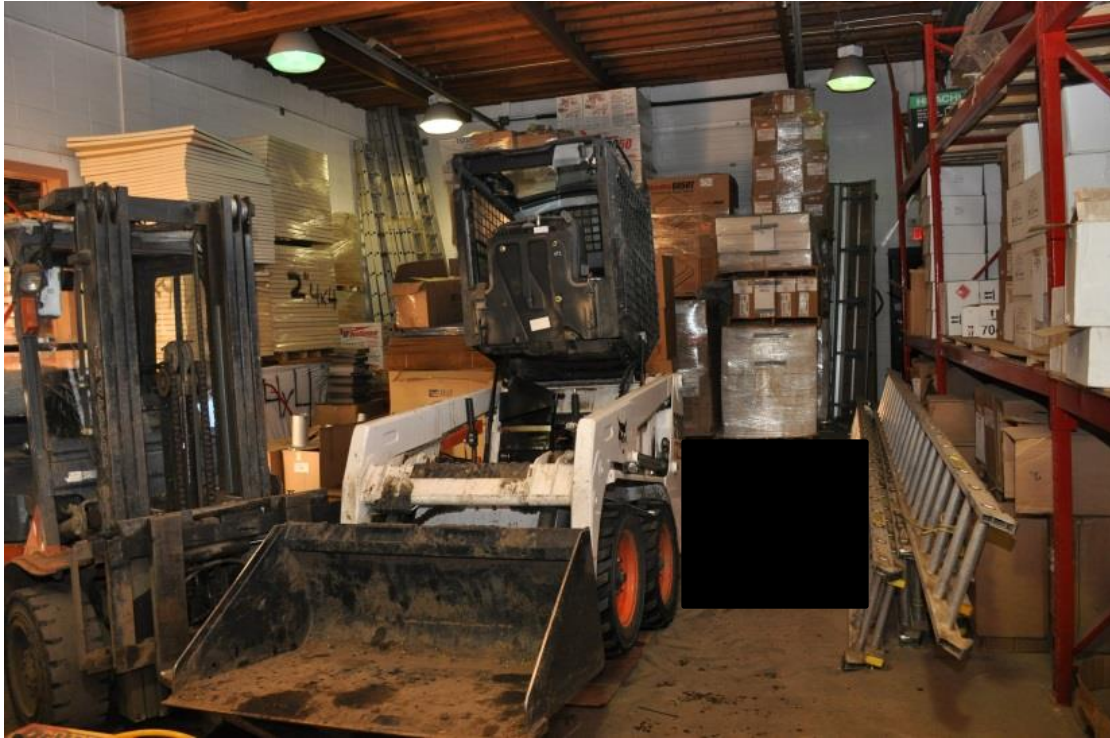
*Figure 3. The raised cab of the skid-steer.*

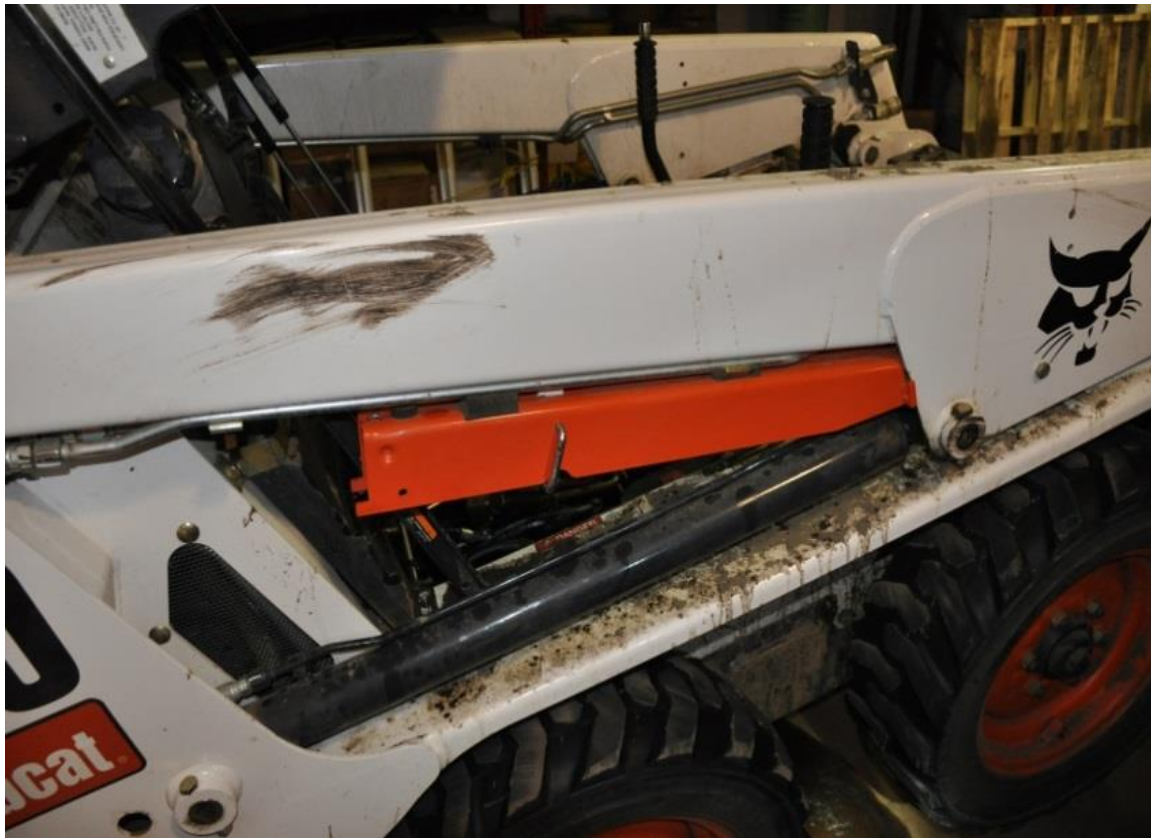
The mechanic had not applied the lift-arm support device to prevent the lift-arms from coming down once the hydraulic oil pressure was lost (Figures 4 and 5).

*Figure 4. The skid-steer lift-arm support was still in the cradle of the boom while the lift-arm with the bucket attached were raised.*

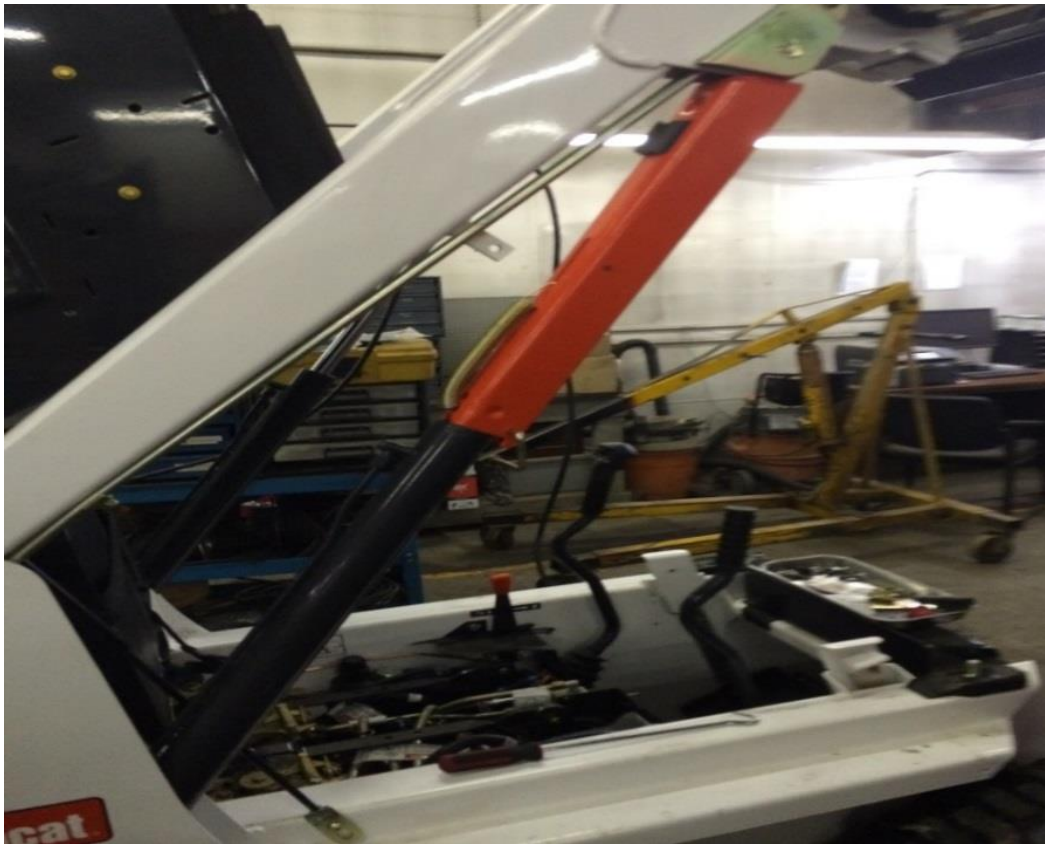
*Figure 5. An example of the lift arm support in position holding the boom while the lift-arms are raised.*

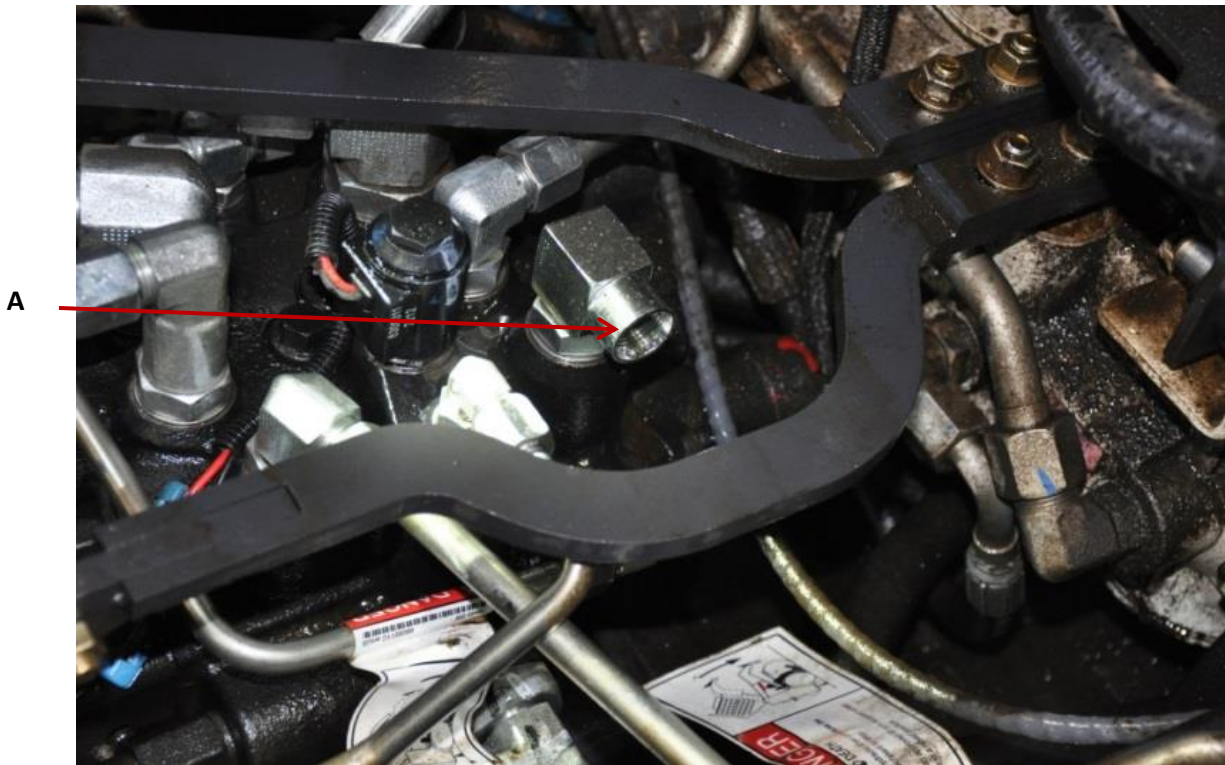
The mechanic then placed himself between the chassis of the skid-steer and the left lift-arm (if looking out of the cab of the skid-steer) and began to loosen the potentially leaking lift circuit line off the control valve (Figure 6).

*Figure 6. The mechanic had removed the suspected leaking lift circuit line off the control valve.  
A: The control valve fitting.*

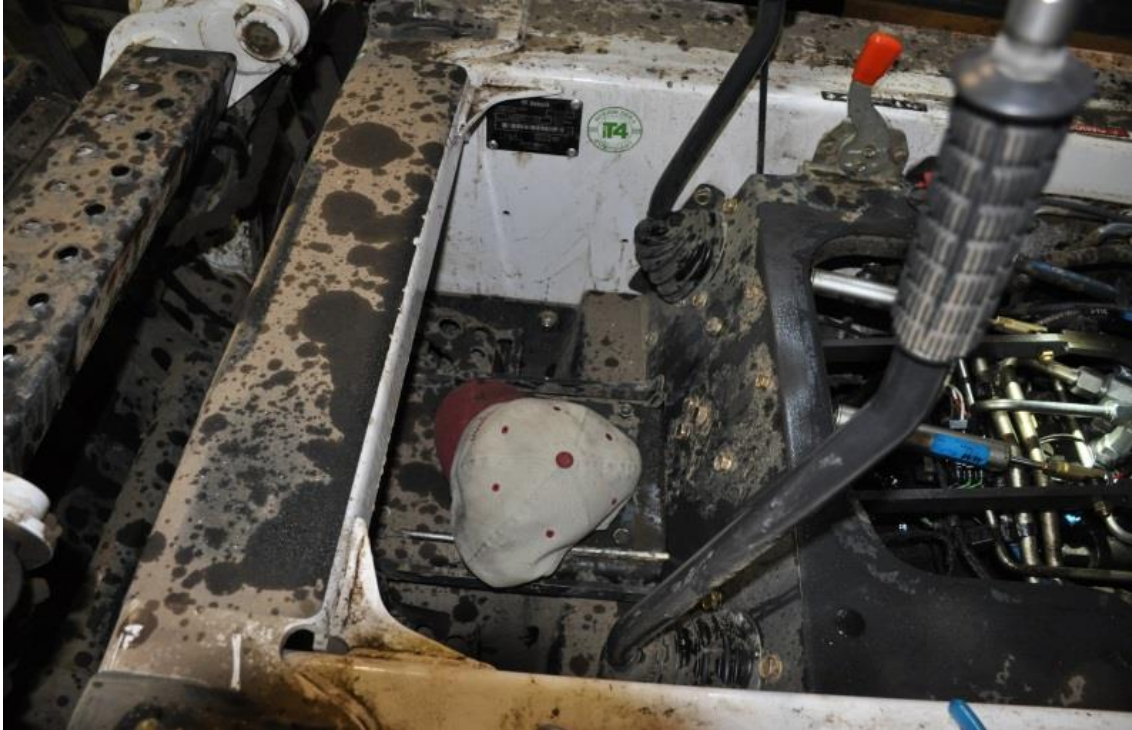
Once the lift circuit line was completely removed from the control valve, the remaining hydraulic pressure in the hose released spraying hydraulic oil within the motor unit (Figure 7). This caused the lift-arms with bucket to come down quickly and pin the mechanic between the left lift-arm and the chassis of the skid-steer.

*Figure 7. The sprayed hydraulic oil inside the motor compartment from the loosened hose.*

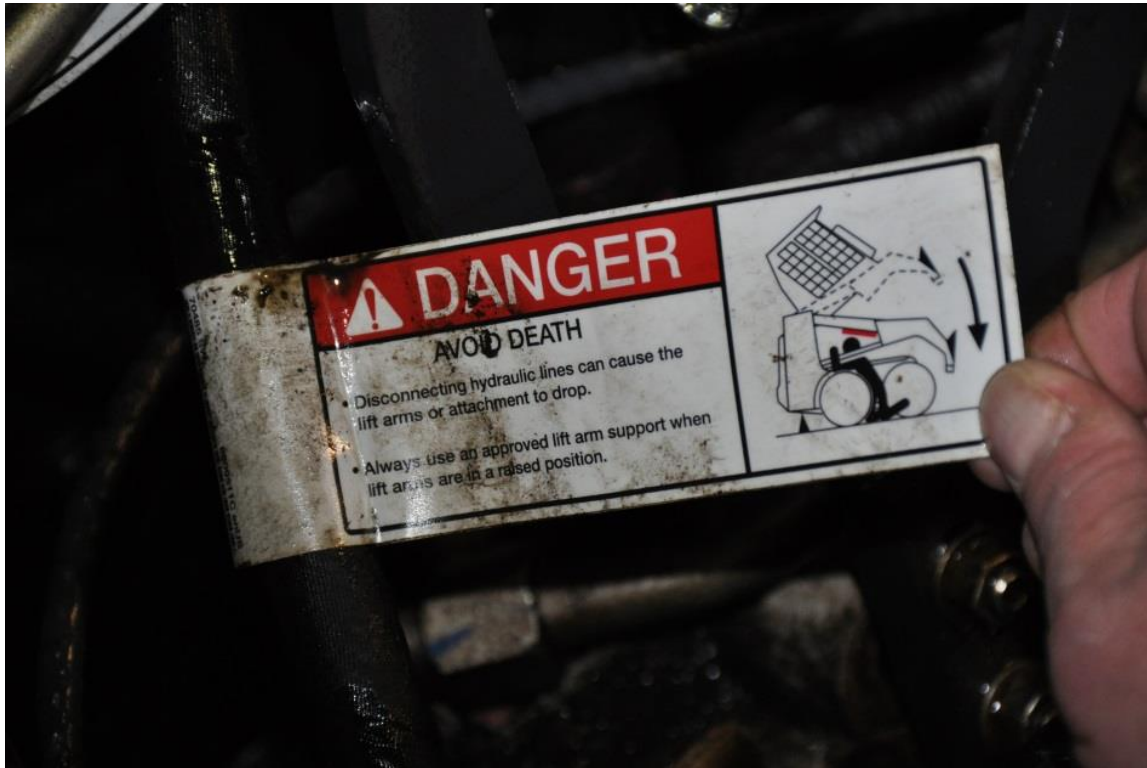
There were postings throughout the skid-steer indicating if the hydraulic line was disconnected it could cause the lift-arm or attachment to drop (Figure 8).

*Figure 8. A tag within the cab of the skid-steer indicated that “disconnecting hydraulic lines can cause the lift arms or attachment to drop.”*
