# RECAPP Facility Evaluation Report

## Aspen Regional Health Authority

### Wabasca / Desmarais General Hospital

B1487A

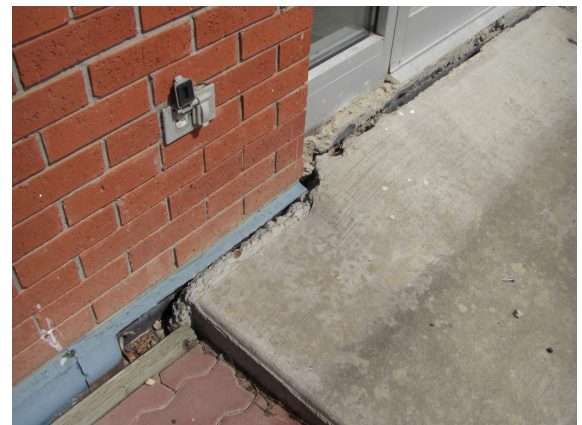
(1989) Original Building (Long Term Care - Exit at Vestibule 83) - has open gap of concrete slab along foundation wall.

(Exit near Long Term Care - Exit at Vestibule 83) - has open gap of concrete slab along foundation wall.

Repair concrete ramp. (approx. 10 square metres)

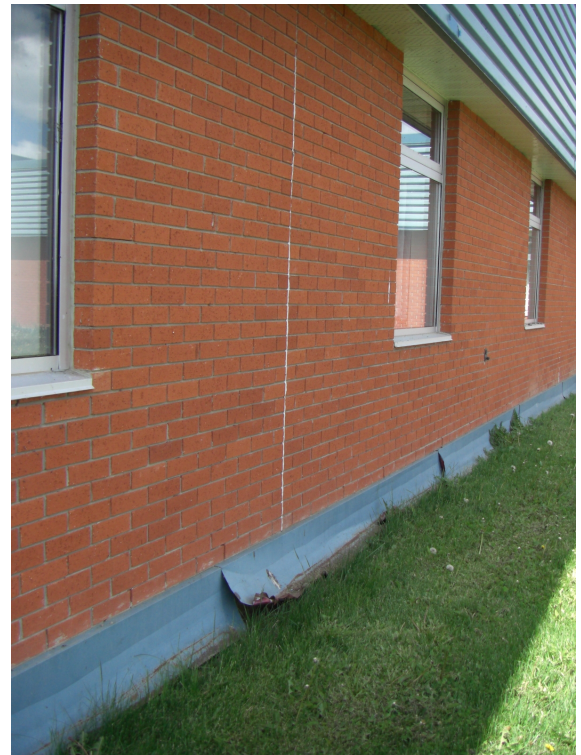
(1989) Original Building - has damaged prefinished metal skirting along foundation walls.

Replace prefinished metal skirting. (approx. 200 linear metres)

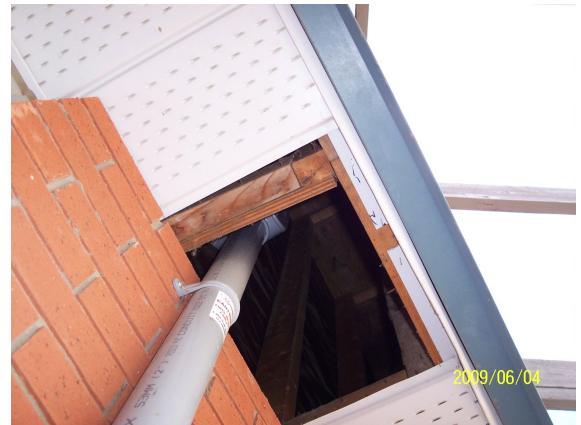
(1989) Original Building (Overhangs) - has missing prefinished perforated metal soffit.  
 (1989) Original Building (Northeast corner of Ambulance) - has damaged prefinished perforated metal soffit.  
 (1989) Original Building (overhang near Laboratory 162) - has damaged prefinished metal soffit

(1989) Original Building (overhang near File Room 03) - has missing prefinished metal soffit.

Repair prefinished metal soffit. (approx. 30 linear metres)

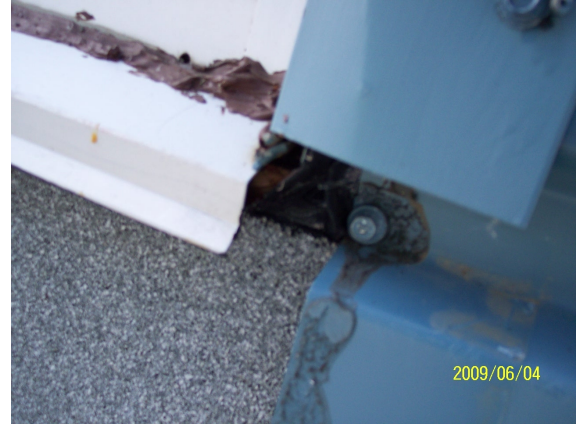
(1989) Original Building (Long Term Care - Patient Rooms 111, Lounge 82) - has worn out gaskets.  
 (1989) Original Building (Cafeteria - Nourishment 44) - has broken windows.  
 (1989) Original Building (Clerestorey of Nursing Station 148) - window sill is too short.

(1989) Original Building (Clerestorey of Nursing Station 148) - window sill is too short.

Repair window sill; replace broken glass and replace gaskets. (approx. 8 windows)
