MOWER FALLS ON WORKER

Type of Incident: Fatality

Date of Incident: November 18, 2009

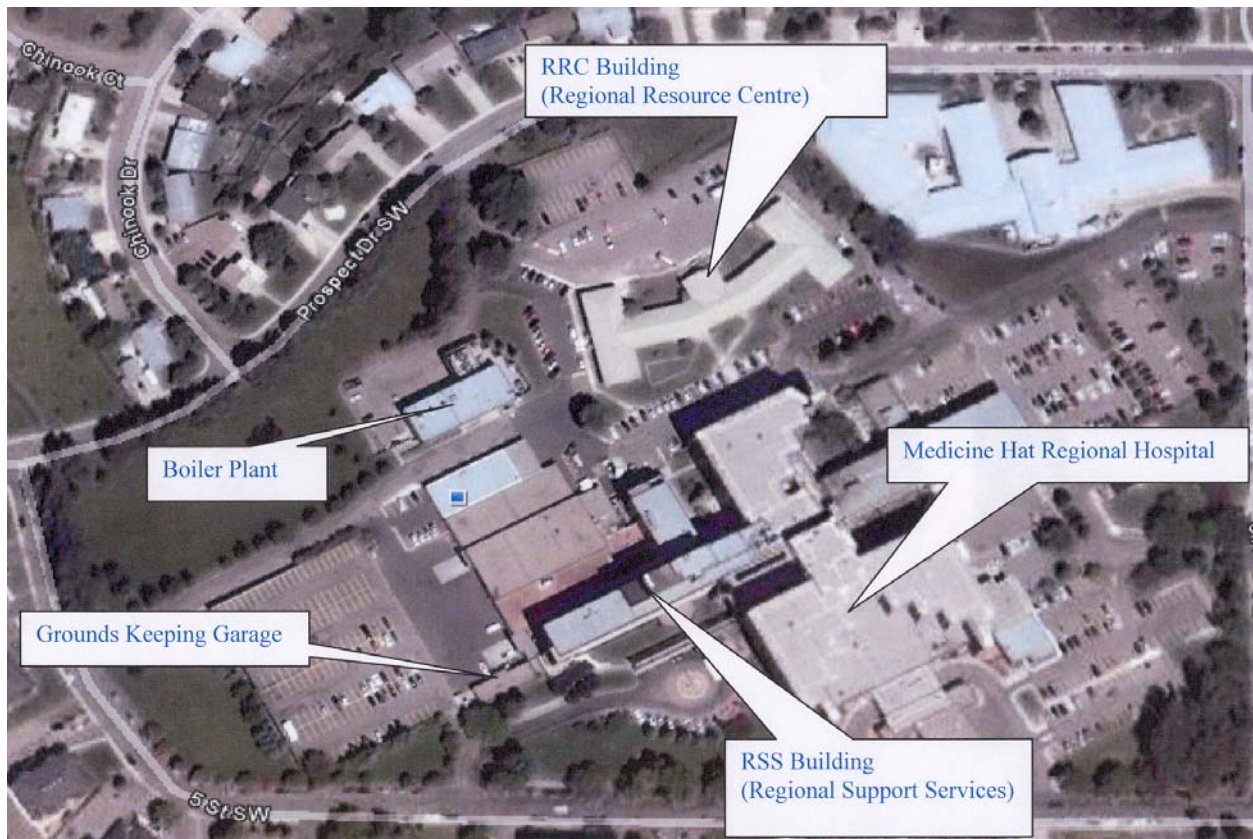
Photograph 1 - Shows the layout of all buildings at the Medicine Hat Regional Hospital site. The incident occurred in the Grounds Keeping Garage (maintenance garage).

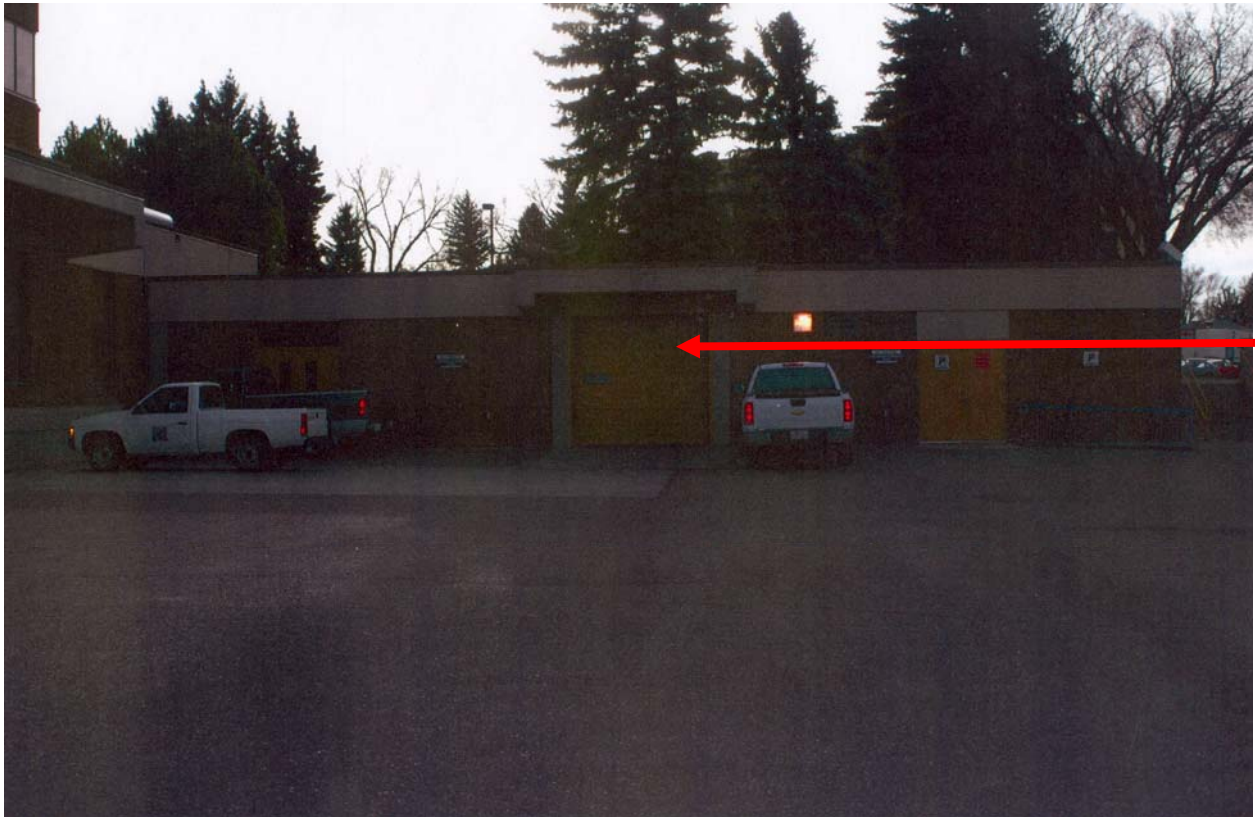
Photograph 2 – Red arrow shows the overhead door into the maintenance garage where the incident occurred.

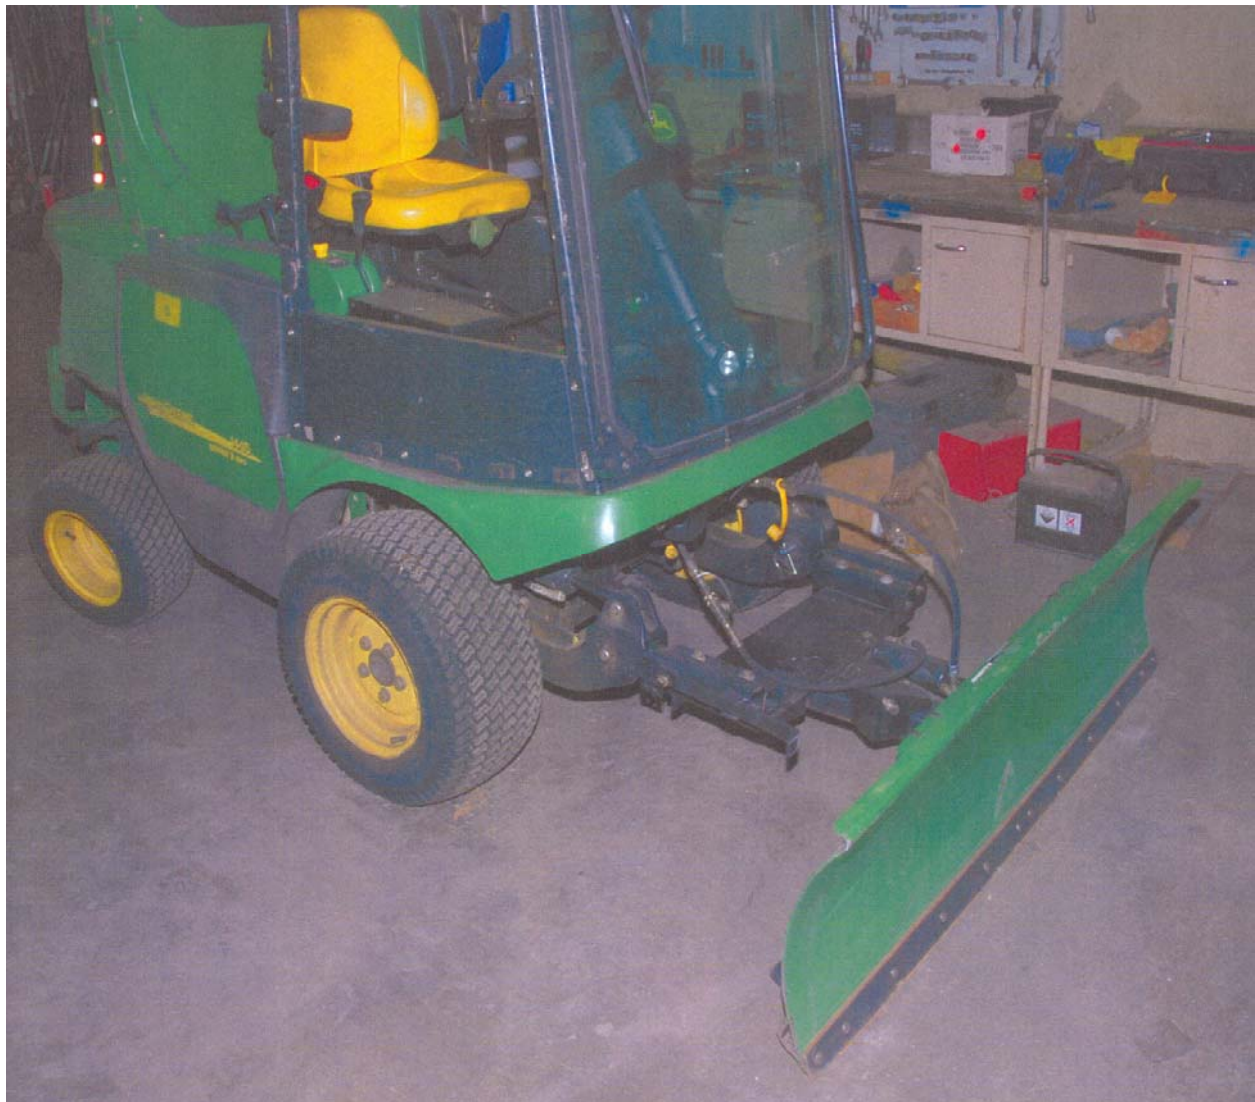
- 5.1.1 The equipment involved in the incident was a John Deere mower, Model 1445, four-wheel drive, Product Identification Number TC1445D060608, used for lawn mowing and snow removal. The left rear wheel had temporarily been removed for servicing (Refer to Attachment B - Photographs 3 and 4).
- 5.1.2 A single, wood block measuring approximately 45 centimeters long, 14 centimeters wide and 14 centimeters deep was found under the rear end of the mower. This wood block was used to support the back end of the mower in the raised position prior to the incident (Refer to Attachment B - Photograph 5).

Photograph 3 – Shows the John Deere Model 1445 mower involved in the incident.

8.2.2 AHS had the John Deere 1445 mower (Product Identification Number: TC1445D060608) inspected and repaired in accordance with the manufacturer's specifications.

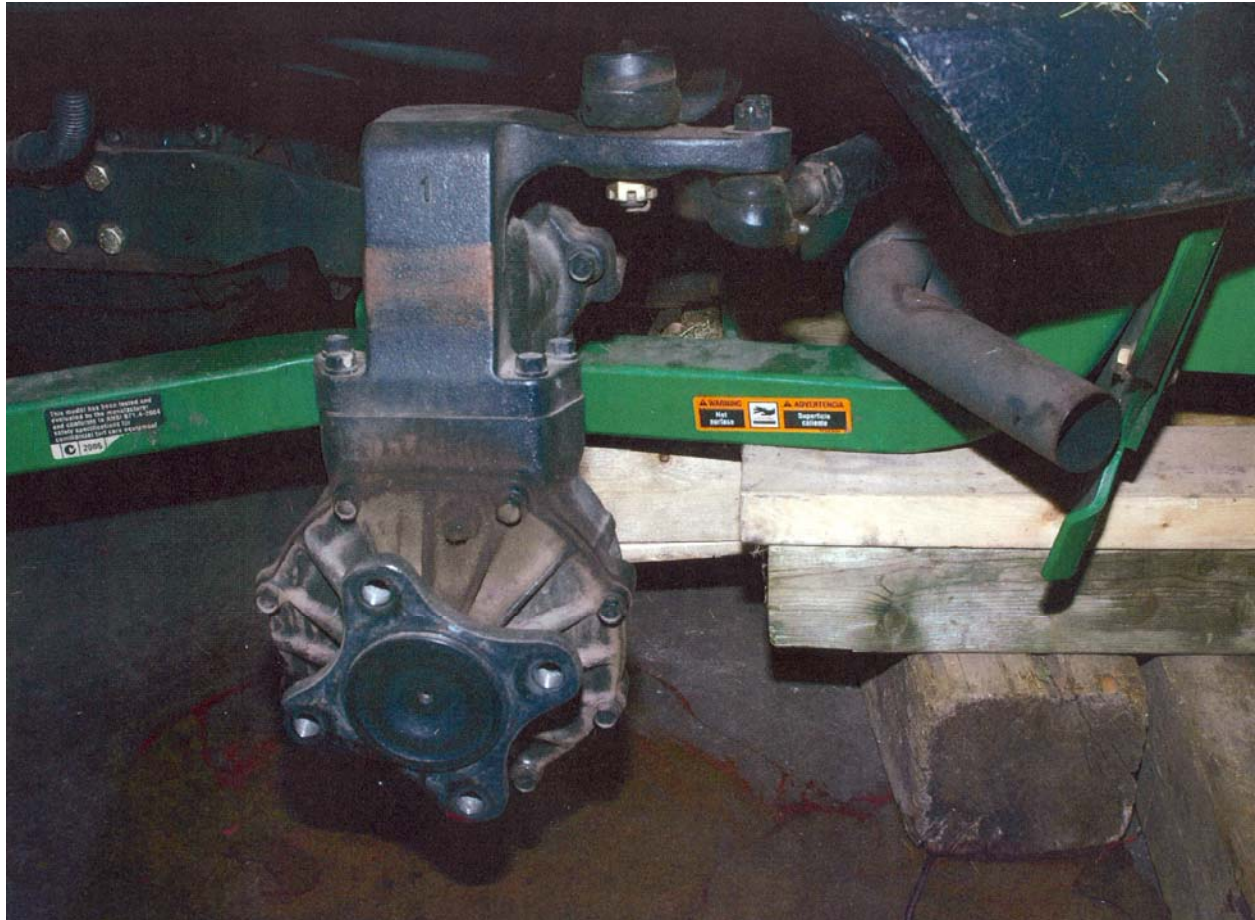
Photograph 4 – Shows the left rear hub of the John Deere 1445 mower. The wheel had been removed for servicing.

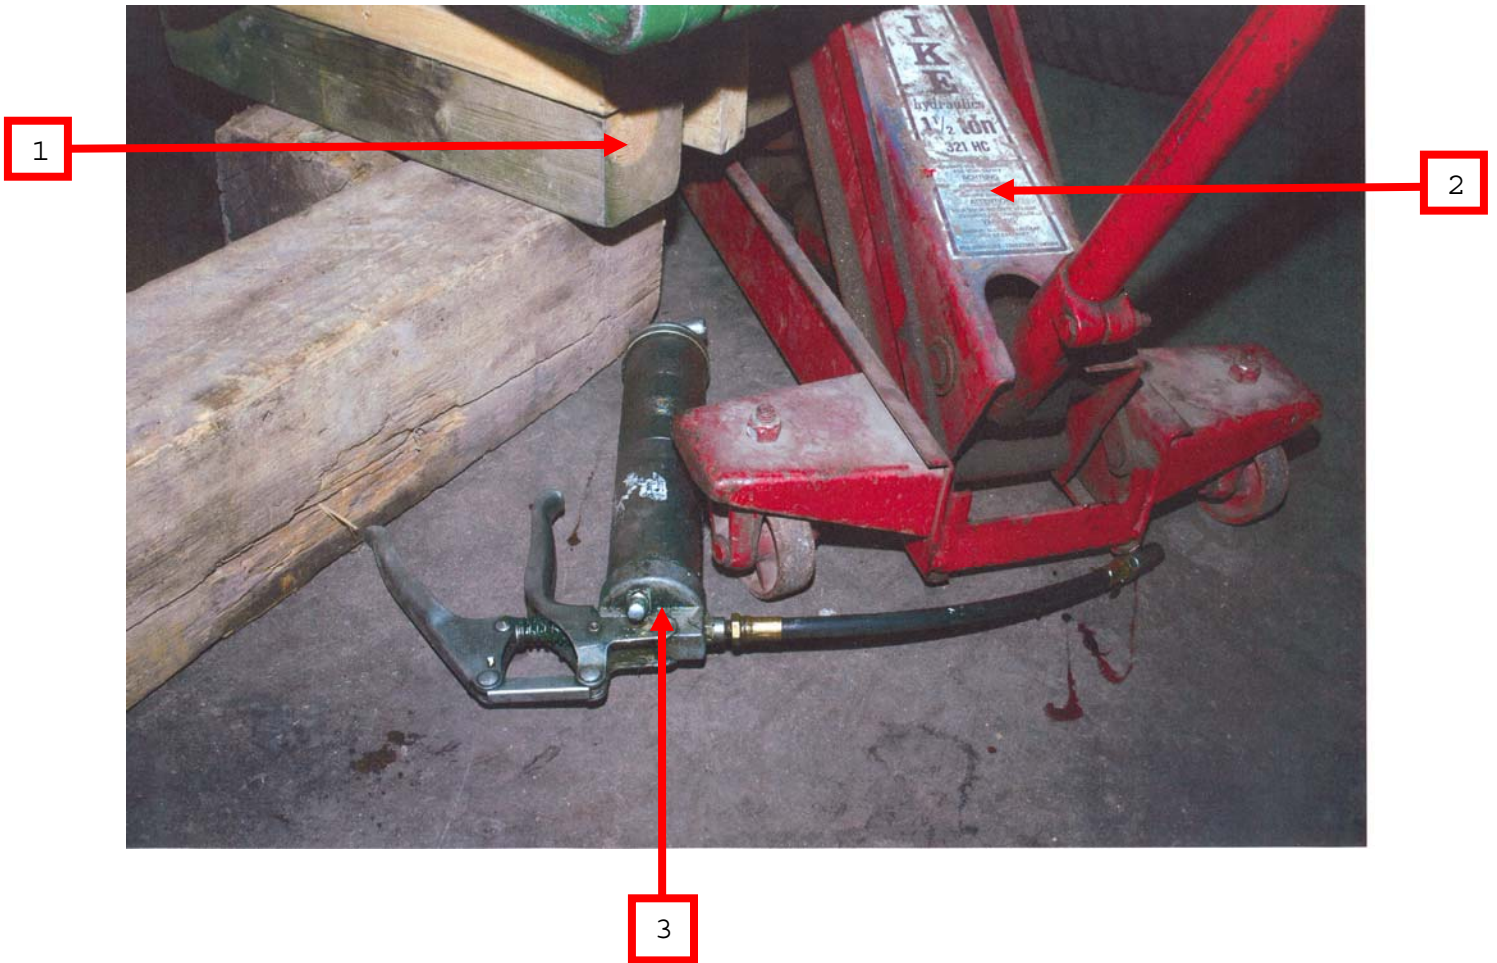
Photograph 5 – Shows:

- 5.1.3 A Nike, Model 321HC, 1.5 ton hydraulic floor jack, Serial Number 23597-4, was found approximately 1.5 meters behind the mower. This jack was found with the hydraulics in the lowered and released position (Refer to Attachment B - Photograph 5).
- 5.1.4 A hand-operated grease gun was found in Worker 1's (*****) left hand (Refer to Attachment B - Photograph 5).

- 7.1.1 Worker 1 (*****) was fatally injured when the mower fell on him.

- 7.2.1 A single wood block was used to support the raised back end of the mower. This was not in accordance with the manufacturer's specifications for blocking procedures.
- 7.2.2 No hazard assessment was conducted for maintenance of the mower.

1. A wood block 45 centimeters long was used to support the mower in a raised position. It was found under the rear end of the mower.
2. The hydraulic floor jack that was found approximately 1.5 meters behind the mower.
3. The hand-operated grease gun found in Worker 1's (*****
left hand.

- Conduct a hazard assessment for maintenance work performed on powered mobile equipment, communicate hazards to affected workers and implement controls.
- A stop use order on the John Deere 1445 mower (Product Identification Number: TC1445D060608) to ensure the unit has been inspected and repaired in accordance with the manufacturer's specifications.
- Review and update the employer's working alone policy and procedures.
- Conduct an incident investigation and prepare a report outlining the circumstances surrounding the incident, including preventive measures.
