Occupational Health and Safety

Fatality Report

**WORKER IMPALED WITH
KINLEY TOOL CUTTER**

Date of Incident: February 2, 2007

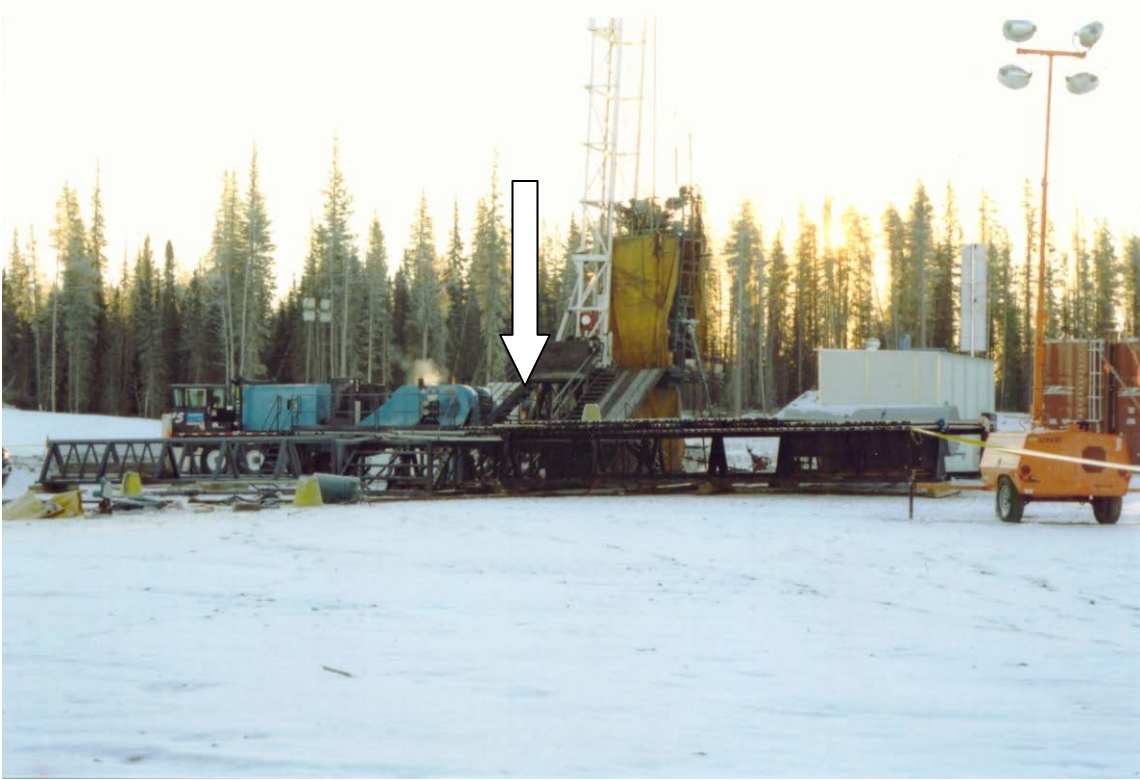
5.1 Slickline Tool (Attachment “A” Photograph#1)

Photograph #1 The Brandette service rig set-up.
The arrow is directed at the catwalk where the tubing had
been placed.

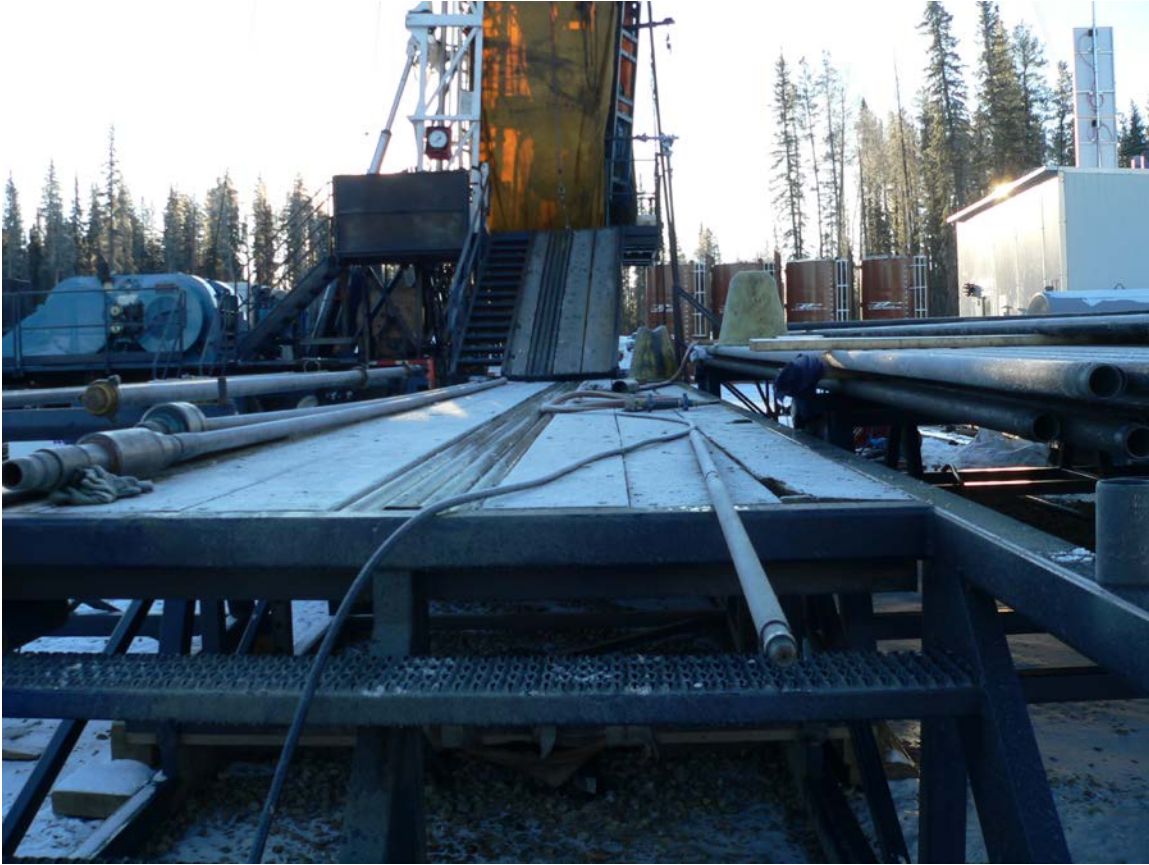
6.1 On February 2, 2007 High Arctic Energy Services LP workers tripped the tubing out of the well with the slickline tools stuck inside and placed it on the catwalk unsecured. The Well Site Supervisor was informed that there was trapped pressure in the tubing. (Attachment “A” Photograph #2) The workers involved in removing the stuck slickline tools were, the Well Site Supervisor, two well testers from Wespro Well Production Testing and a Kodiak Wireline Worker. The two well testers volunteered their services to assist the other workers trying to remove the stuck slickline tools inside the tubing string. 1228462 Alberta Limited was contracted to Wespro and he became the victim.

Photograph #2 Closer view of the catwalk where the tubing had been placed with the slickline tools stuck inside.

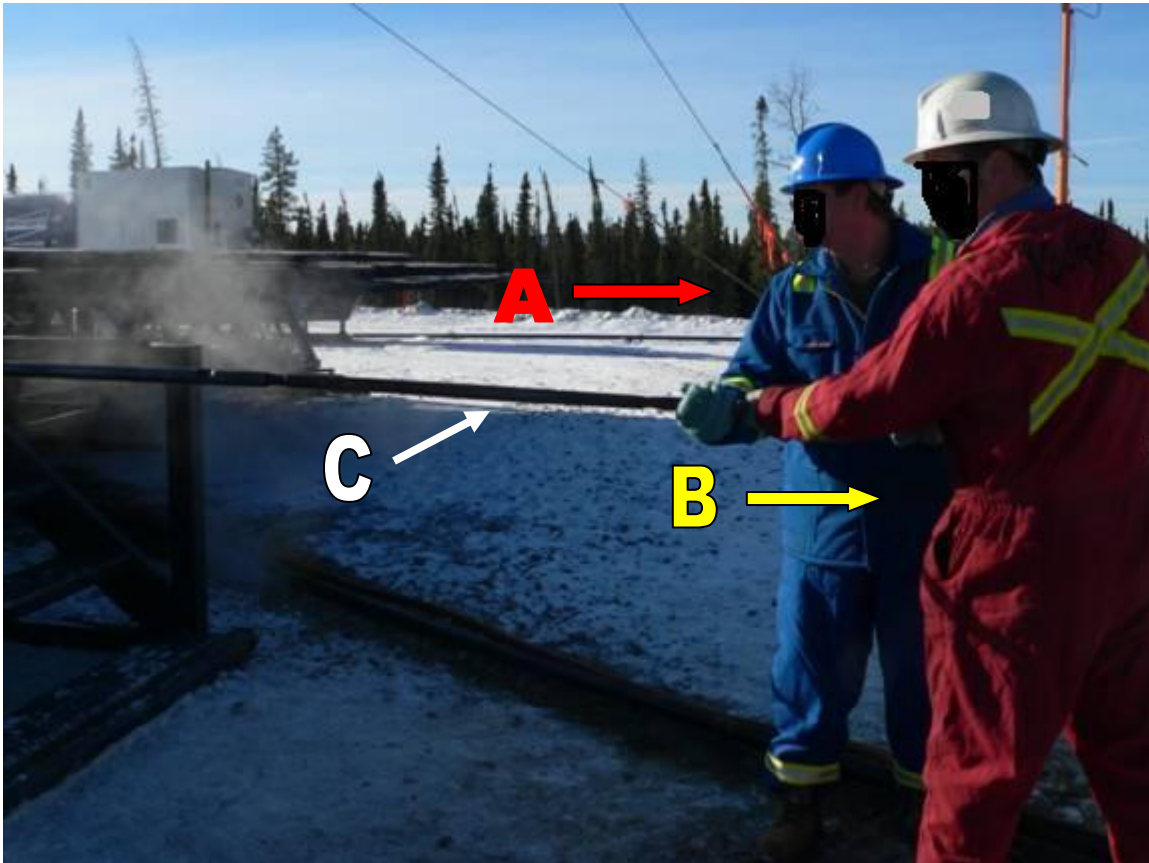
Photograph #3

- 6.4 When the tubing was jarred it released the trapped pressure caused by the tool stuck inside the tubing. As the tubing was not secured to the catwalk when the pressure was released the end of the tubing moved slightly to the left and the other end was forced back against the steps of the catwalk. (Attachment “A” Photograph # 3) When the tubing moved it was pointing in the direction of where the owner of 1224862 Alberta Limited was positioned.

Shows where the workers were positioned at the end of the catwalk when they were jarring on the stuck slickline tools inside the tubing string.

Arrow A is where the owner of 1228462 Alberta Limited was positioned.

Arrow B is where the Kodiak worker was positioned.

Arrow C indicates the direction the tubing moved when the trapped pressure released when it struck the stairs on the catwalk.

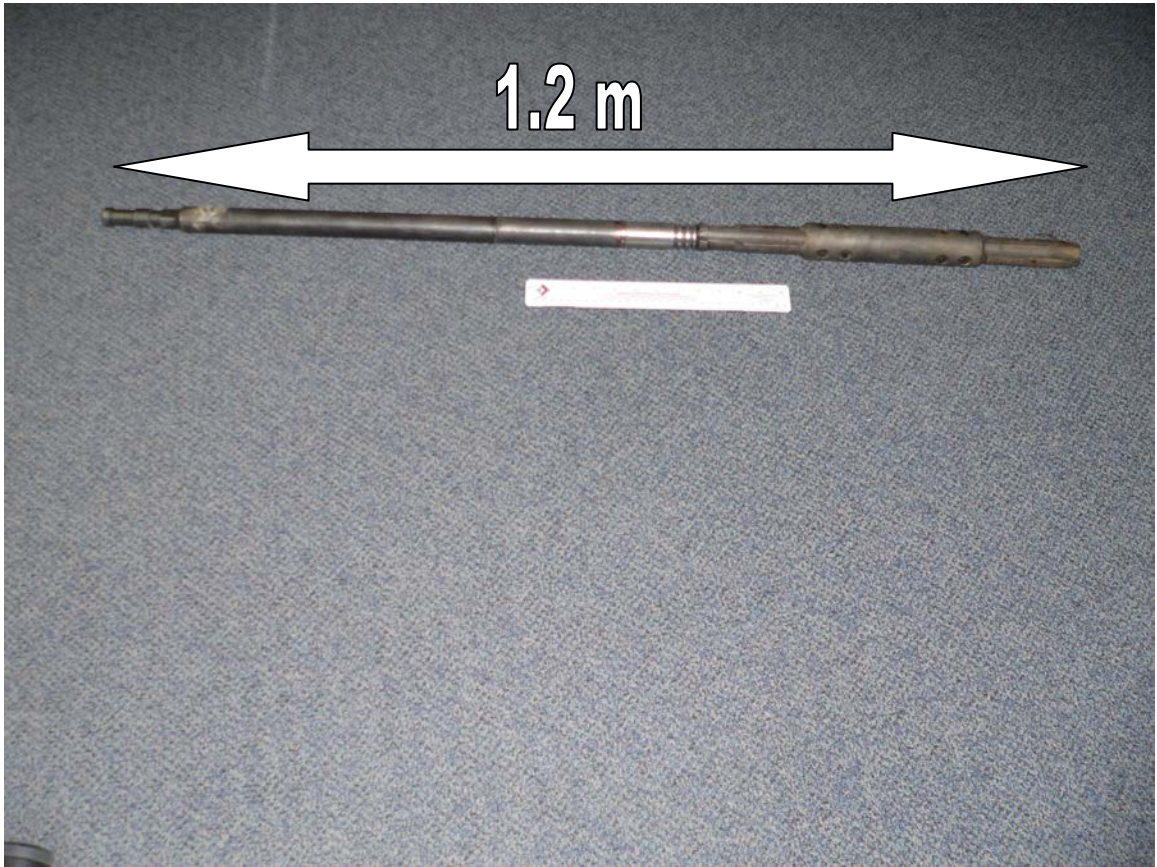
- 6.5 The Kodiak Worker was struck in the facial area with sand and other debris and the owner of 1228462 Alberta Limited was impaled in the left lower back region with the Kinley tool cutter. (Attachment “A” Photograph #4)

- 7.1.1 A worker was impaled with a Kinley tool cutter when it expelled under pressure out of a tubing string.

Photograph #4 View of the Kinley tool cutter that impaled the worker.
This tool was stuck inside the tubing which the workers
were attempting to remove.
