**WORKER RUN OVER WITH GRADER**

Type of Incident: Fatality

Date of Incident: May 27, 2010

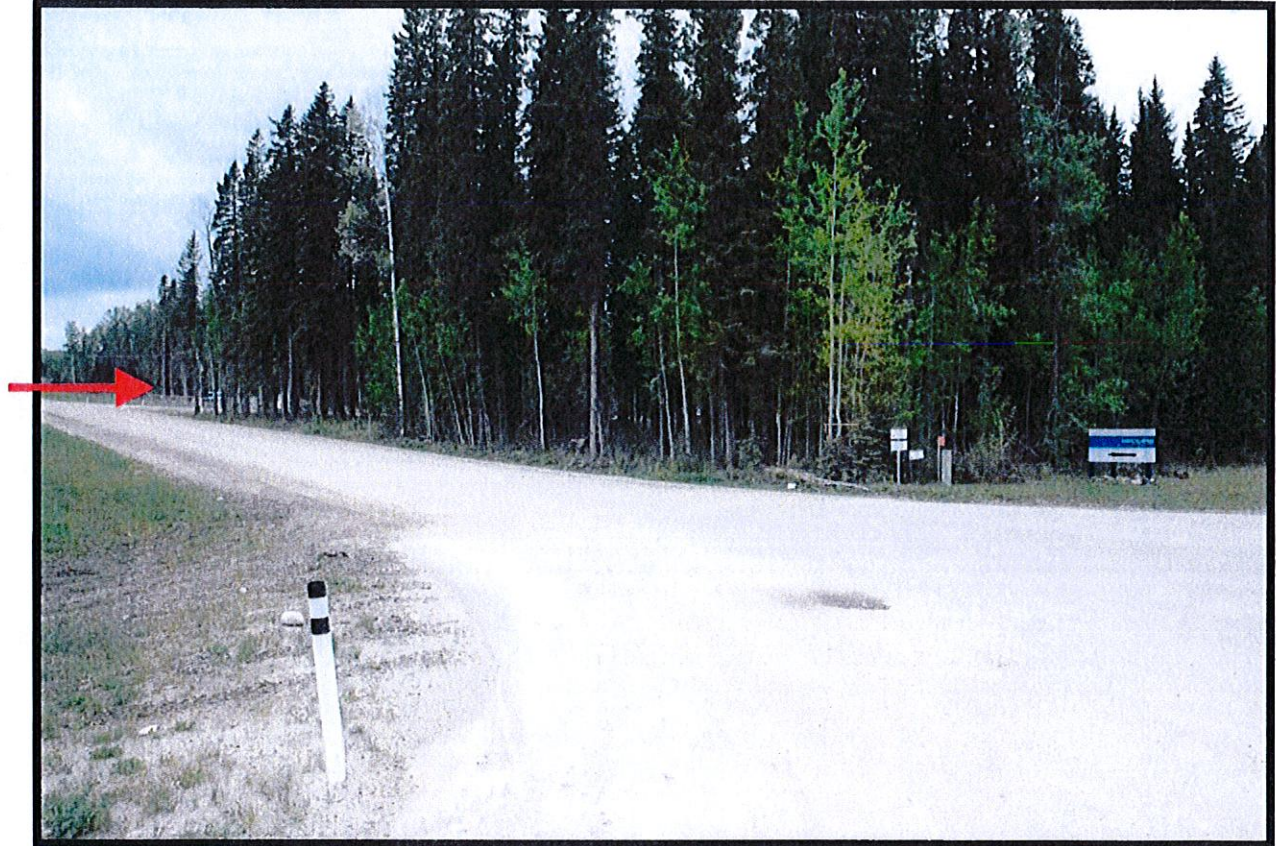
**Photograph 1** – Shows the entrance to the Willesden Green Class II Landfill from Highway 22.  
The arrow shows the access on to the landfill site.

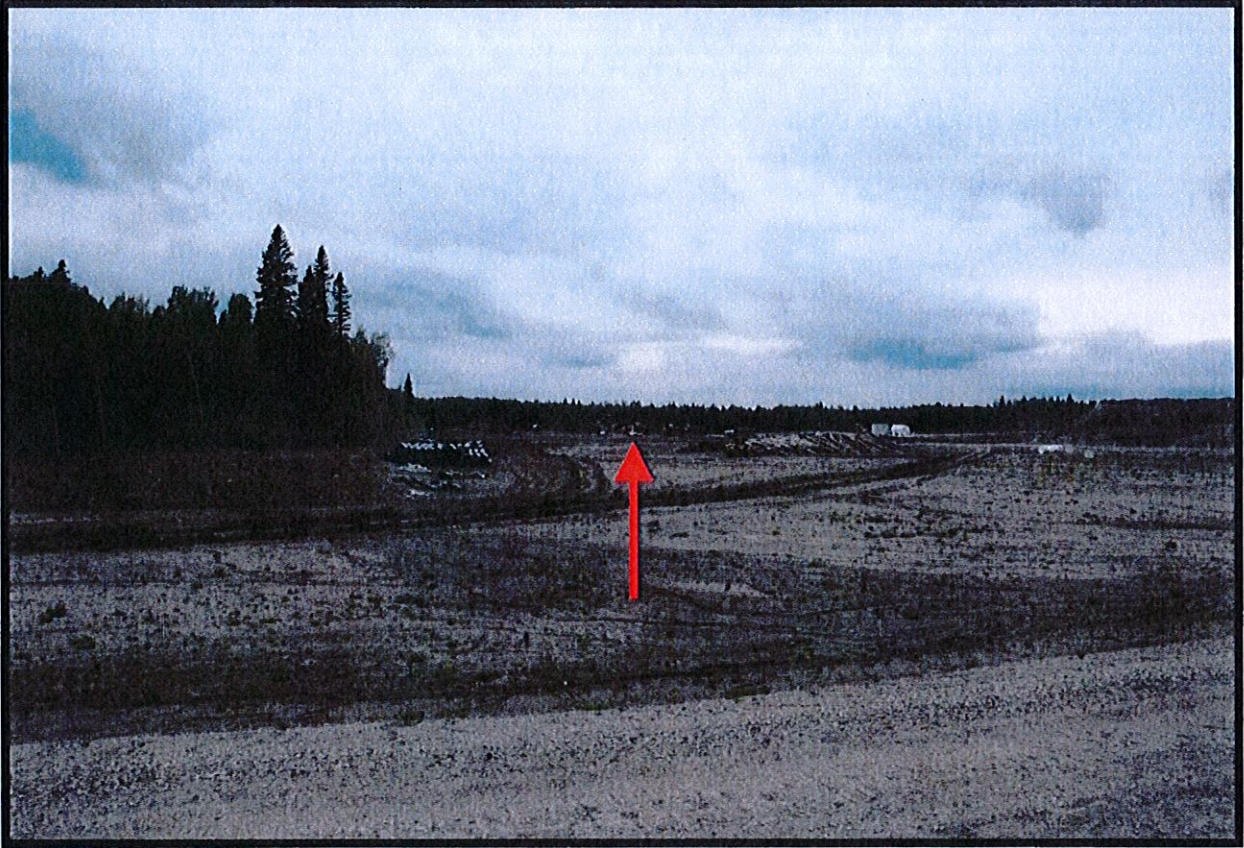
**Photograph 2** – Shows an overview of the incident site from the access road. The arrow shows the approximate location of the incident.

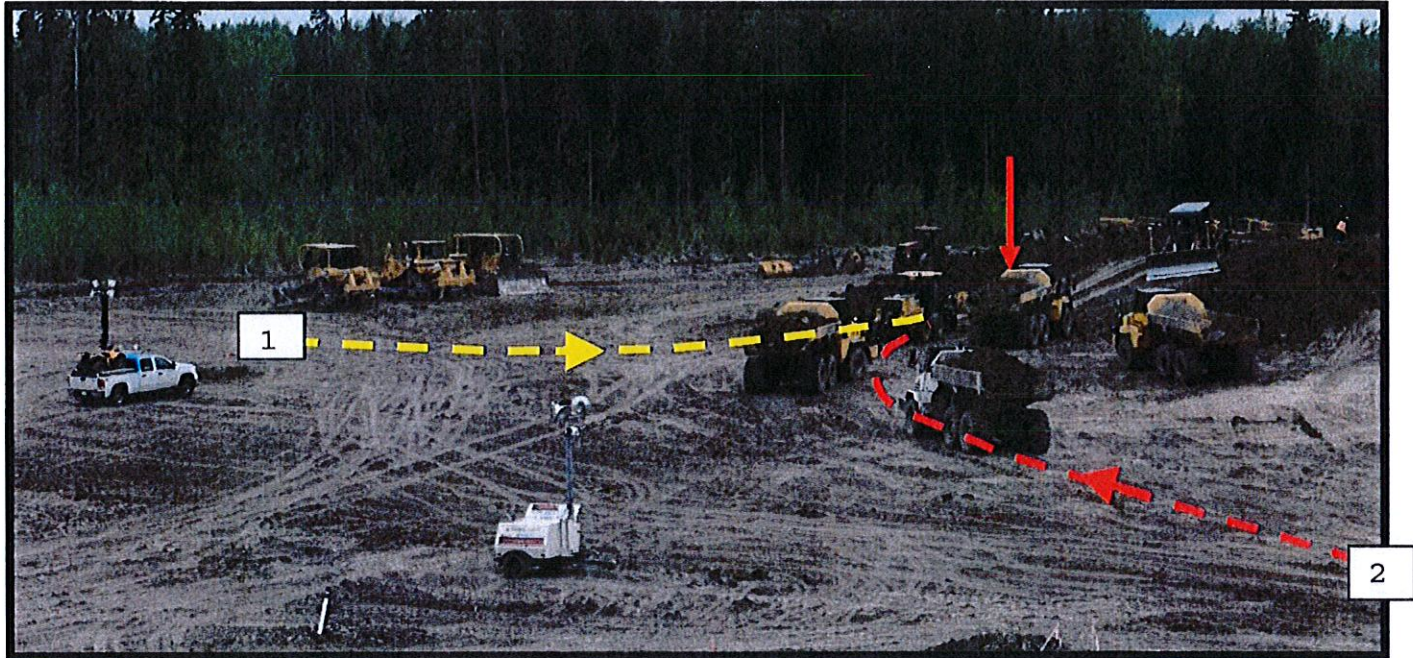
**Photograph 3** – Shows an overview of the incident site. The arrow shows the approximate location of the incident.

1. Approximates the path the Supervisor ( ) took when he walked to the D6R dozer
2. Approximates the route the Grader Operator ( ) travelled

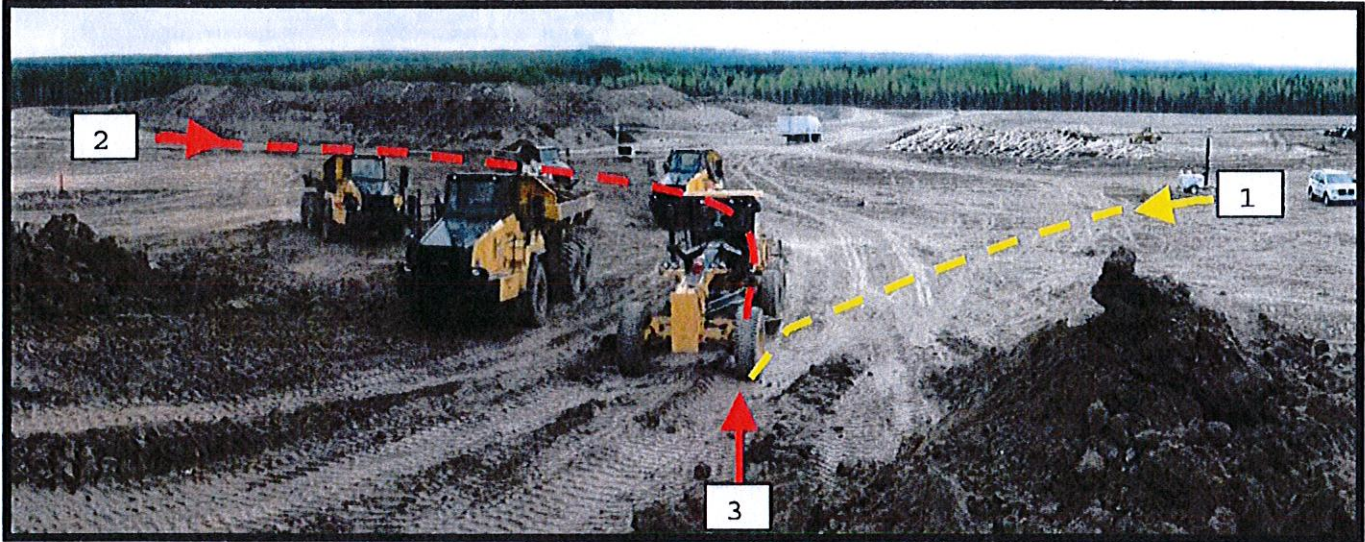
**Photograph 4** – Shows an overview of the incident site. The arrow shows the approximate location of the incident.

1. Approximates the path the Supervisor ( ) took when he walked to the D6R dozer
2. Approximates the route the Grader Operator ( ) travelled
3. Approximate location where the grader contacted the Supervisor ( )

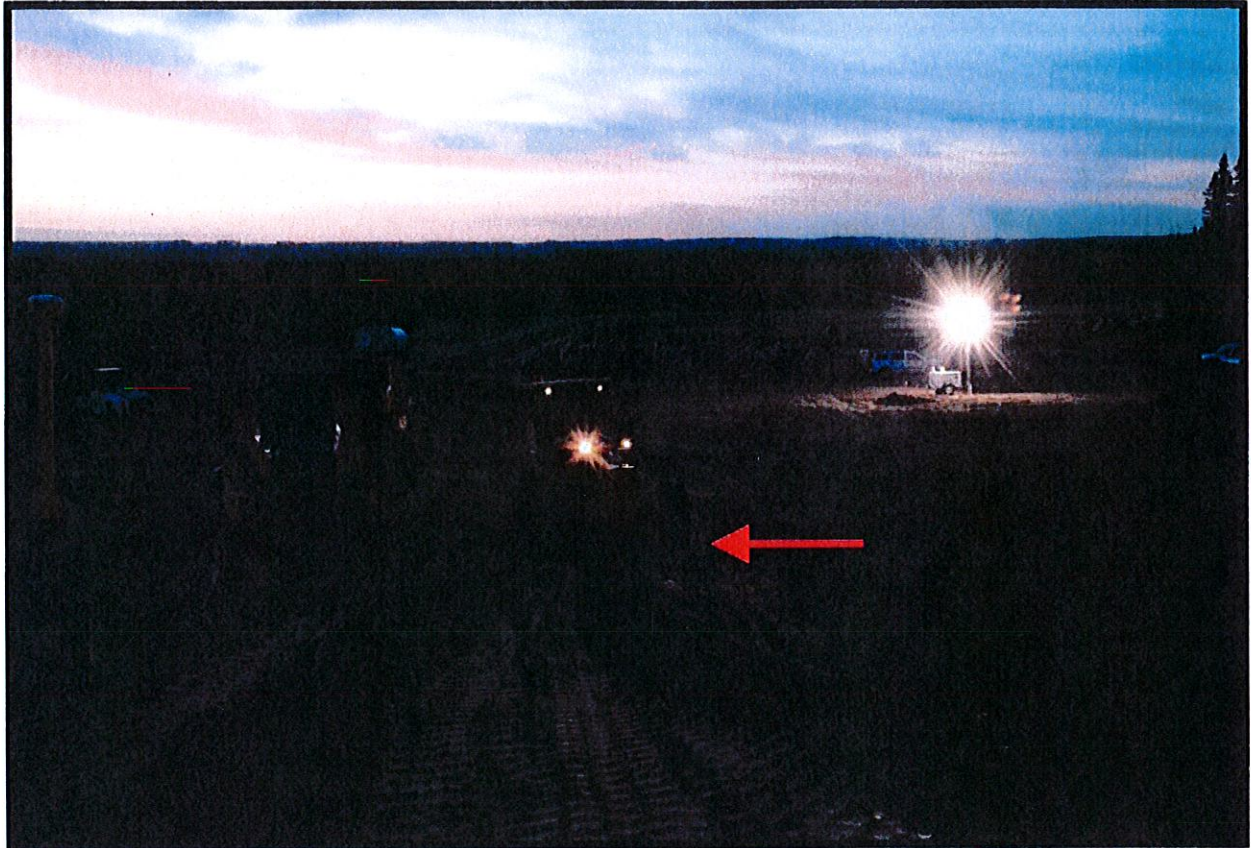
5.1.1 The grader involved in the incident was a John Deere 872D Grader. It was a six wheel drive grader that weighed approximately 19,200 kilograms. The estimated weight on the front axels, based on the manufacturer's specifications was 5,200 kilograms or 2,600 kilograms per wheel (Reference Attachment B – Photograph 5).

**Photograph 5** – Shows an overview of the incident site with the grader lights on and the light plant operating. The arrow shows the approximate location of the incident.

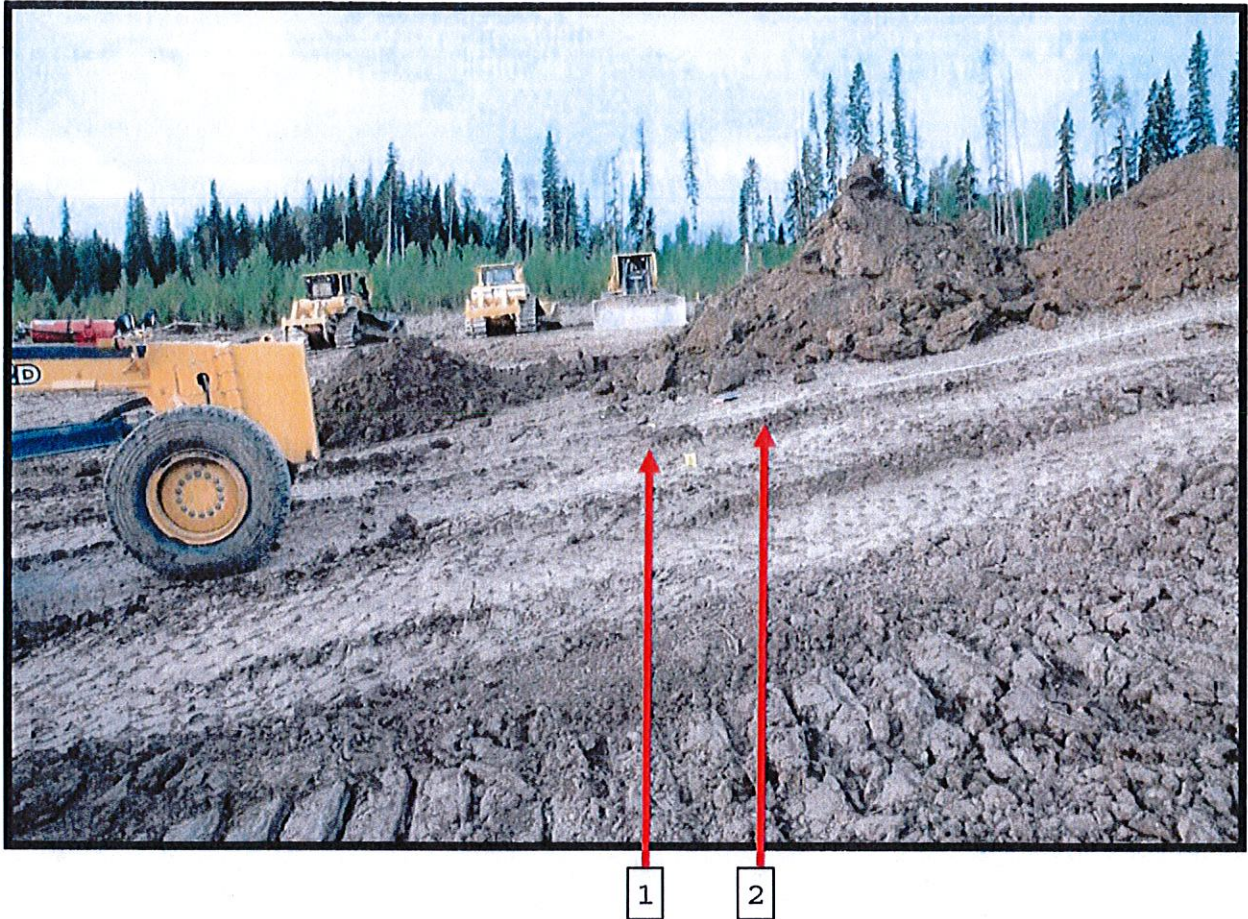
5.1.2 The grader's front head lights illuminated the ground in front of the grader approximately 14 meters ahead of the front wheels (Reference Attachment B – Photograph 6).

**Photograph 6** – Shows a side view of the incident site.

1. Approximate location where the Supervisor / \_\_\_\_\_ was contacted by the grader.
2. Approximate location where the grader head lights shine on the ground

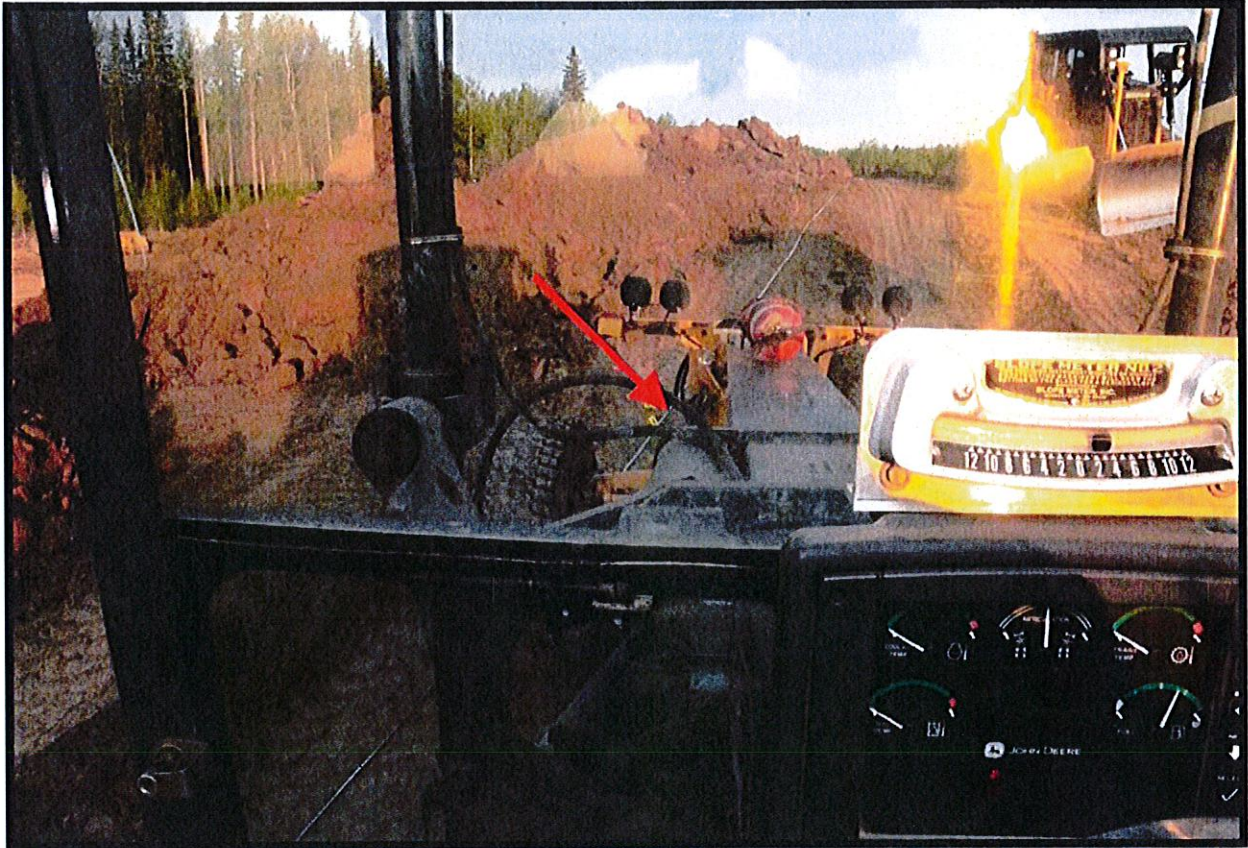
5.1.3 The normal position of the grader operator when grading is to sit in the operator's seat and lean slightly to the side where the blade tip is visible. The grader operator would normally look down and monitor the blade tip while grading to check the depth of cut. The operator's view immediately in front of the grader was partially obstructed by the push block and angle indicator (Reference Photographs 7).

**Photograph 7** – Shows the Grader Operator's ( ) view while leaning to the left during typical grading operations. The arrow shows the approximate location where the Supervisor ( ) was struck by the grader.

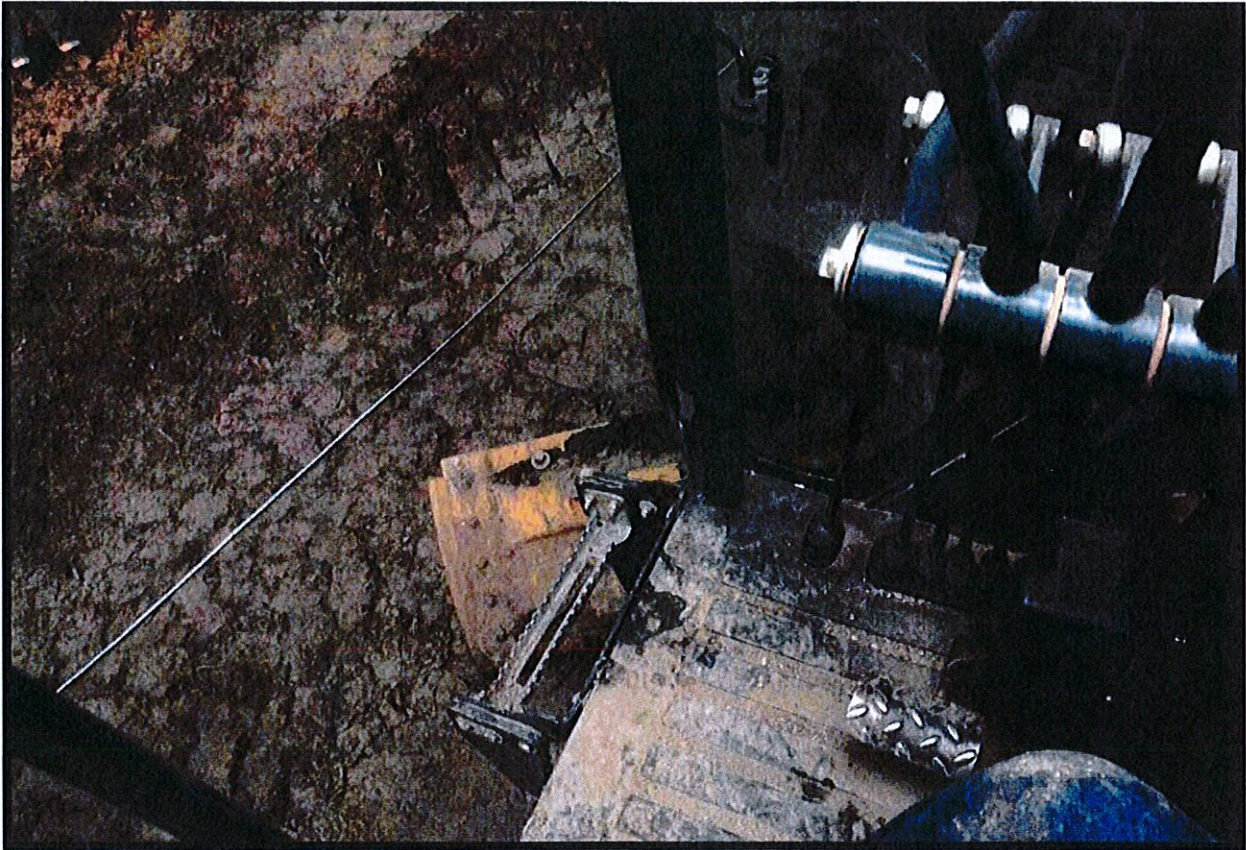
**Photograph 8** – Shows the Grader Operator's ( ) view while looking down at the grader blade. The front wheels are not visible while monitoring the blade tip.
