Worker fatally injured in fall from tank trailer

August 7, 2020

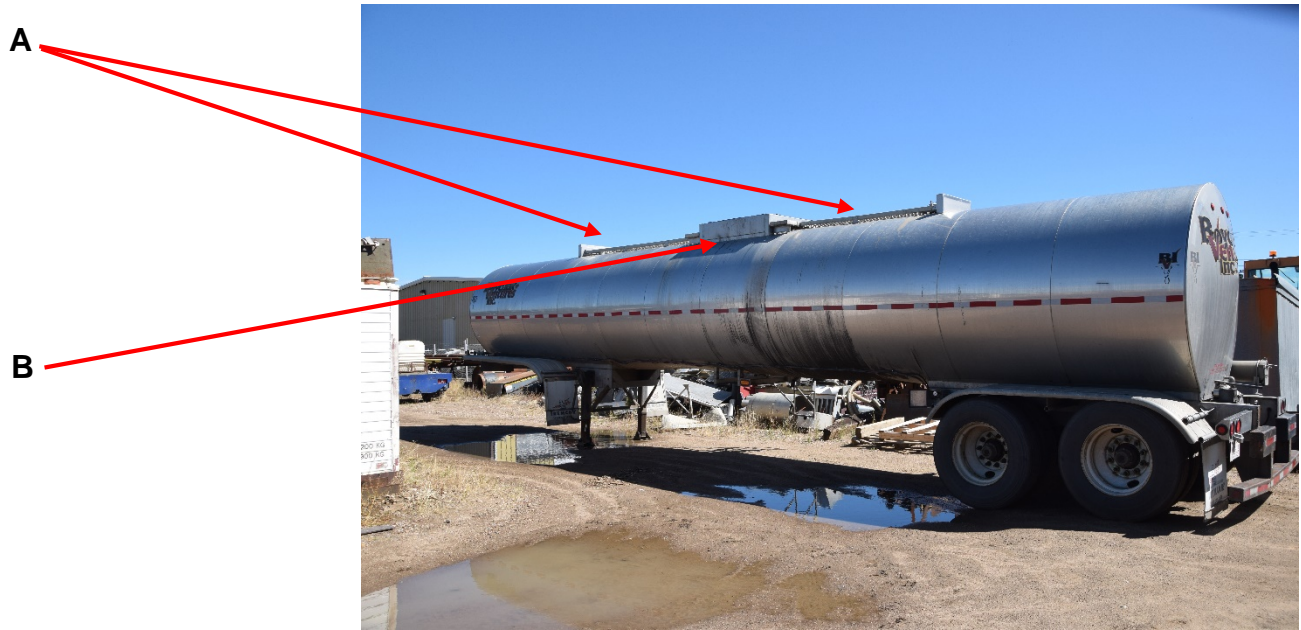
Figure 4. Tank trailer - driver's side

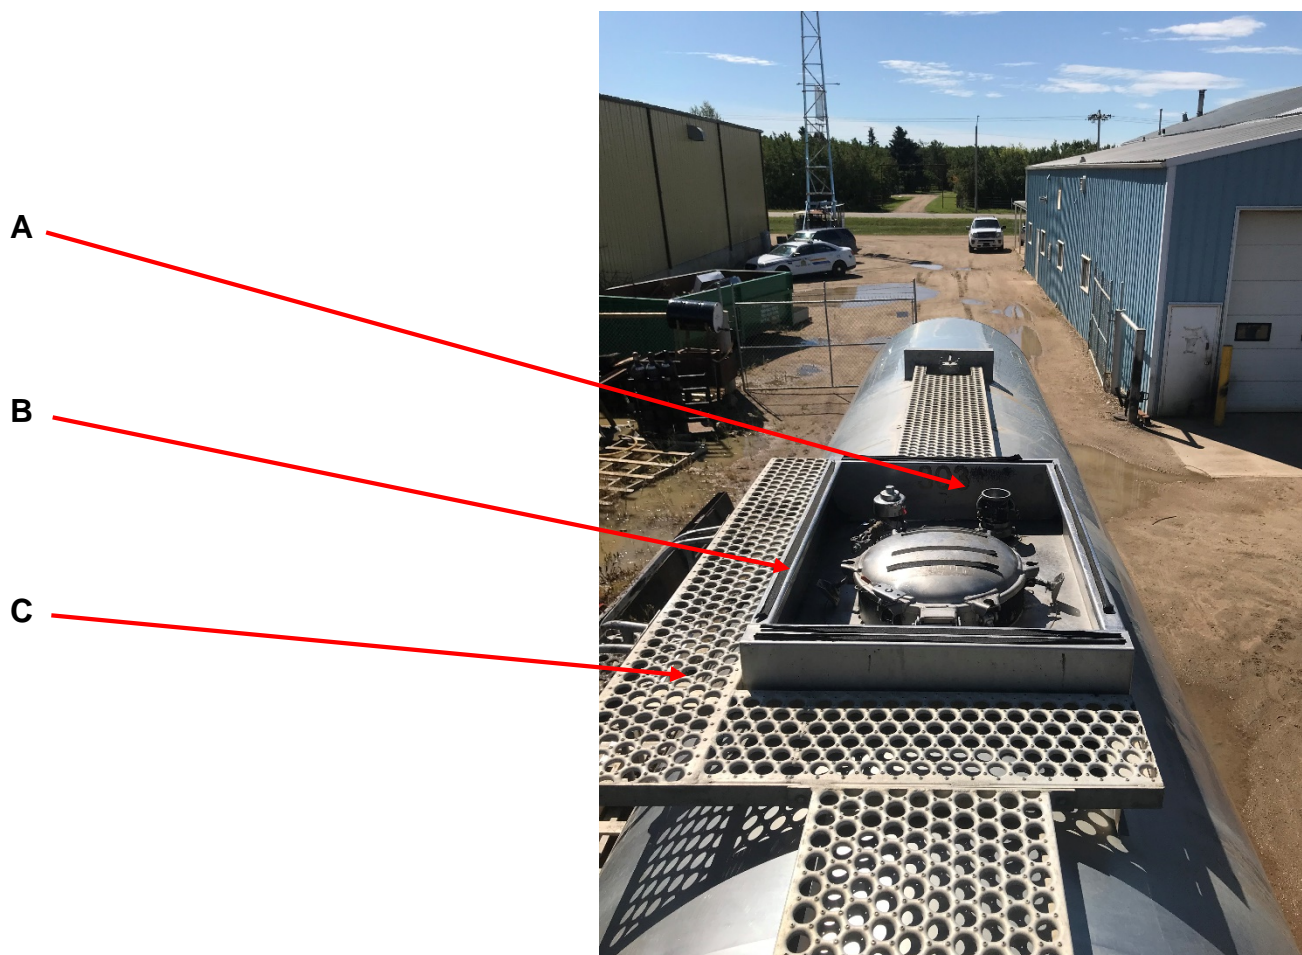
Figure 6. Top of tank trailer – catwalk and valve cluster
