Occupational Health and Safety

Fatality Report

**WORKER CRUSHED BY PUMPJACK
COUNTERWEIGHT**

Date of Incident: November 9, 2009

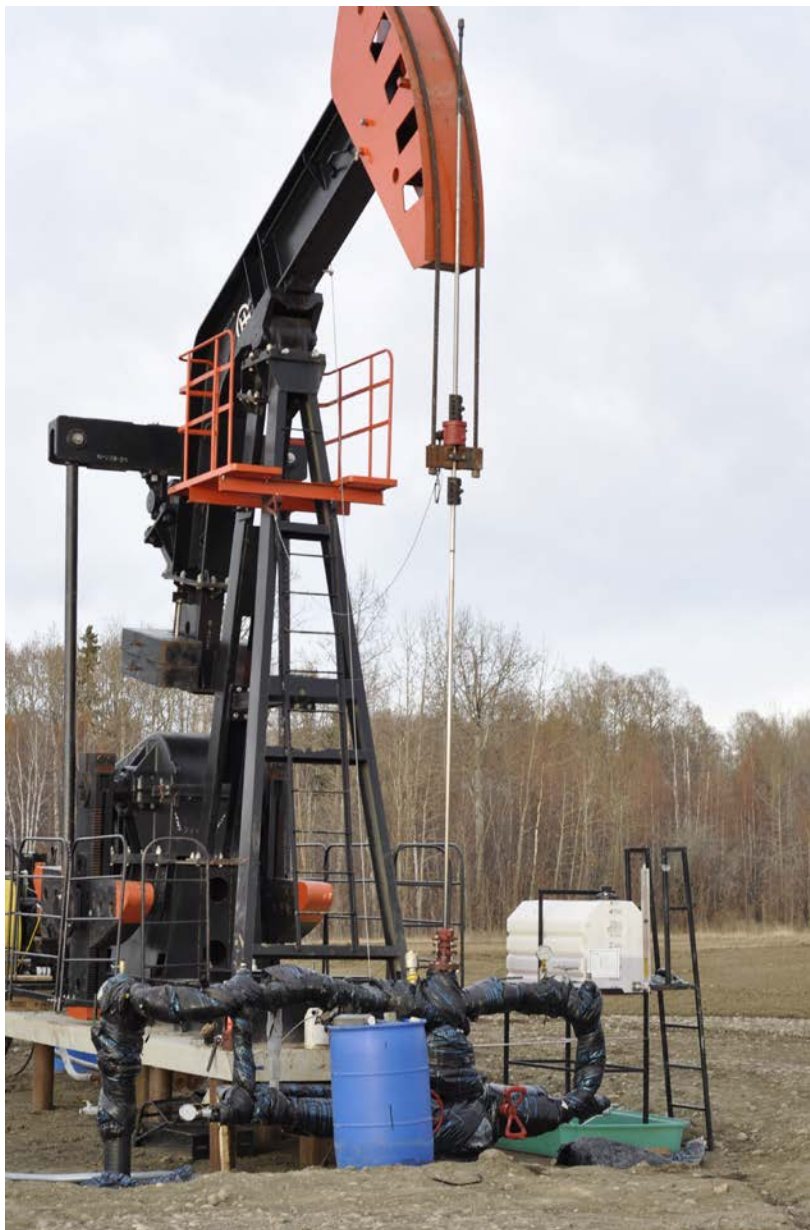
Photograph #1

5.1.1.1 Model # CW 228-213-100, Pumpjack specifications 7.5 m X 2.22 m X 7.06 m. The pump was commissioned on October 2009 and produced an average of 32 m³ per day. (Attachment C – Photographs # 1).

Shows the HG Walking Beam Pumping Unit, looking northeast.

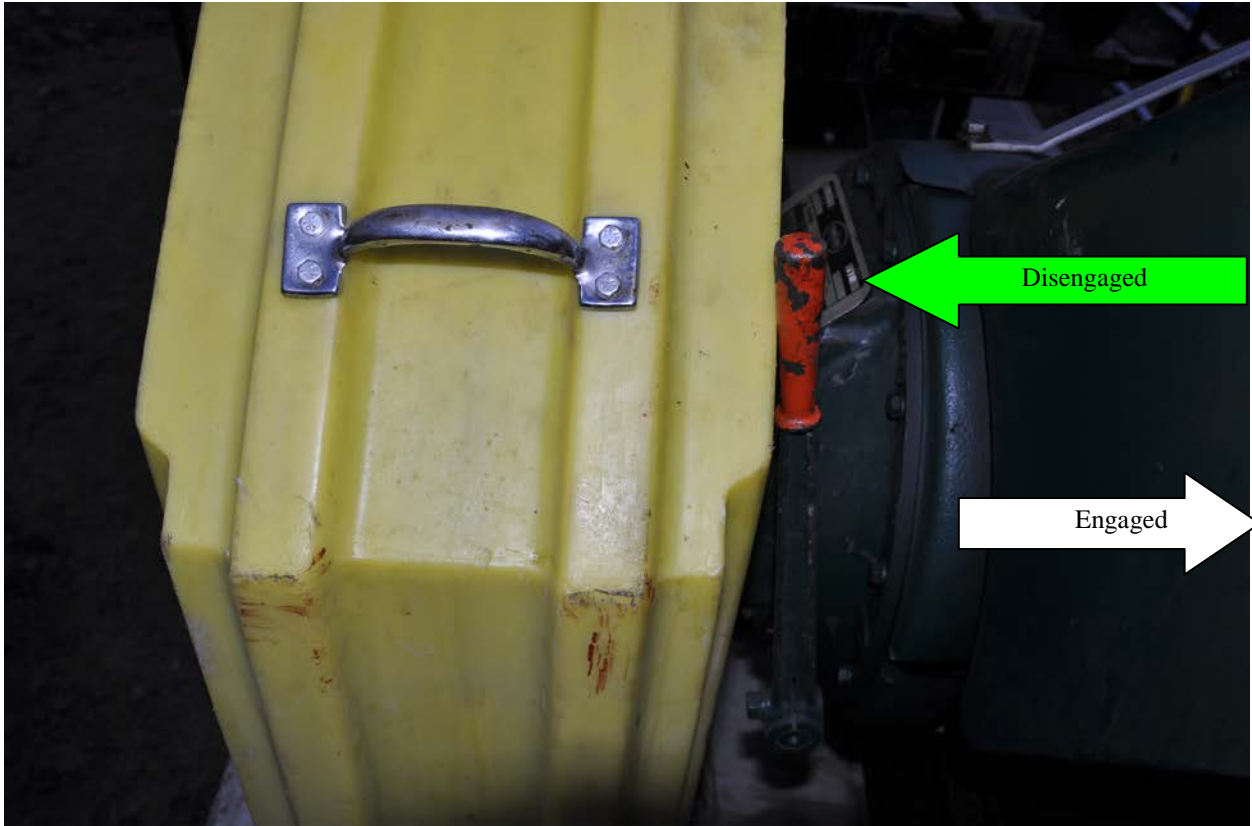
Photograph #2

5.2.2 The HG Walking Beam Pump Jack was observed with the clutch disengaged and the handbrake disengaged. The gas motor was turned off. Blood smears were noted on two gas valve handles and the belt drive cover. No blood was noted on the clutch handle. (Attachment C – Photograph #2).

Shows the clutch cover for the transmission was disengaged at the time of inspection. Note blood on the pulley cover.

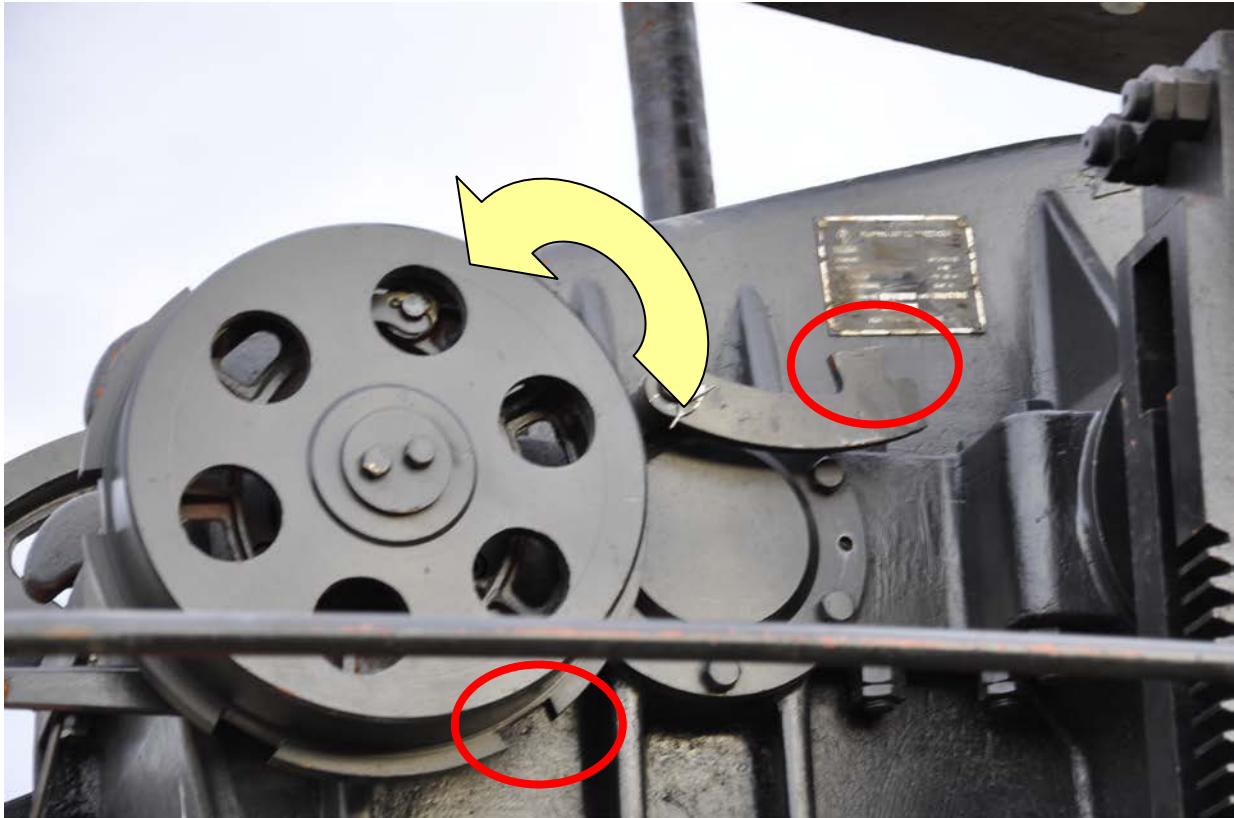
Photograph #3

5.2.3 The brake safety on the HG Walking Beam Pump was not engaged. Other lock out devices was not installed on the HG Walking Beam Pump. (Attachment C – Photographs #3, #4).

Shows that the lock out for the HG Walking Beam Pumping Unit was not engaged. The red circles denote the key and keyway. When the key is engaged with the keyway; the key acts as a lock to prevent the pump from turning.

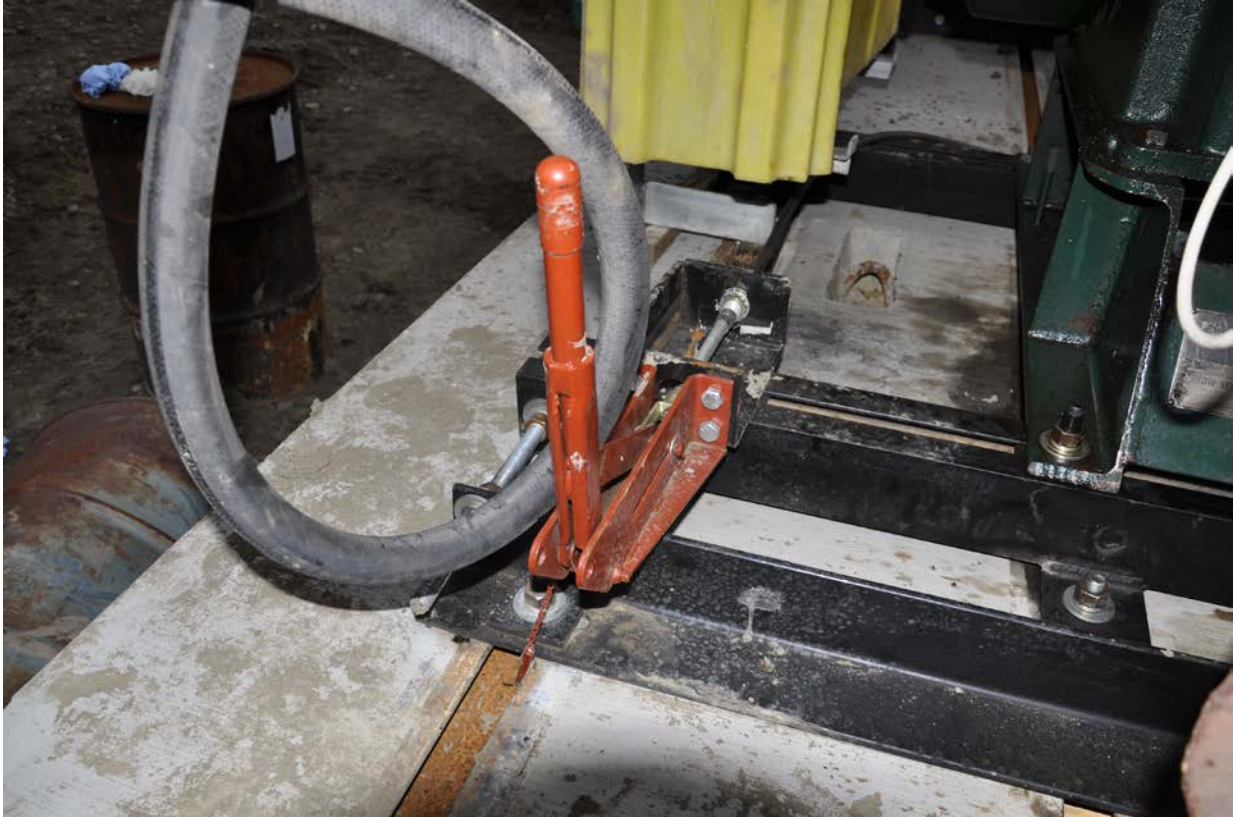
Photograph #4

- 6.6 The Site Supervisor [REDACTED] and the Labourer [REDACTED] disengaged the clutch of the pumpjack. The Site Supervisor [REDACTED] watched the rotation of the counterweight until it stopped. The Site Supervisor [REDACTED] indicated that the crank pin stopped at the 8:00 o'clock position. It was later determined that the brake was not engaged by the Labourer [REDACTED] at this time. (Attachment C – Photographs #2, #4)

- 7.2.1 The Site Supervisor [REDACTED] and the Labourer [REDACTED] did not manage and control the hazardous energy of the pumpjack's rotating counterweight. The Labourer [REDACTED] did not set the brake for the pumpjack to eliminate any accidental rotation of the counterweight.

Shows the brake mechanism handle was in the vertical position. The handle in this position does not engage the brake for the HG Walking Beam Pumping Unit. The brake is engaged when in the horizontal position or the handle is down.

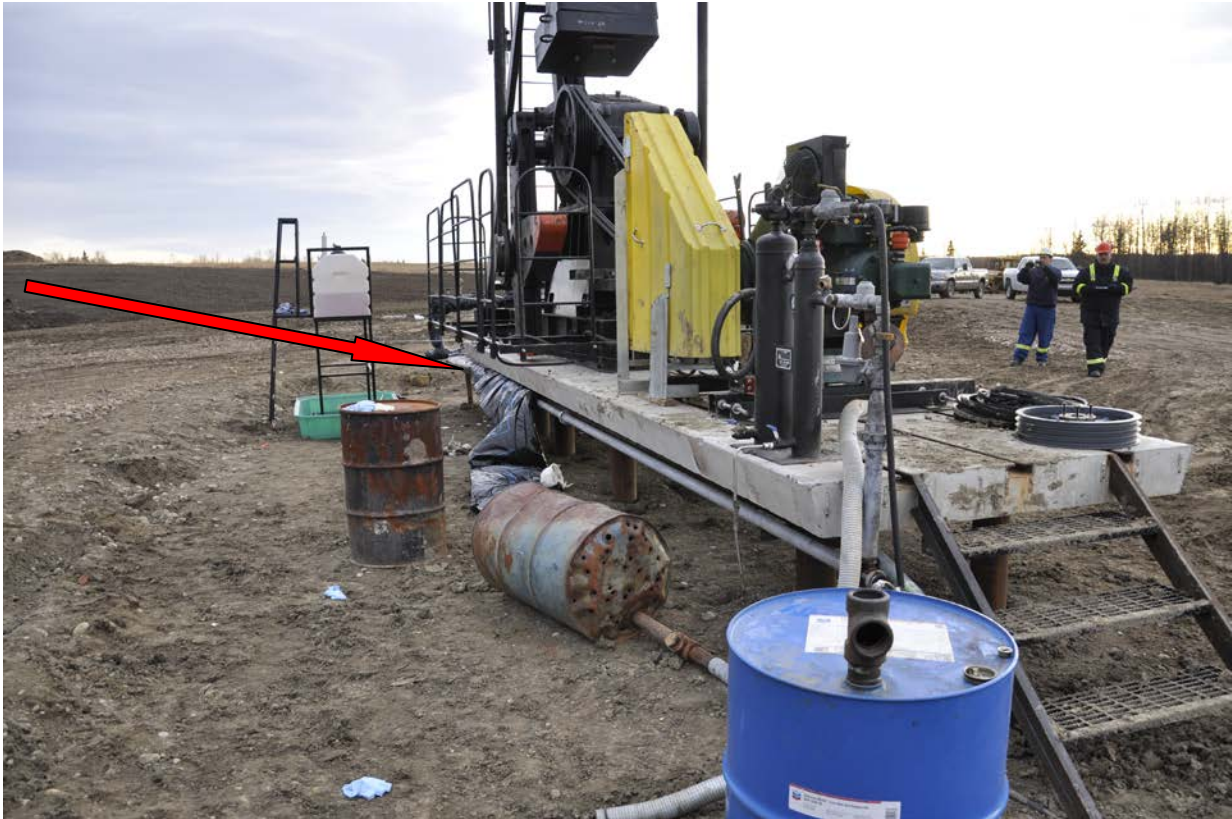
Photograph #5

- 6.10 Starting from the wellhead the Site Supervisor [REDACTED] and the Labourer [REDACTED] began wrapping the piping with new insulation. They proceeded north towards the motor on the east side. The Labourer [REDACTED] worked just ahead of the Site Supervisor [REDACTED] as they approached the fenced area of the crank pin and counterweight, where a length of the piping ran under the fenced area and below the cement pad. They were stuffing the insulation blanket in between the pad and the exposed piping. (Attachment C – Photograph #5)

The two workers were insulating the pipe running underneath the concrete pad. The Labourer [REDACTED] was working close to the counterweight when he was struck on the head.

- 8.2.1 The Owner, Sifton Energy Inc. conducted an investigation into the circumstances of the incident and implemented measures to prevent a re-occurrence. Sifton Energy Inc. added appropriate guarding around the pumpjack counterweight preventing workers from entering underneath.
- 8.2.2 The employer, Konan Oilfield Services Ltd. provided lock out training for all new employees and ensured that workers will be competent to do the work or be under the direct supervision of a person competent to do the work.
- 8.2.3 The employer, Konan Oilfield Services Ltd. co-operated by providing information requested by Occupational Health and Safety during the investigation.

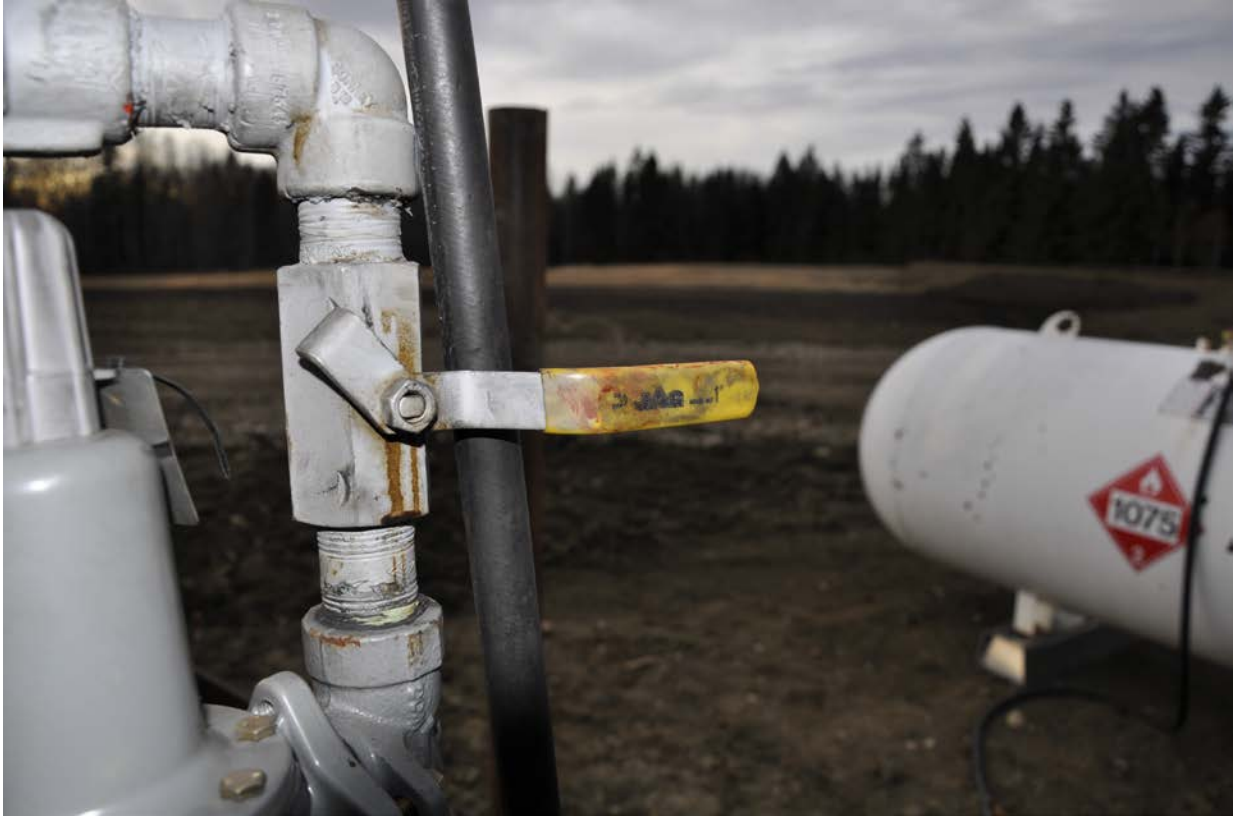
Photograph #6

- 6.14 The Site Supervisor [REDACTED] called the Foreman [REDACTED] to notify him of the incident.
- 6.15 911 was contacted by the Site Supervisor [REDACTED]. He was unable to hear the 911 operator clearly so he went to shut off the valves supplying fuel gas to the motor of the pumpjack. (Attachment C – Photographs #6, 7)

After the incident the Site Supervisor [REDACTED] proceeded to shut off this valve that was the gas supply to the motor in order to hear the 911 operator.

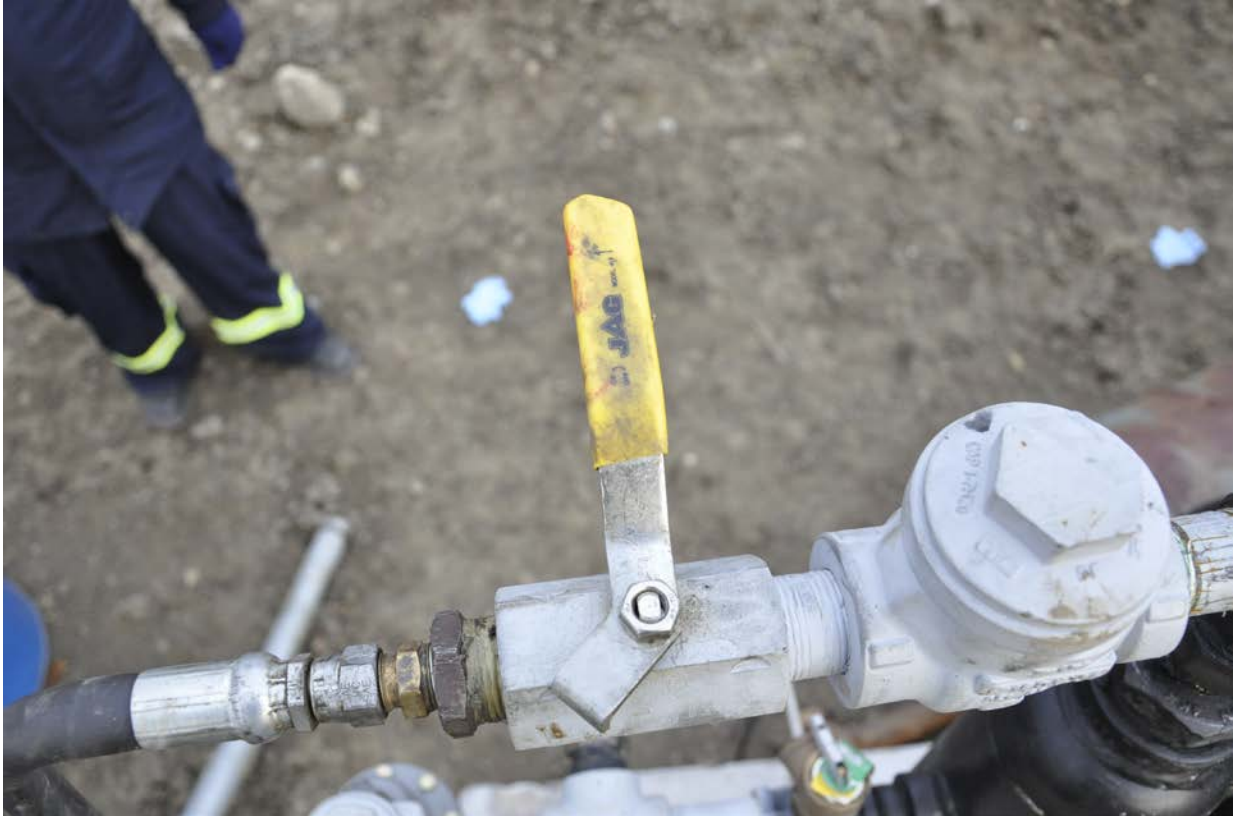
Photograph # 7

The second in-line gas valve was also observed in the off position.

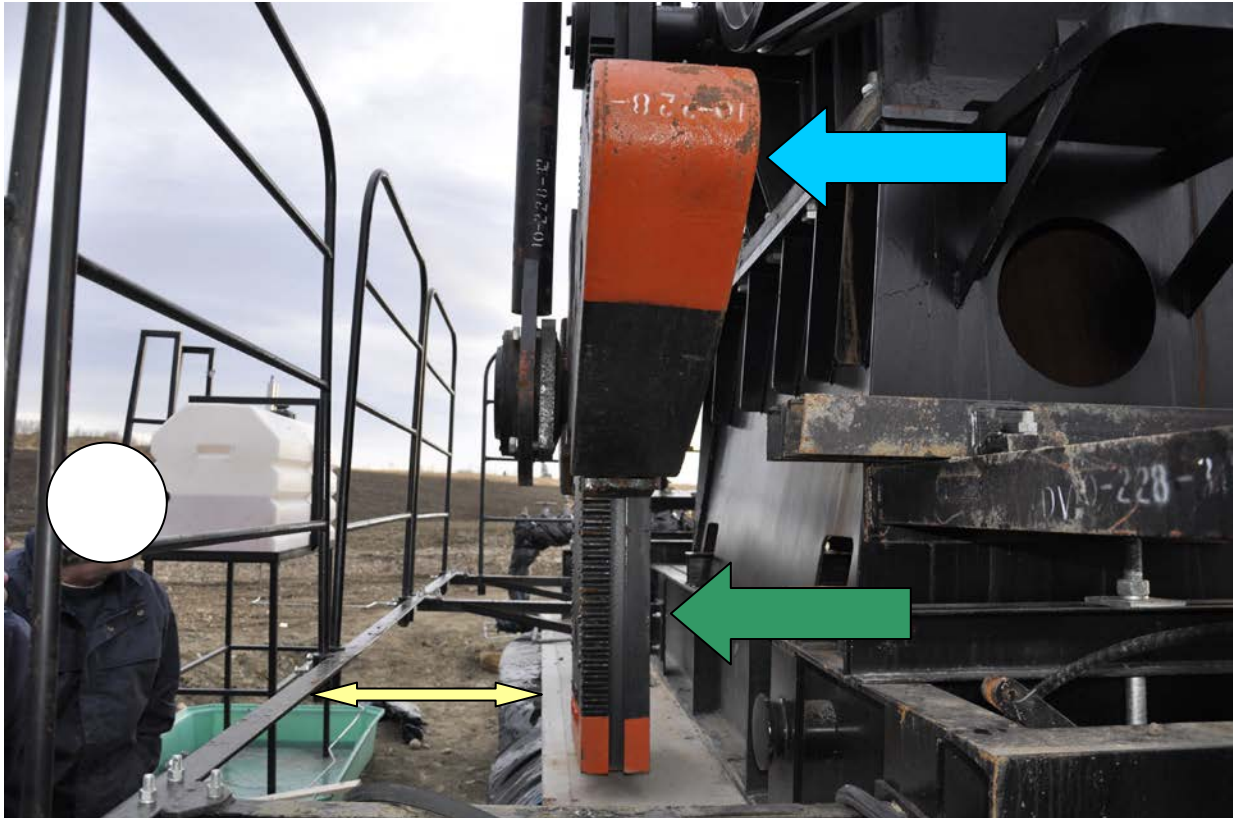
Photograph #8

5.2.6 White plastic scrapings were found on the bottom right side of the crank pin and under the crank pin on the cement pad. The white plastic scrapings were consistent with marks found on the hardhat belonging to the Worker #2 [REDACTED]. (Attachment C – Photographs # 8, 9, and 10).

- 7.1.1 The Labourer [REDACTED] was fatally injured when he was struck on the left side of the head by the crank pin where counterweights attach to the pumpjack as he worked installing insulation in the area beside the counterweight.

The yellow arrow shows the position of the Labourer [REDACTED] when he was struck in the head while he worked next to the crank pin (green arrow). The blue arrow shows the counterweight attached to the crank pin.

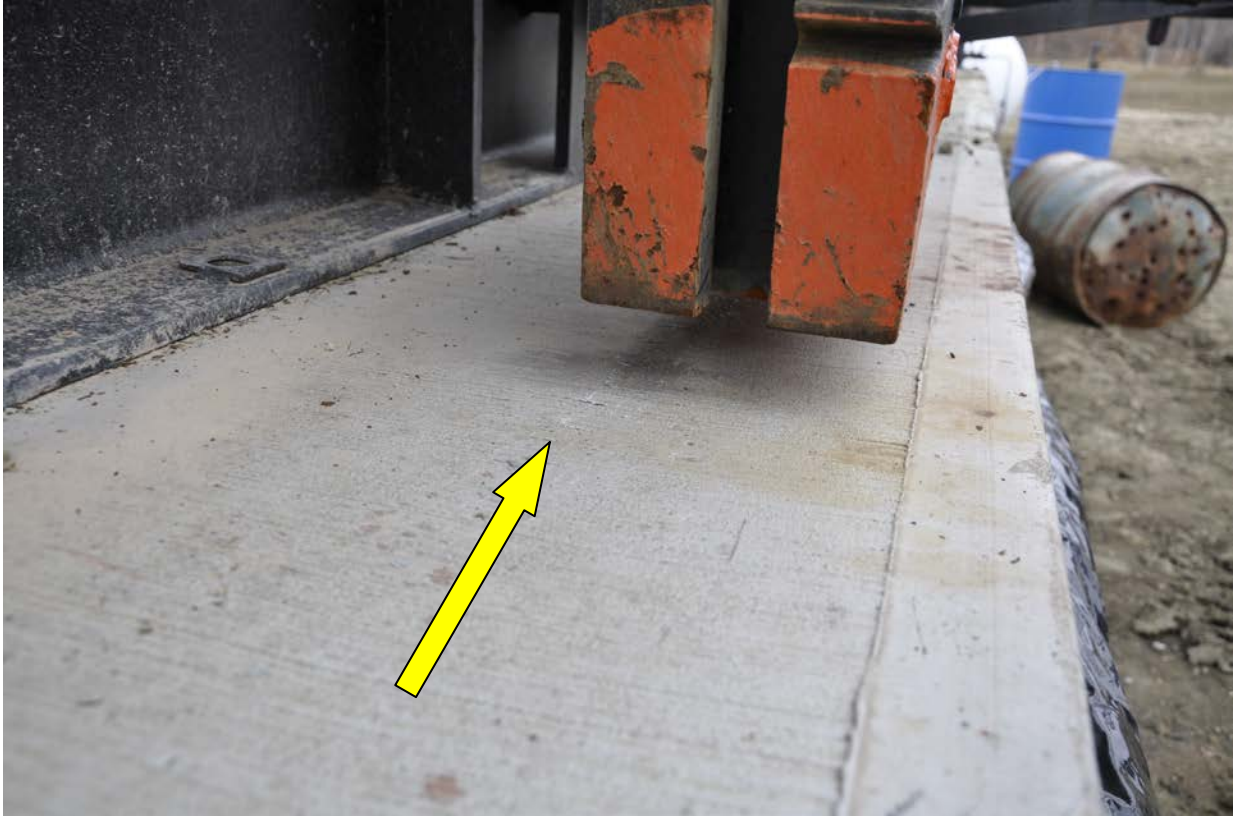
Photograph #9

The yellow arrow shows the scraping that occurred to the Labourer's [REDACTED] [REDACTED] hard hat when he was struck in the head as he worked next to the crank pin.

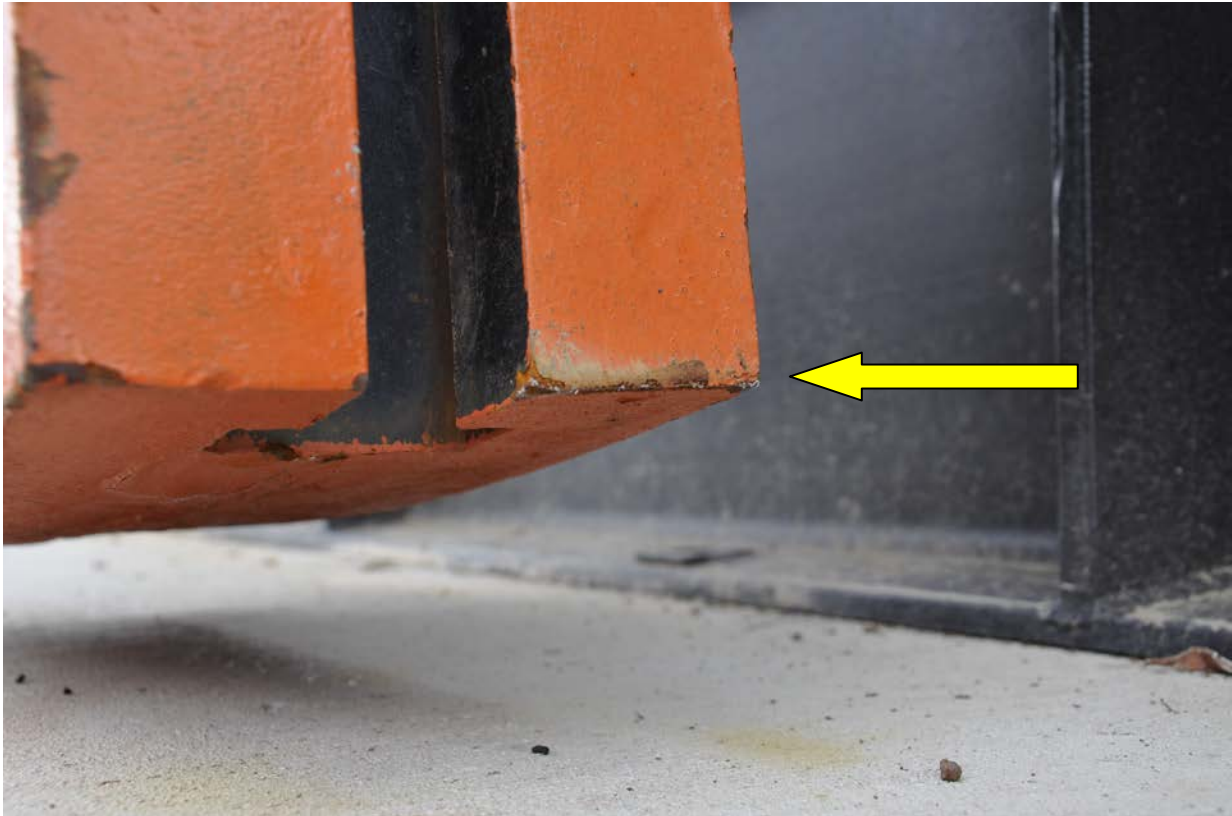
Photograph #10

The yellow arrow shows the scraping that transferred to bottom right edge of the crank pin from the Labourer's [REDACTED] hard hat.

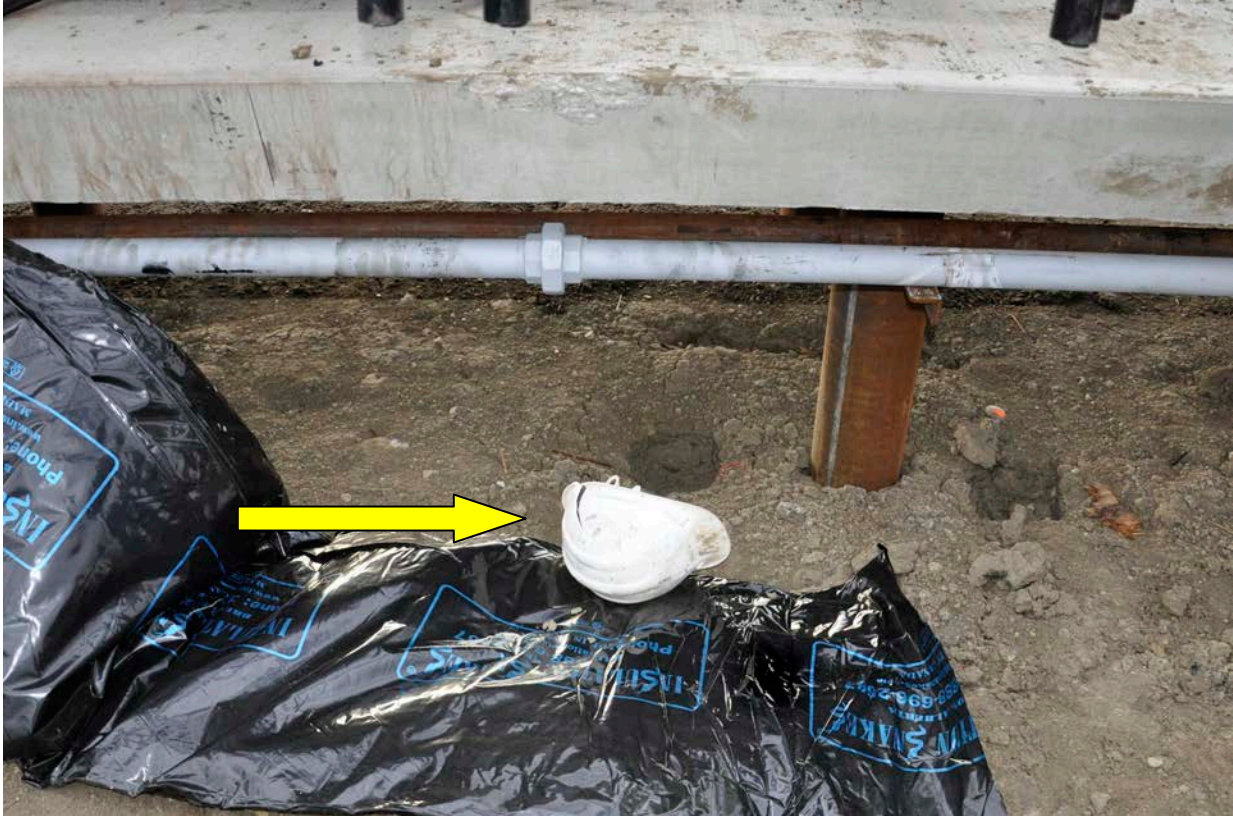
Photograph #11

5.2.4 A white hardhat near the Labourer [REDACTED] was observed with a 10 cm crack on the left side. (Attachment C – Photographs #11)

The yellow arrow shows the crack found on the Labourer's [REDACTED] hard hat.

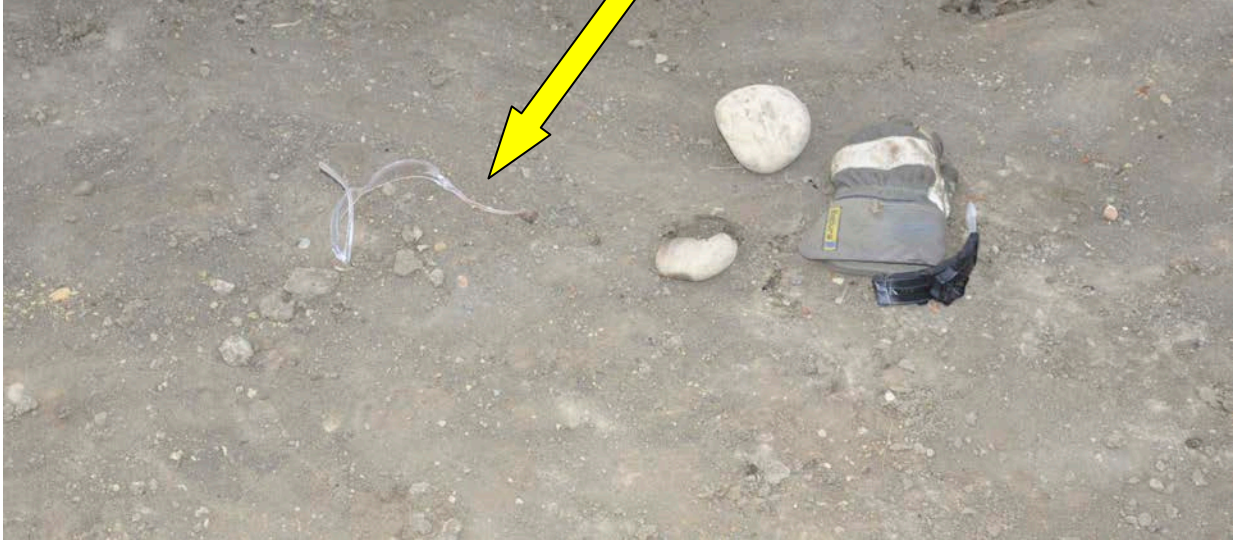
Photograph #12

5.2.5 Safety glasses were also found with a bend in the left arm closest to the temple or rim of the safety glasses. The bend in the arm was consistent with where the worker was struck on the left side of the head with the crank pin. (Attachment C – Photograph #12).

The yellow arrow shows the safety glasses that were worn by the Labourer [REDACTED] [REDACTED] at the time of the incident.
