# **Workplace Health and Safety Fatality Report**

**Worker Fatally Injured in Vehicle Incident**

**Date of Incident: March 7, 2007**

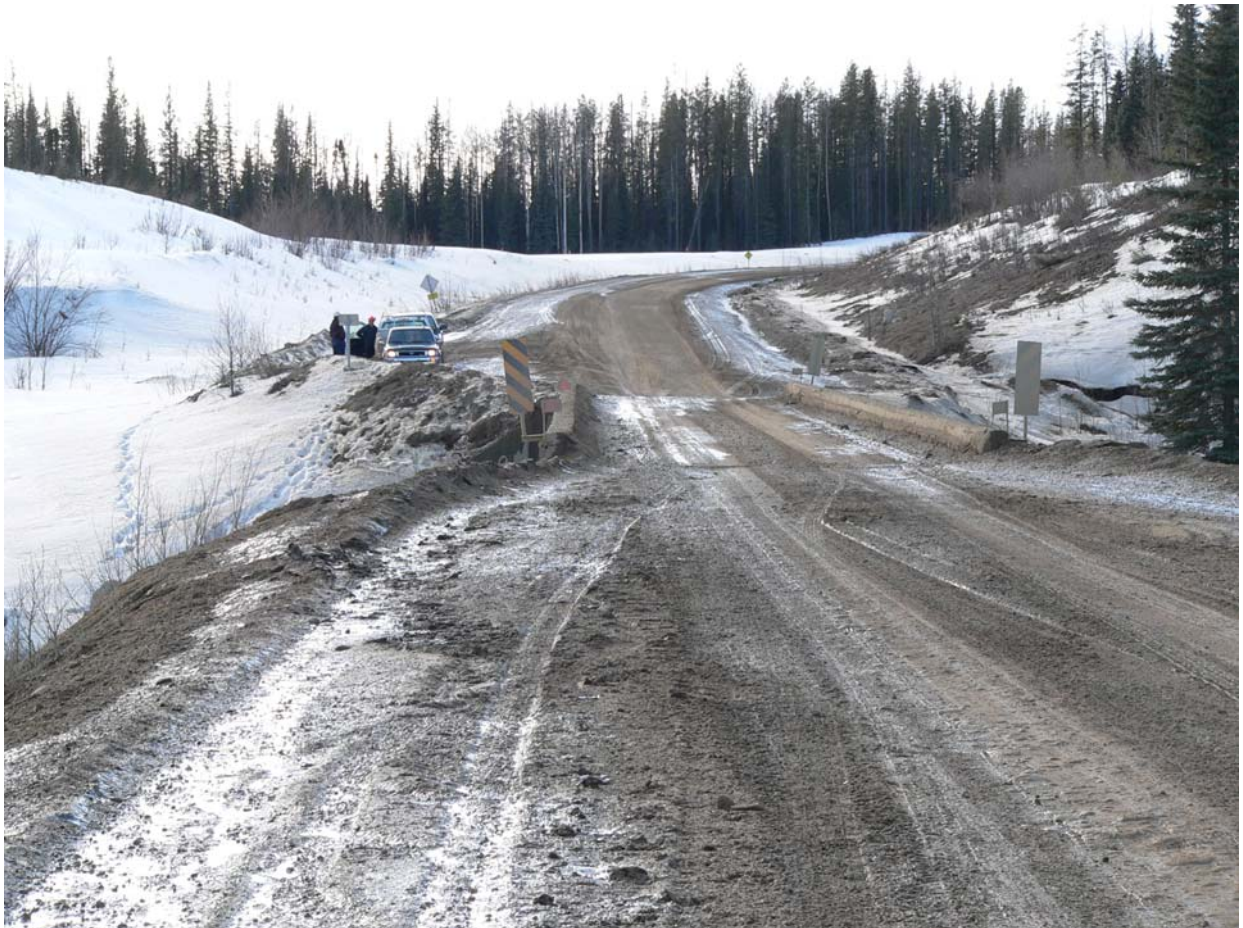
4.1 The bridge over the Wildhay River at km 34 on the Polecat log haul road, approximately 25 km north and west of Hinton. (Attachment "A", Photographs #1, #2) (Attachment "B", Map)

Photograph #1 Shows the bridge at Kilometre 34 on the Polecat Road, looking approximately west. The vehicles in the photograph are parked in the pull-in on the south side of the road, where the Foreman's truck hit the snow bank.

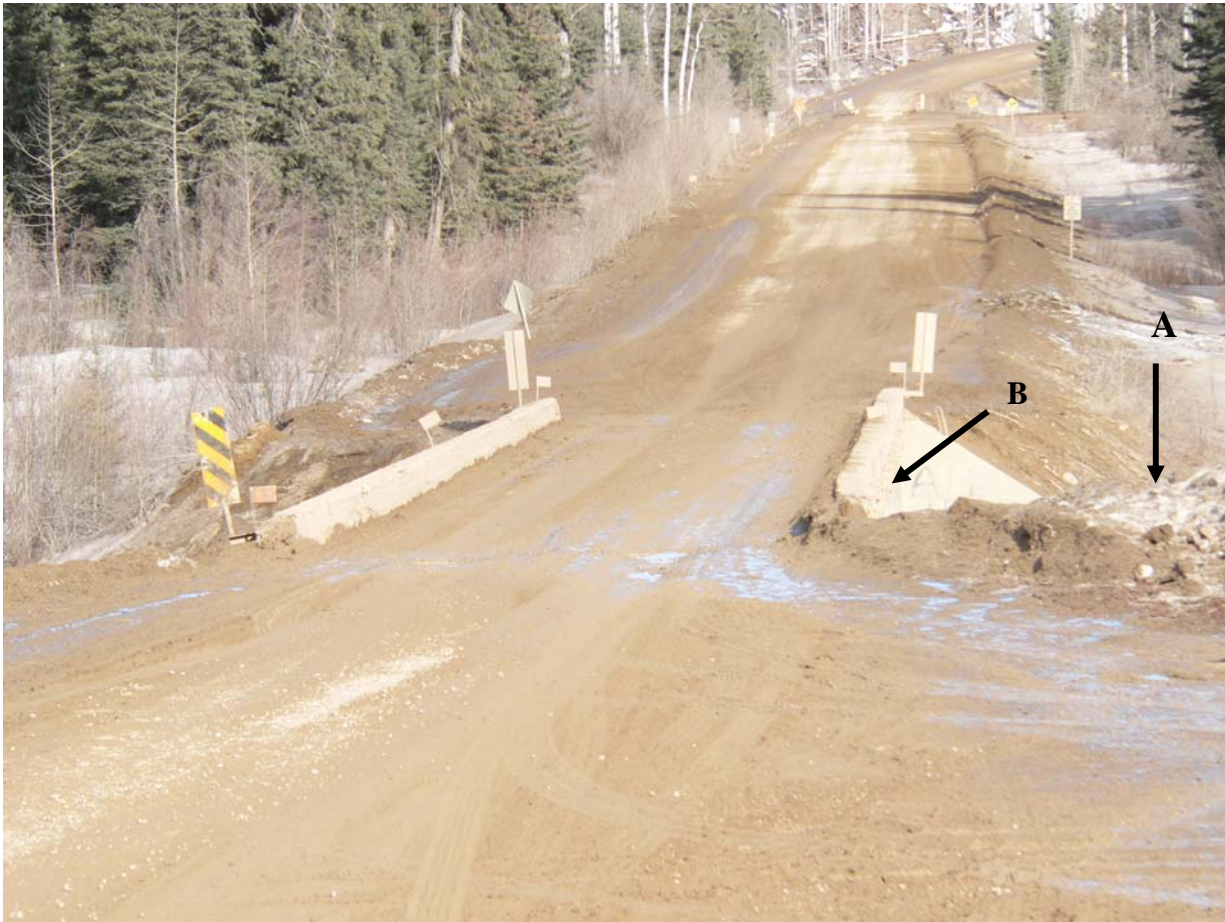
6.5 At approximately 1:45 p.m. the Foreman approached a single-lane bridge crossing the Wildhay River at km 34 on the Polecat Road. At the same time a gravel truck was approaching the bridge travelling west, in the opposite direction to the Foreman's vehicle, but the gravel truck was still approximately 400 m away from the bridge. (Attachment "A", Photographs #1, #2)

Photograph #2 Shows the bridge at Kilometre 34 on the Polecat Road, looking approximately east. Arrow "A" indicates the snow bank on the south side of the road. Arrow "B" indicates where the Foremen's truck struck the side of the bridge.

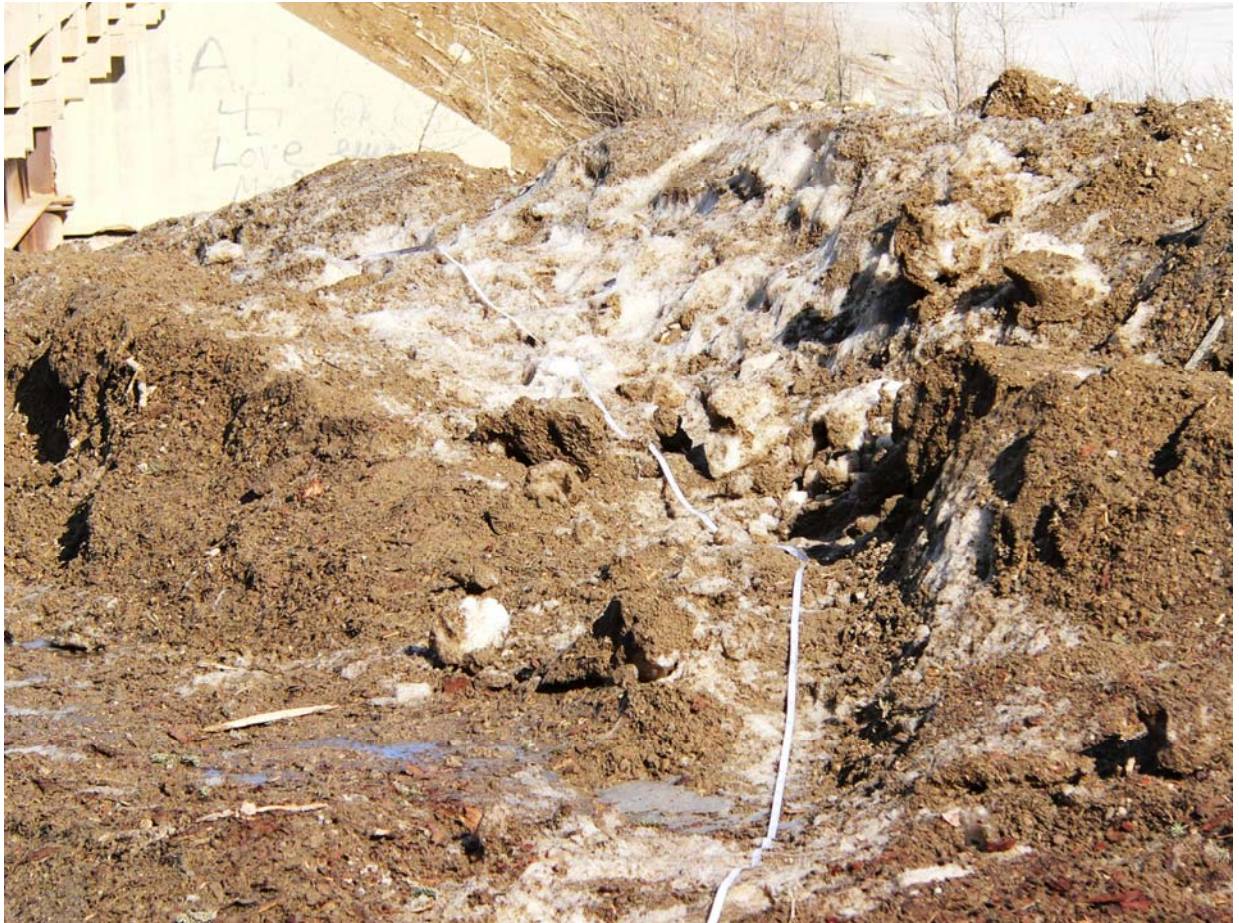
were snow banks at the edges of the pull-ins at the west end of the bridge, that were left when the road had been plowed. Tracks showed that the Foreman's vehicle's passenger side wheels entered the snow bank on the south side of the road 26 m from the west end of the bridge. (Attachment "A", Photographs #2, #3)

Photograph #3 Shows the track made in the snow bank by the passenger side wheels of the Foreman's truck. The tape shows the wheel track.

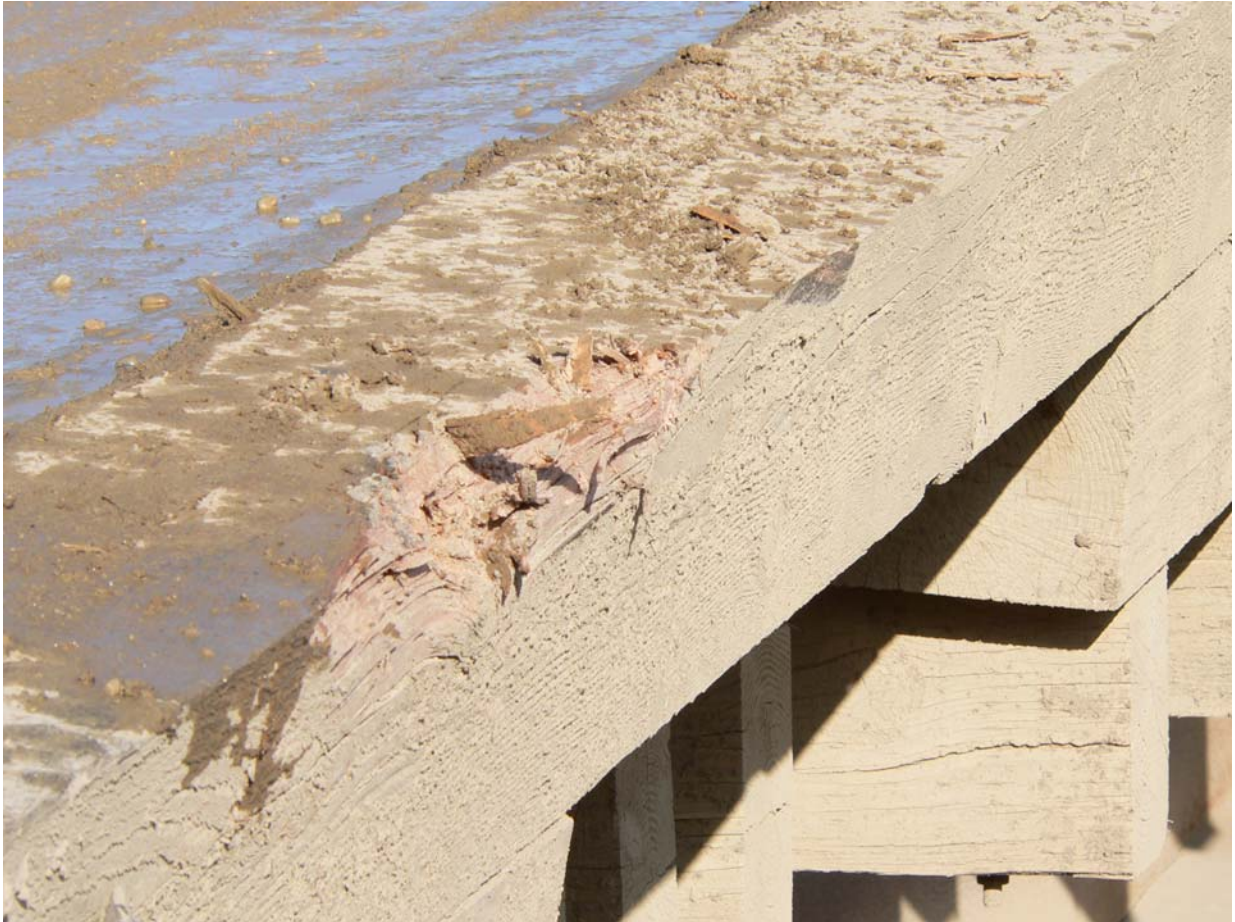
- 6.7 Tracks left in the snow bank showed that the Foreman had attempted to correct his direction and return his vehicle onto the road. However, his vehicle struck the south side wall of the bridge deck and the vehicle flipped. The cab roof was crushed and collapsed onto the cab by impact with rocks on the river bank. The vehicle came to rest on its wheels in the river. The Foreman's head and upper body were hanging out of the driver's side door window. Blood and bone fragments were found on rocks 10 m east of where the vehicle had struck the bridge and 7 m below the deck level of the bridge on the west bank of the river. This indicated that the Foreman had struck his head on the rocks as the truck flipped and fell into the river, suffering fatal injuries. The river was only a few centimetres deep at the location where the truck came to rest. (Attachment "A", Photographs #2, #3, #4, #5)

Photograph #4 Shows the impact mark made when the Foreman's truck struck the south side of the bridge.

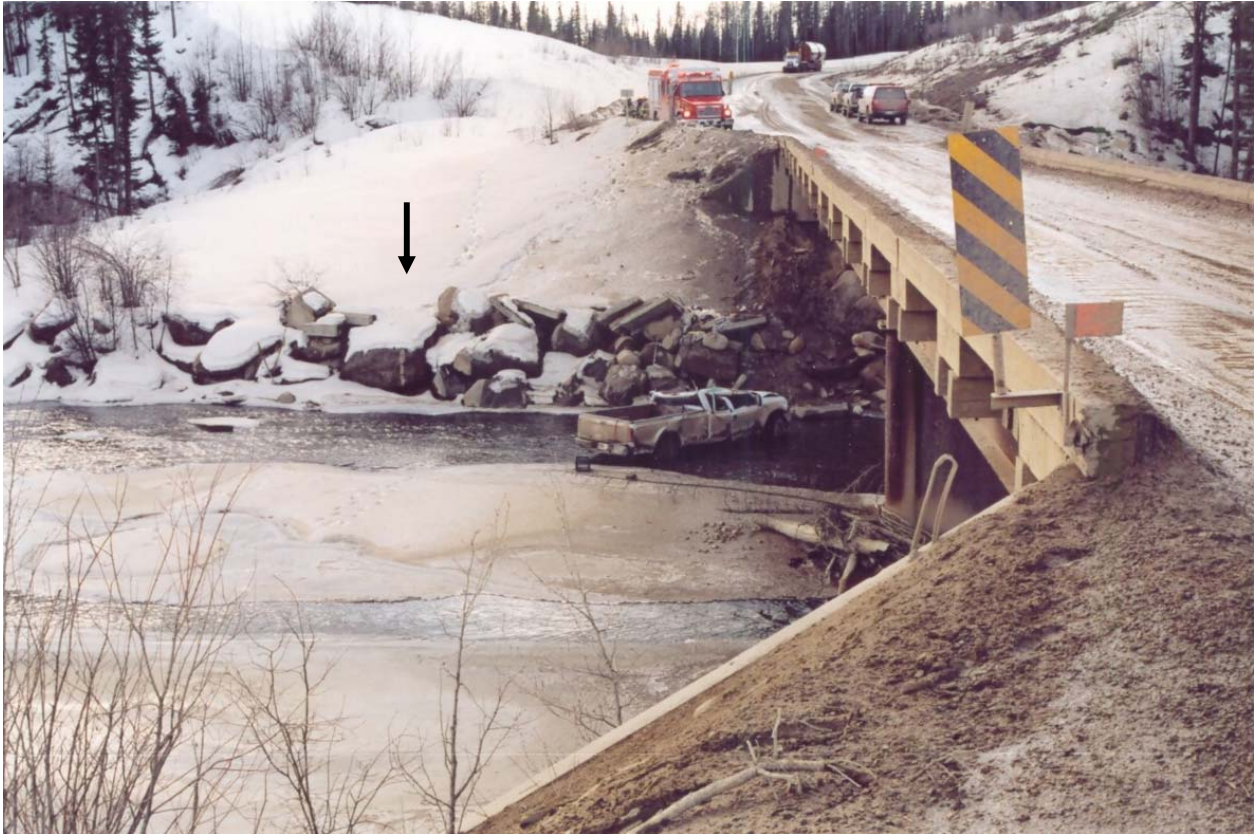
- 7.1.1 The Foreman was driving his personal vehicle on a log haul road, approaching a single lane bridge. The Foreman lost control of his vehicle, drove into a snow bank and then struck the side of the bridge. The vehicle flipped end over end and came to rest in the river. The Foreman struck his head on rocks at the river bank, suffering fatal injuries.

Photograph #5 Shows the Foreman's truck where it came to rest in the river. Arrow indicates rocks on the west bank of the river that the vehicle impacted before it came to rest. Photograph reproduced courtesy of RCMP Hinton Detachment.
