# **Worker fatally injured after fall from building**

December 12, 2020

## **Incident summary**

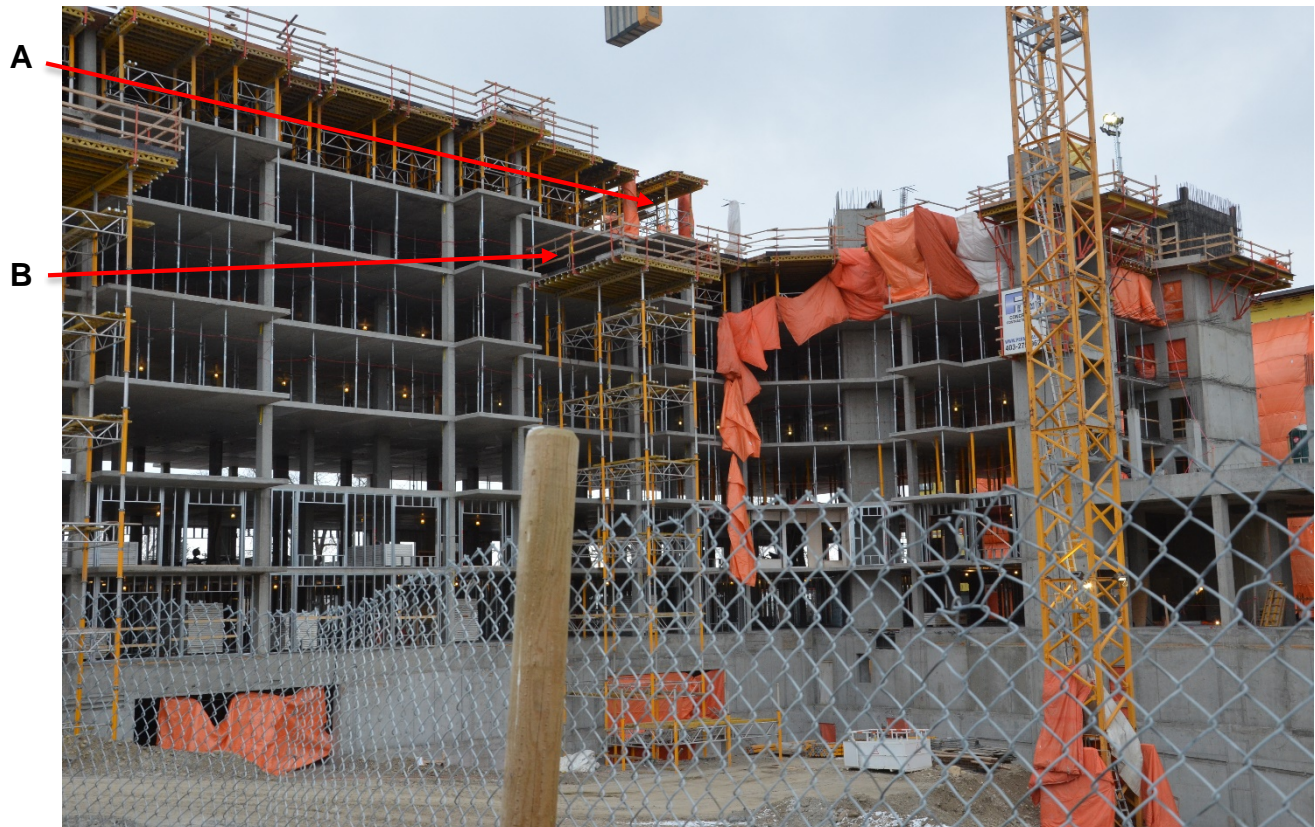
*Figure 1. The south side of the building where the incident occurred.*

*A. Incident location on the seventh floor.*

*B. The sixth floor platform where the tables were attached to the crane.*

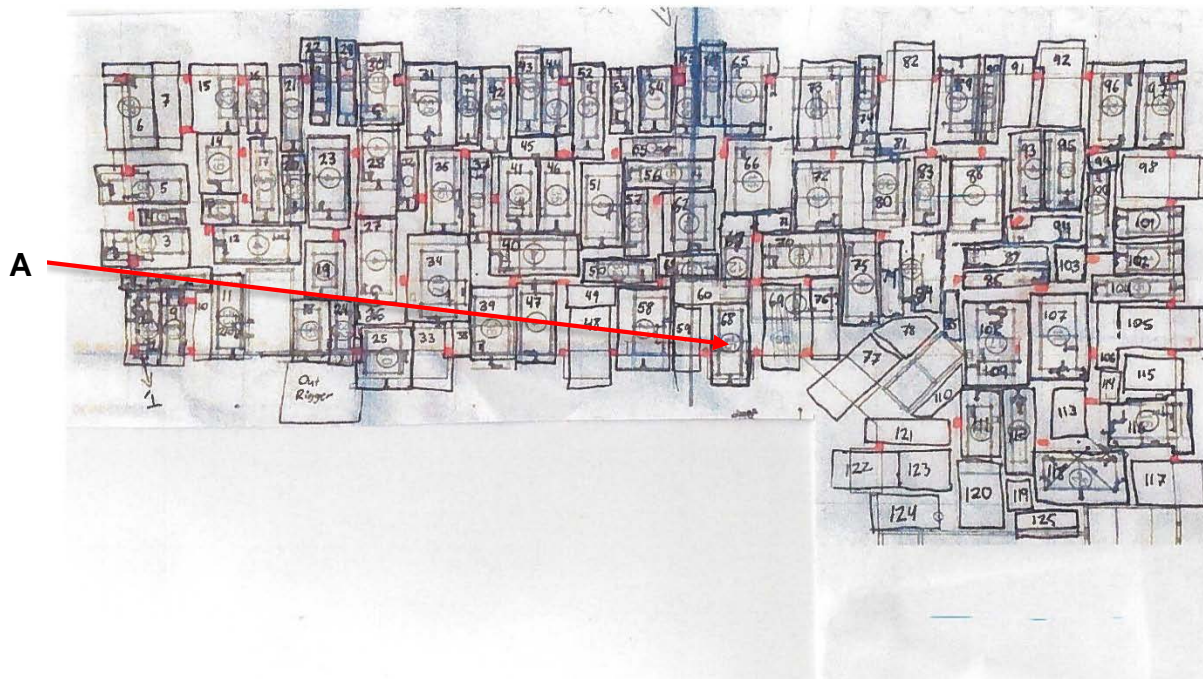
Figure 3. Diagram showing the location of the table, from the incident, on the seventh floor. The orange dots represent pillars. North is at the top of the diagram (drawing provided by Perma-Cast).

A. Location of table from the incident.

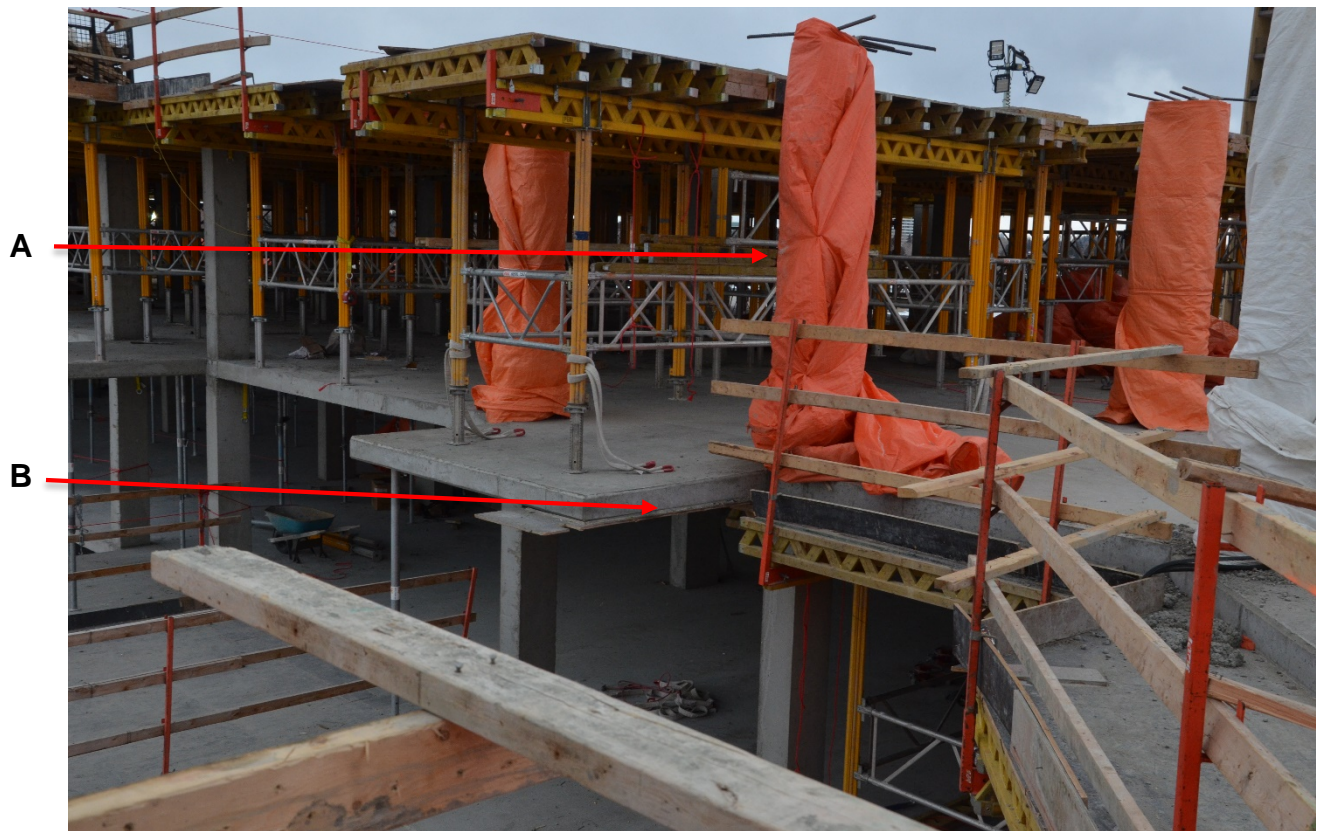
Before the table could be set down, the legs of the table had to be adjusted to the correct height. The Lead Hand moved toward the south end of the table and passed a tarp covered pillar (Figure 4). The Lead Hand stepped sideways to their left (east) and off of the concrete down onto a piece of unsecured plywood. The Journeyman Crane Operator heard the Lead Hand swear and both the Journeyman Crane Operator and the Crane Rigger saw the Lead Hand fall. The Carpenter, who was about half a metre away to the east of the Lead Hand, was standing next to a guardrail when the Lead Hand fell.

*Figure 4. Incident location on the seventh floor.*

*A. Tarped pillar where Lead Hand walked past.*

*B. Area where the Lead Hand stepped onto a piece of unsecured plywood.*
