**PAINTER FALLS 3.14 M AND  
IS FATALLY INJURED**

Type of Incident: FATAL

Date of Incident: APRIL 26, 2010

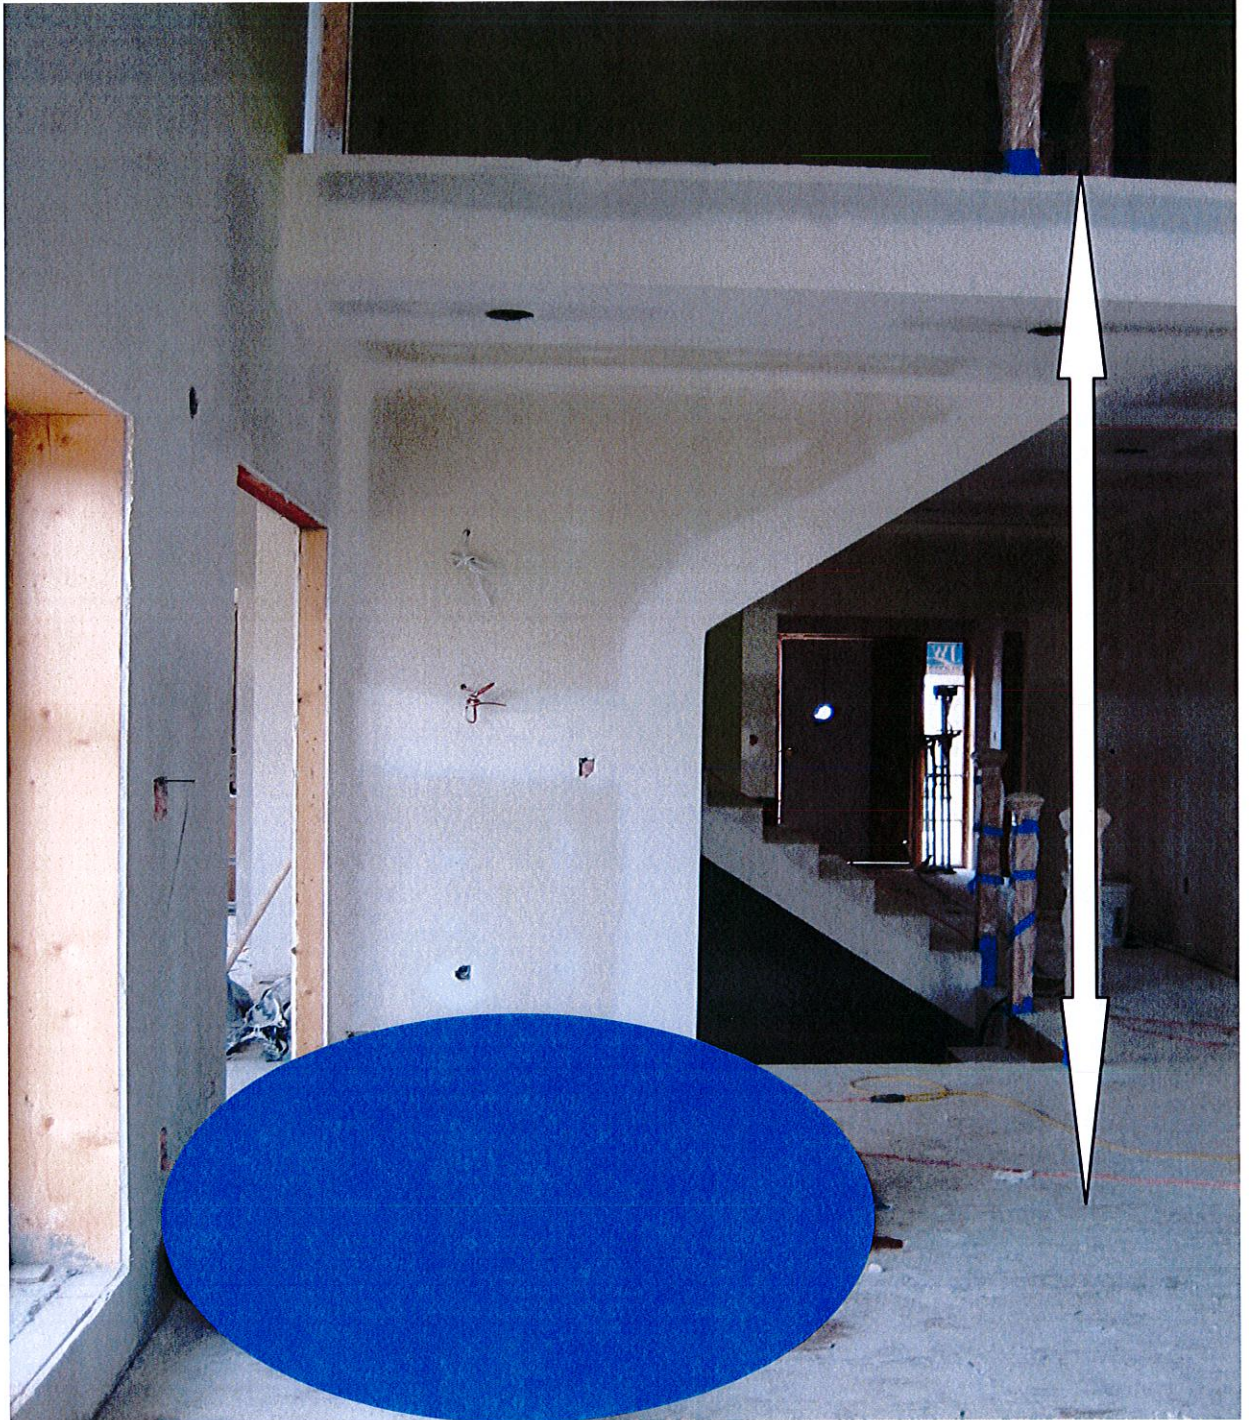
Photograph #1

- 6.5 At approximately 12:30 p.m. the Assistant Painter ( ) heard a loud bang. He thought that a paint pail had fallen, but when he turned around he saw the Painter ( ) laying on the floor. Attachment C, Photographs #1,#3, #4)

- 7.1.1 Worker fell 3.14 m from the mezzanine floor level onto the plywood main floor level and was fatally injured.

The white arrow indicates the distance the Painter fell and it is 3.14 m.

The blue spot is the where the Painter was found after he fell.

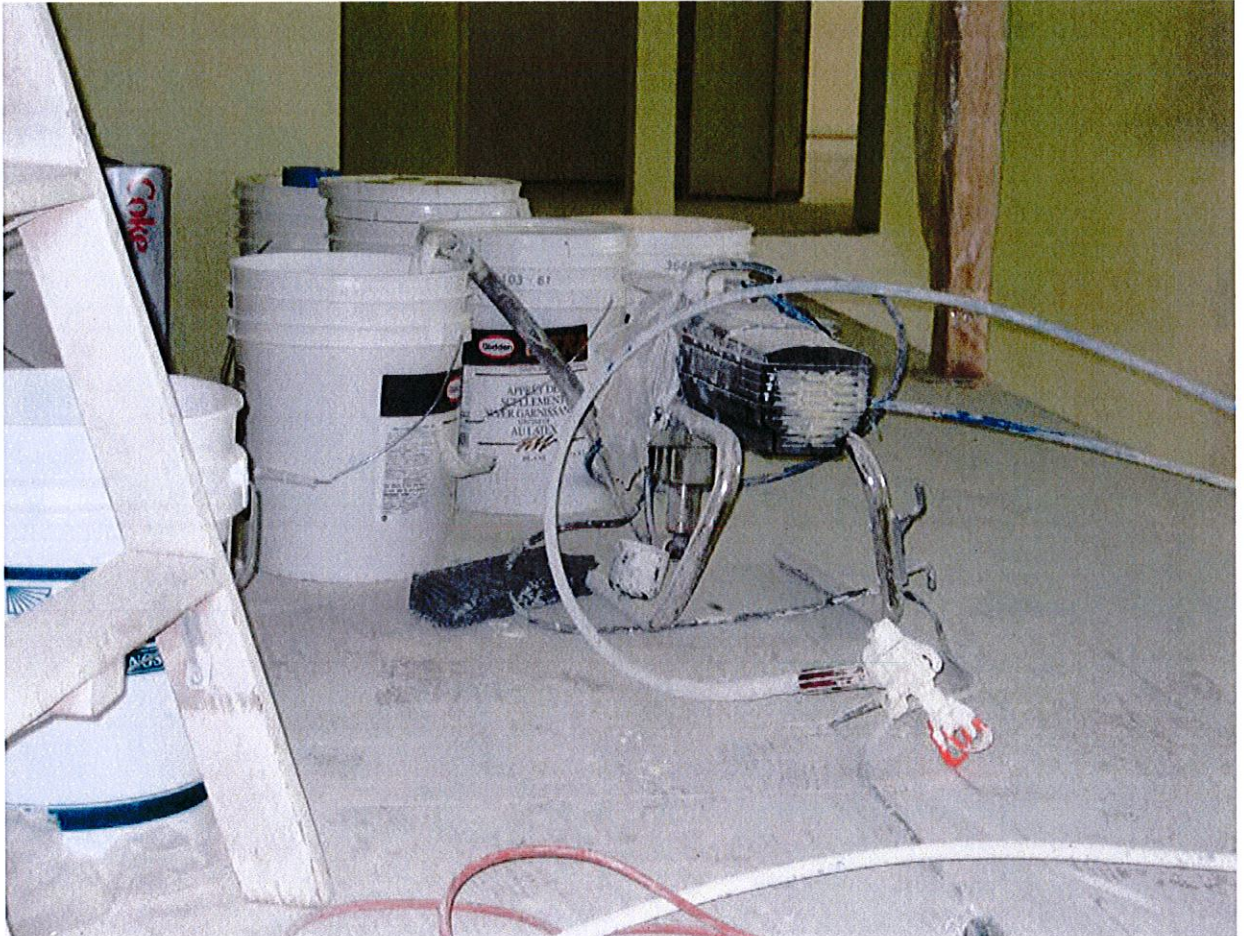
- 5.1.1 Paint spraying equipment. (Attachment “C” Photograph #2)

Photograph #2 Shows the paint sprayer and pails of paint the Painter was using at the time of the incident.

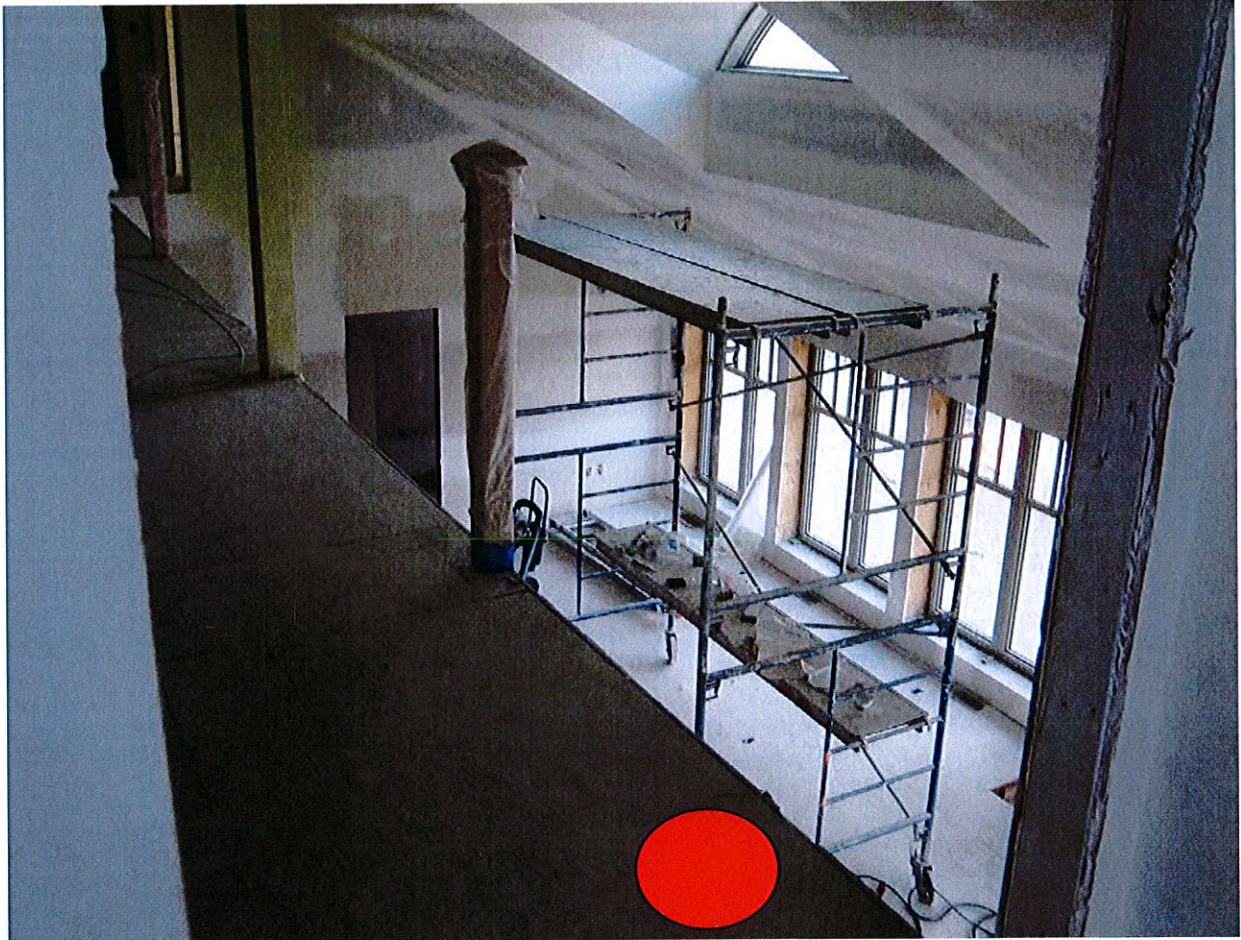
- 7.2.2 There were no guardrails at the edge of the mezzanine floor from where the Worker was conducting his work. Occupational Health and Safety Investigators found that guardrails had been installed by Effect Home Builders to protect workers from falling from the mezzanine floor level. At some time before the fatal incident the guard rails had been removed by an unidentified worker. The lumber that had been used to make the guardrails was found by Investigators on the mezzanine floor after the incident.

Photograph #3 The red circle indicates the area where the Painter was believed to be standing when he fell. There were no guardrails installed at the time of the incident.

- 8.1.5 Occupational Health and Safety issued an order to Effect Home builders Ltd. for the installation of guardrails inside the home under construction and on the outside patio.

8.2.3 Occupational Health and Safety removed the stop work order after Effect Home Builders Ltd. complied by installing appropriate fall protection measures to prevent workers from falling when working at a vertical distance of 3 metres or more.

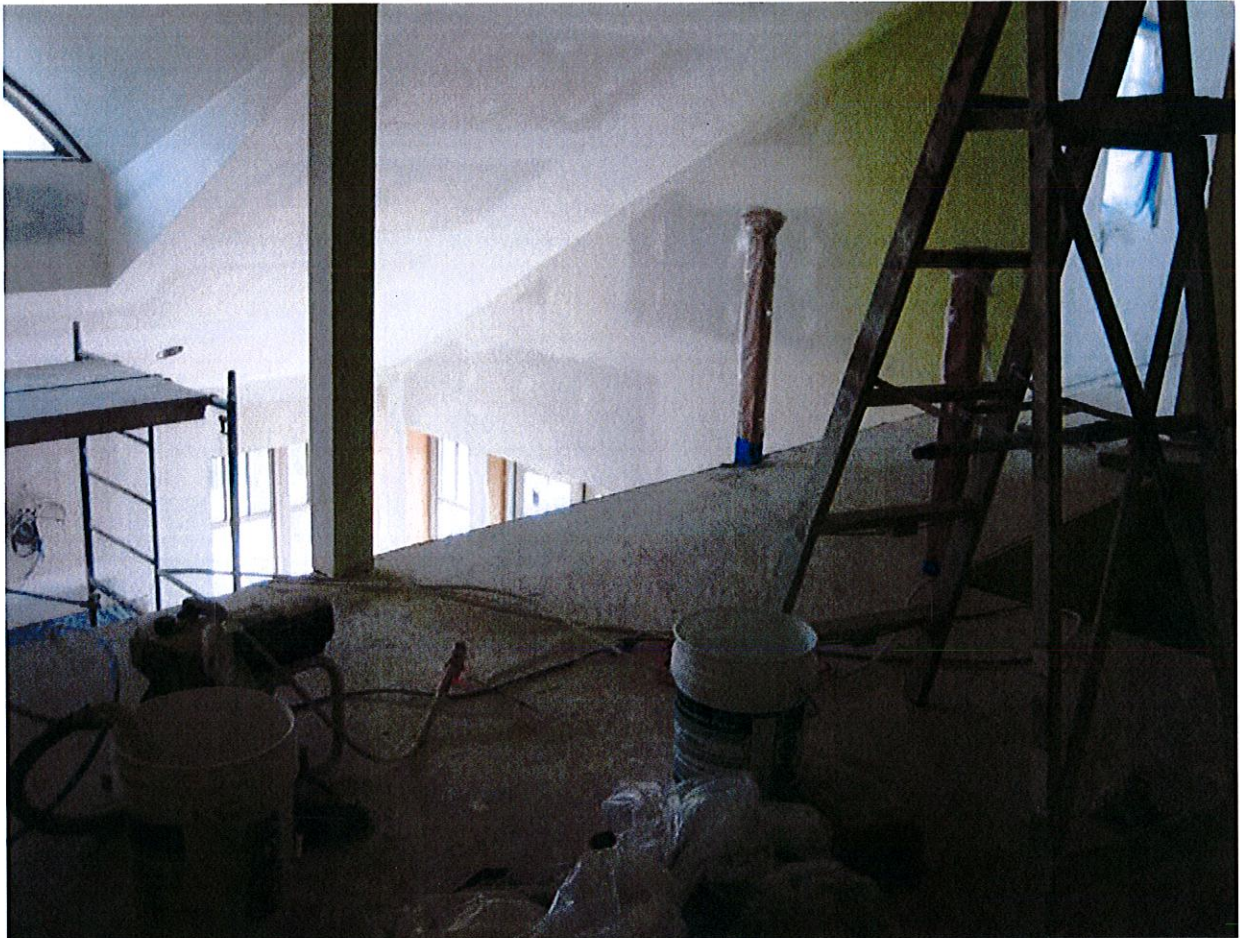
Photograph #4 Another view from the mezzanine where the Painter was working from at the time of the incident.
