Fatality Investigation Report

Worker Struck by Vehicle

October 15, 2014

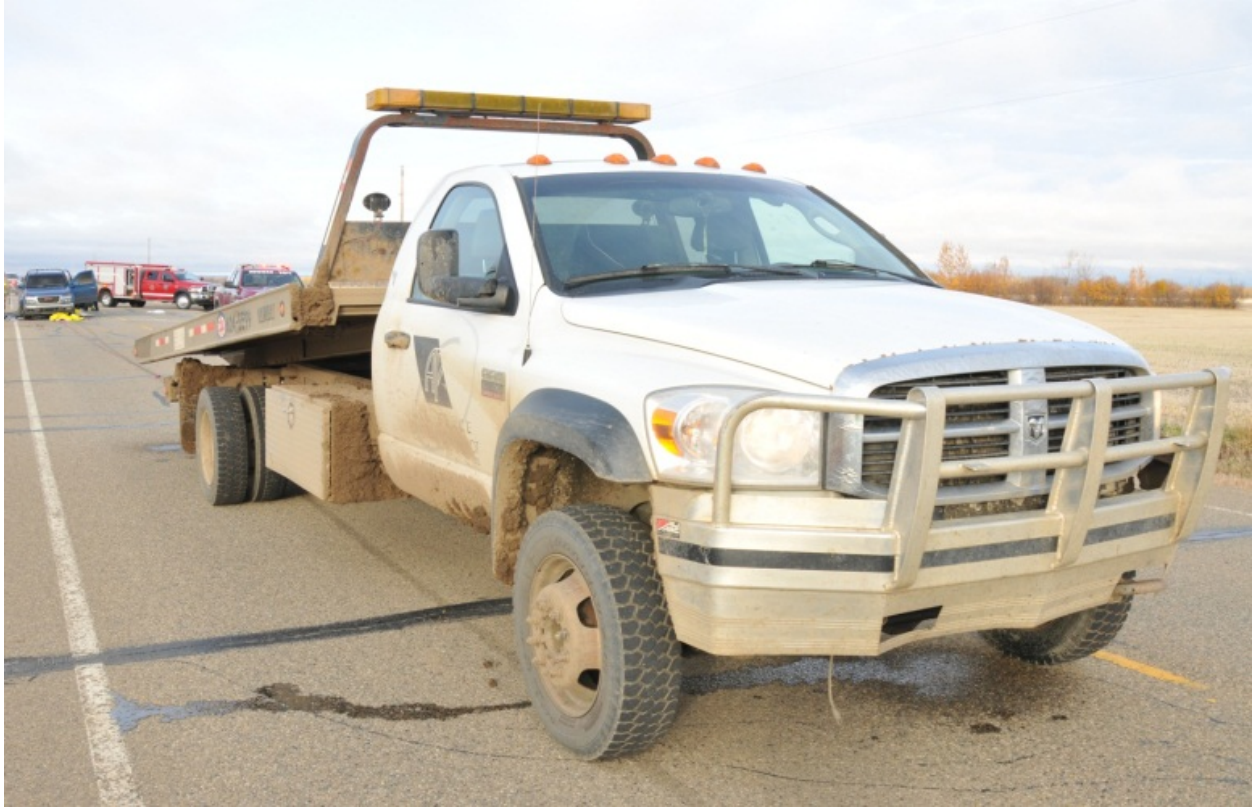
Figure 1 depicts the tow truck.

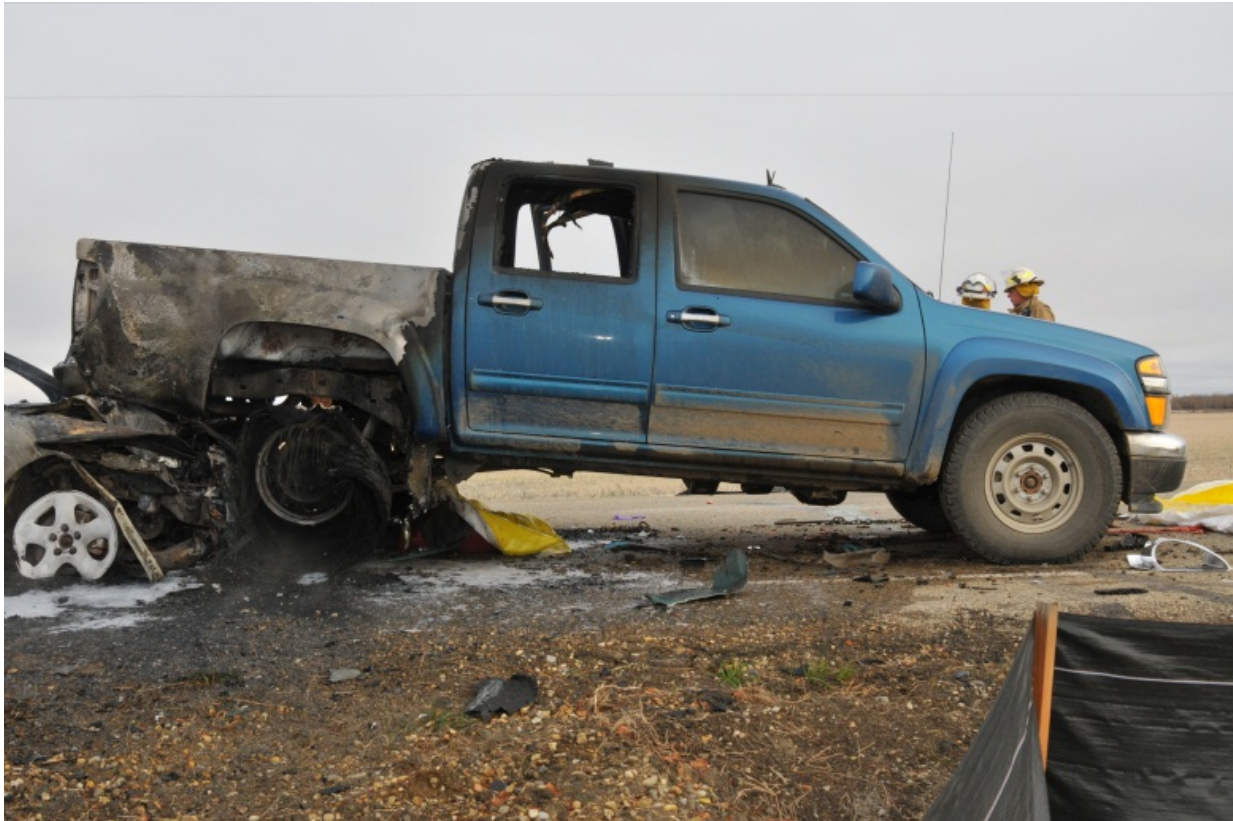
Figure 2 depicts the disabled truck's position (facing east on Range Road 830 – resting on the passenger car hood) after rolling off the back of the tow truck when struck by the passenger car. Photograph provided by Peace River Royal Canadian Mounted Police (RCMP).

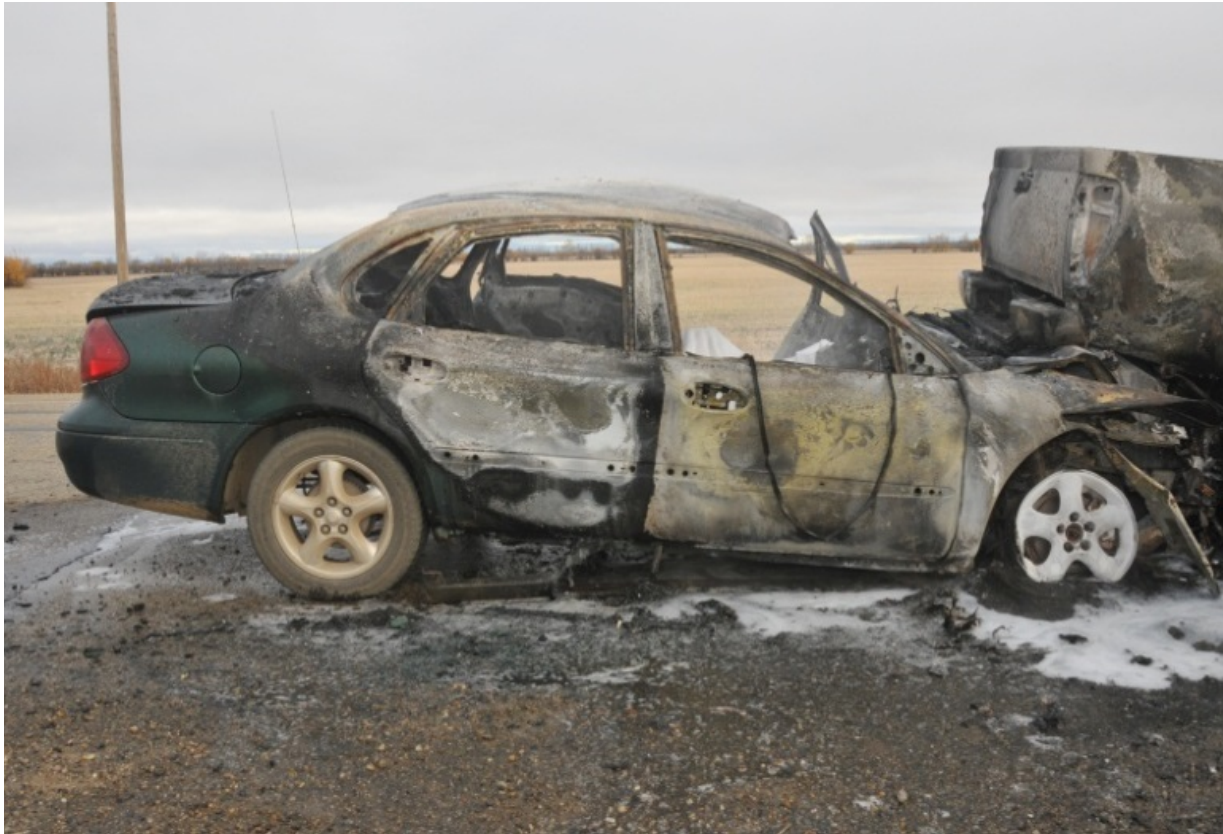
Figure 3 depicts the passenger car that struck the back of the tow truck and tow truck operator. Photograph provided by Peace River RCMP.

The RCMP collision reconstruction analysis concluded “The calculated minimum impact speed was 71 km per hour (kph); the actual impact speed was most likely much higher. Driver inattention (passenger car) was a contributing factor. Vehicle speed, road conditions and environmental conditions were not contributing factors”.

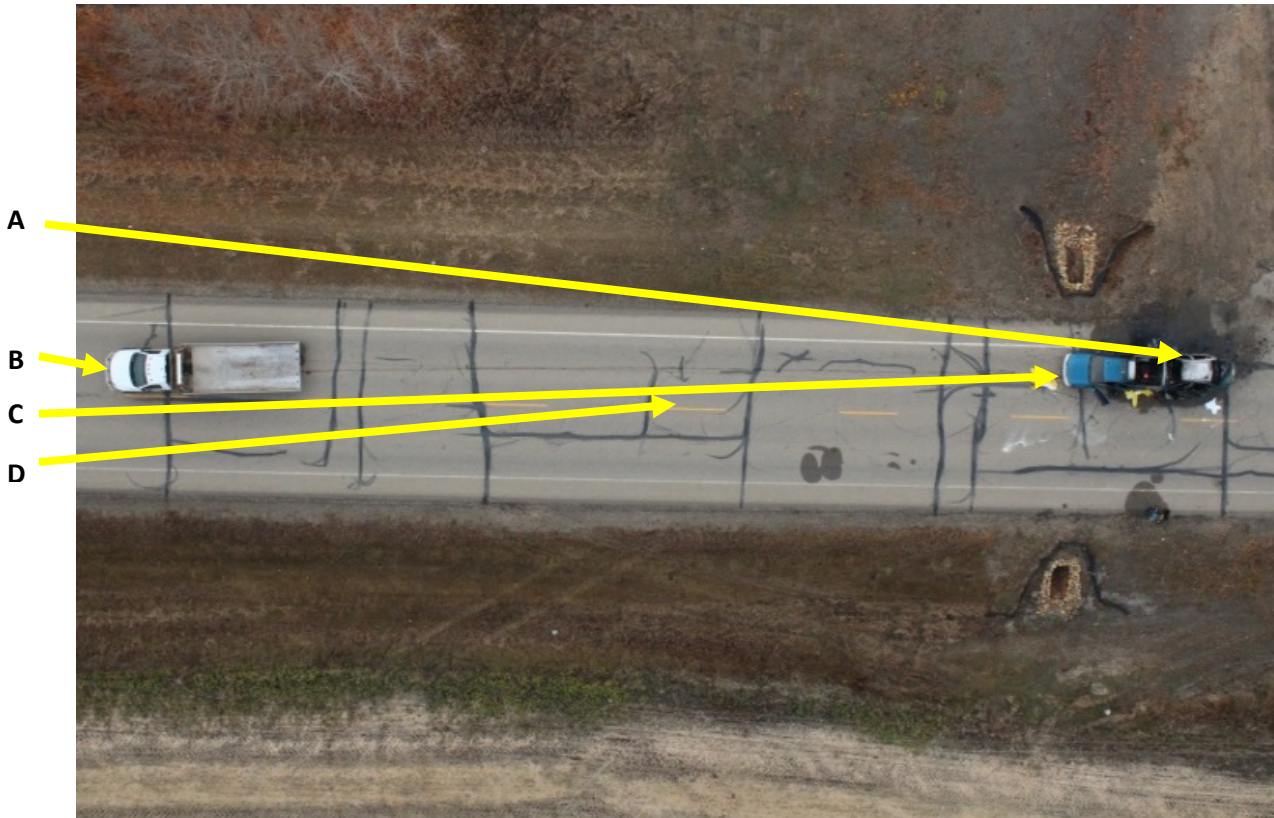
Aerial Image of Collision Scene

Figure 4 was taken on October 15, 2014, by RCMP collision reconstruction analysis officer at the scene. The picture is an aerial photograph which depicts the positions of the three vehicles post-incident. Photograph provided by Peace River RCMP.

- A. Green passenger car*
- B. White tow truck*
- C. Blue disabled truck*
- D. The distance of 44.98 metres (m) between A and B after impact.*
