**WORKER CRUSHED BY DISTRIBUTION
PANEL DURING INSTALLATION**

Type of Incident: Fatal

Date of Incident: May 15, 2012

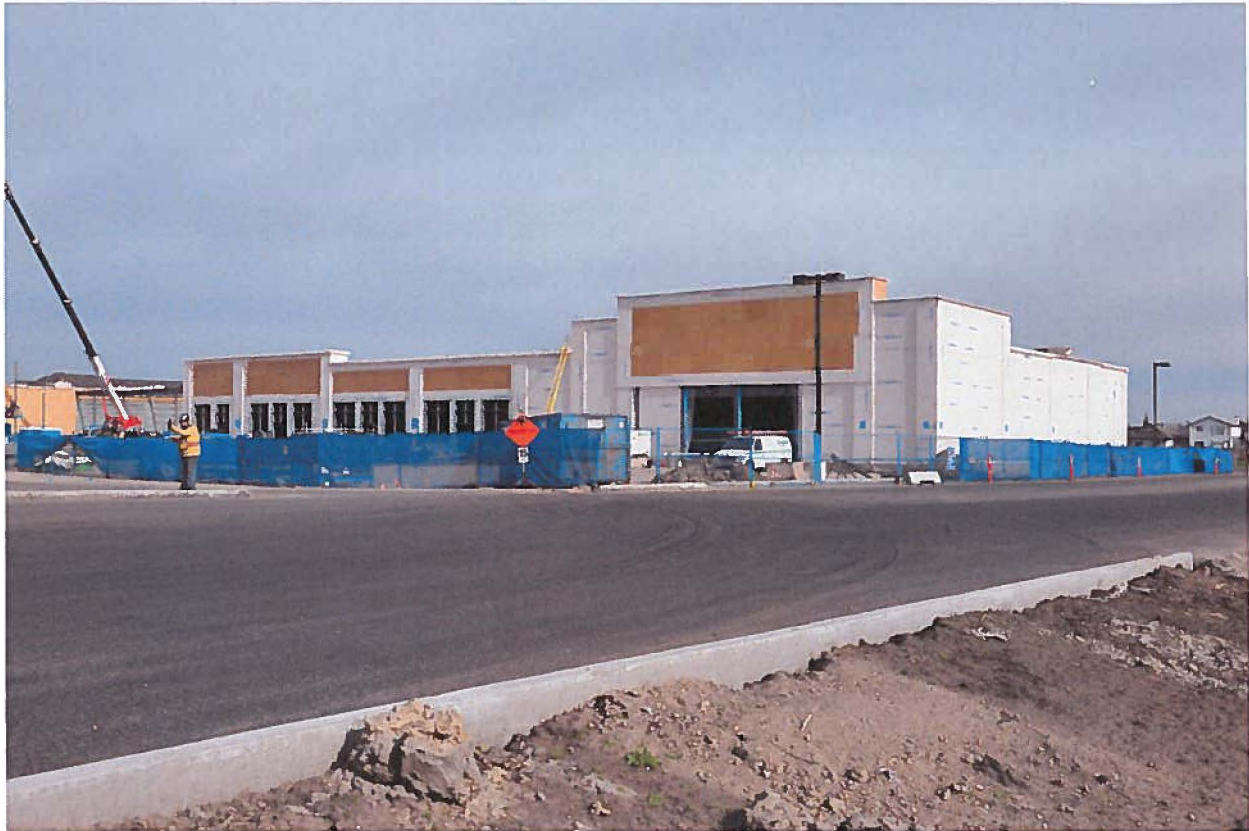
5.2.7 The building was under construction at the time of the incident. The location within the building where the incident occurred was under development for a large retail store. (Refer to Attachment C – Photograph 6)

Photograph #1 Retail building where the incident took place while under construction at 151 Century Crossing, Spruce Grove, AB.

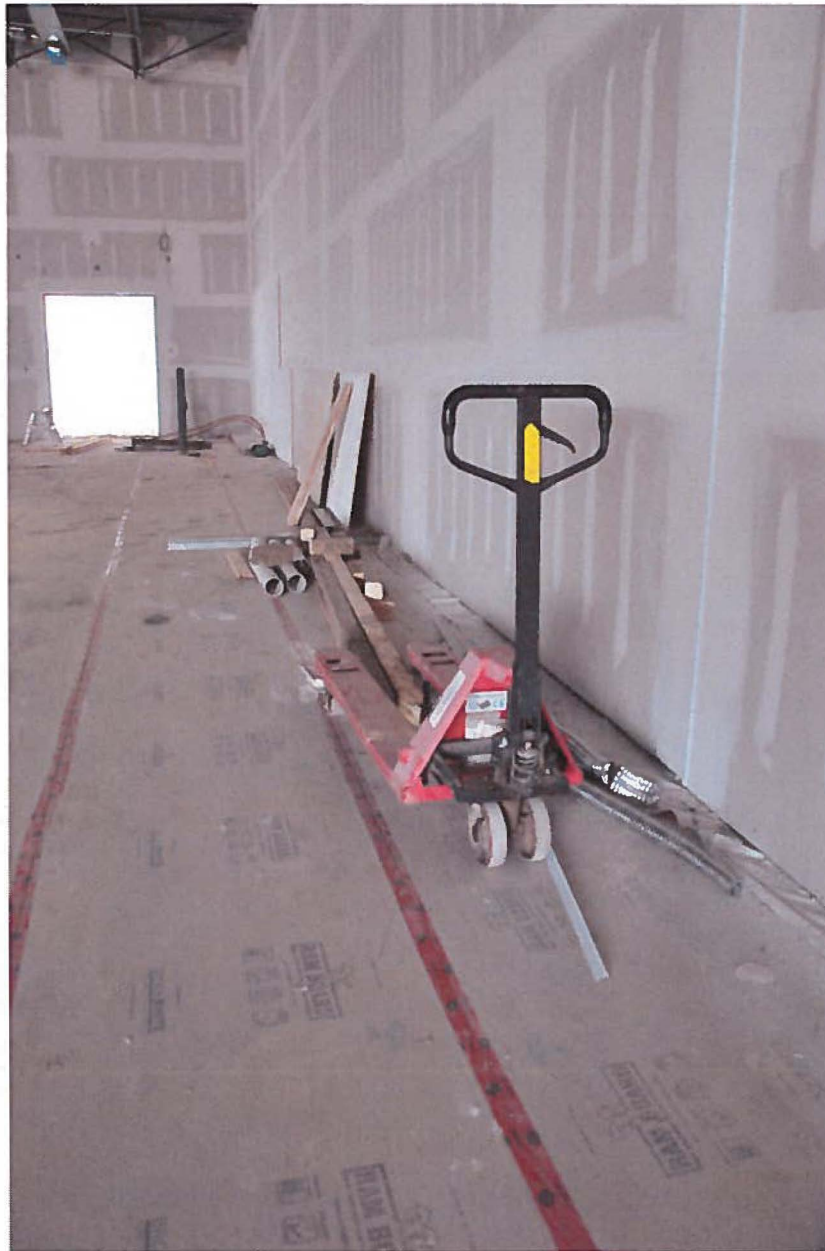
5.1.1.1 Pallet jack was .52 metres (m) x 1.22 m.

Photograph #2 Shippers Supply pallet jack .52 m x 1.22 m,
weight capacity 2494 kg.

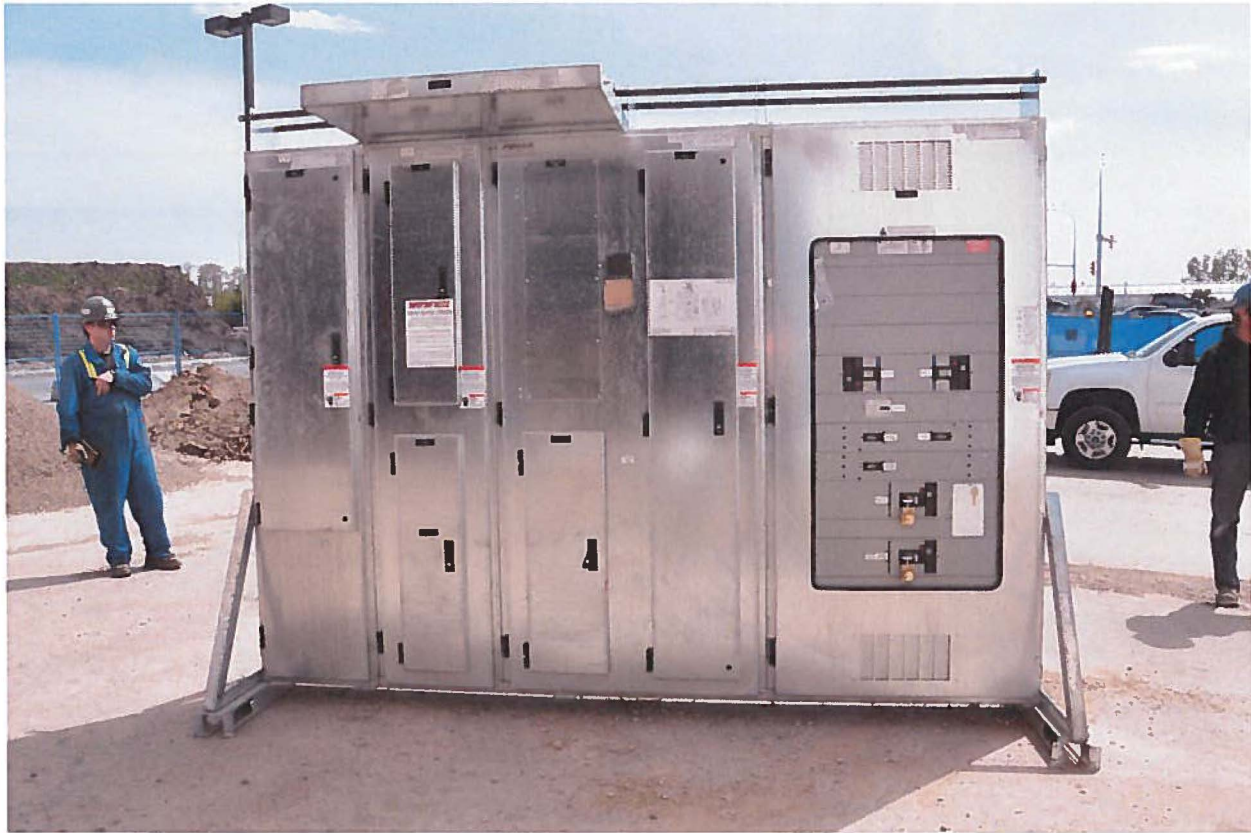
5.1.2.1 Distribution panel weighed 812.0 kilograms (kg) during the installation at the time of the incident. Panel dimensions: 25 centimetres (cm) x 12.5 cm vertical length, 25 cm wide, and 5 cm x 21.25 cm horizontal length.

Photograph #3 The Hill Phoenix electrical distribution panel involved in the incident weighed 812.0 kg. Panel dimensions: 25 cm x 12.5 cm vertical length, 25 cm wide, and 5 cm x 21.25 cm horizontal length.

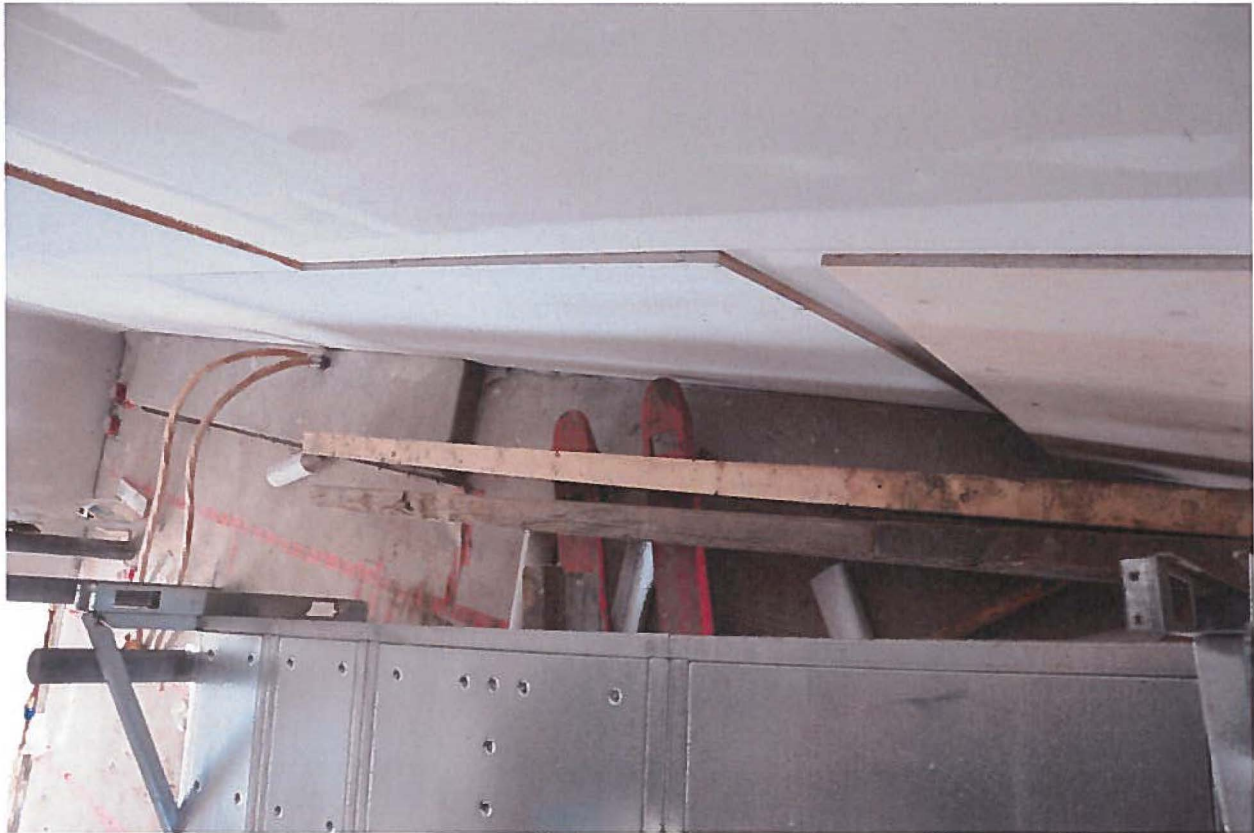
5.1.3.1 Pressure safety valve (PSV) piping, 101 millimetres (mm) x 121 mm lumber of various lengths. (Refer to Attachment C – Photograph 3)

Photograph #4 Post-incident location of the pallet jack, PSV piping, and lumber that was used to manoeuvre the distribution panel.

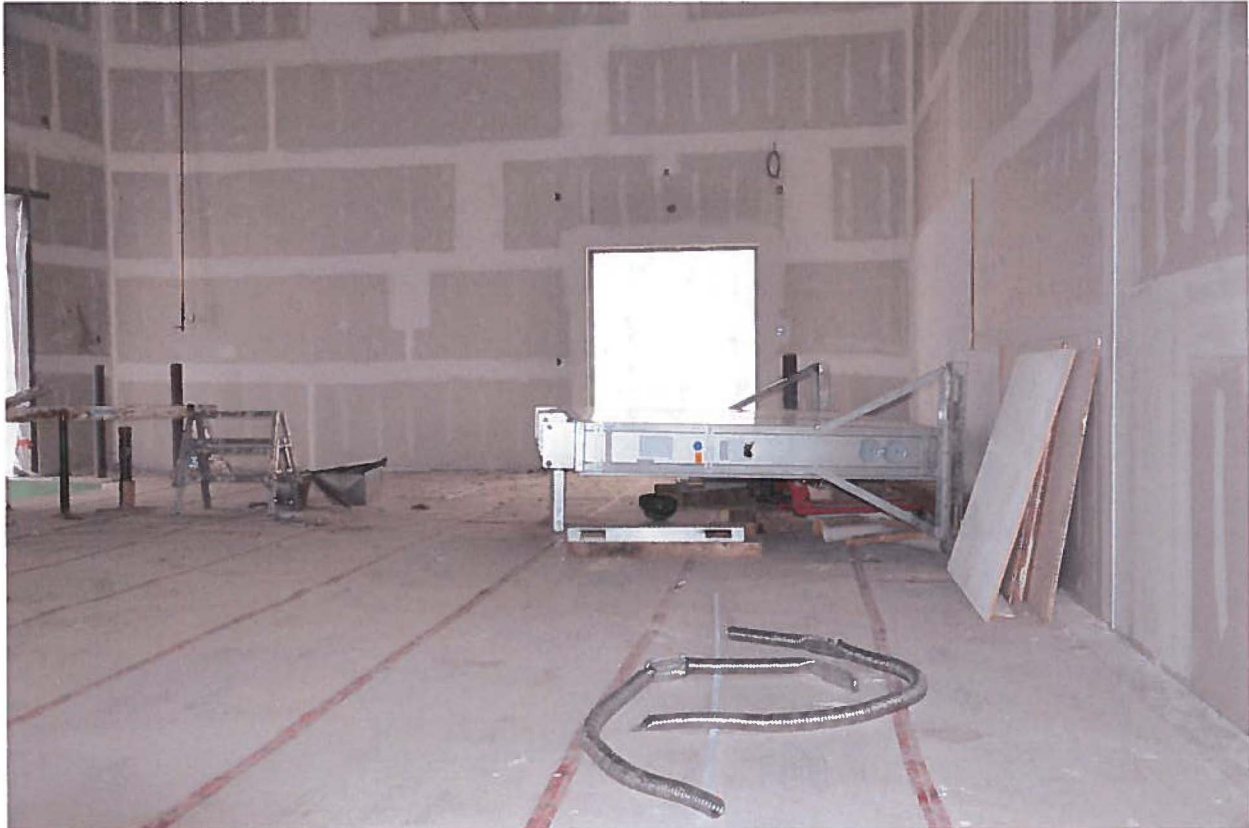
5.2.2 The electrical distribution panel was found angled on the south side of the bullards, front side down on the floor, with the overhang elevating the top of the electrical distribution panel. The electrical distribution panel was positioned on top of the pallet jack. (Refer to Attachment C – Photographs 4 and 5)

Photograph #5 Post-incident photo of the distribution panel positioned after the incident.

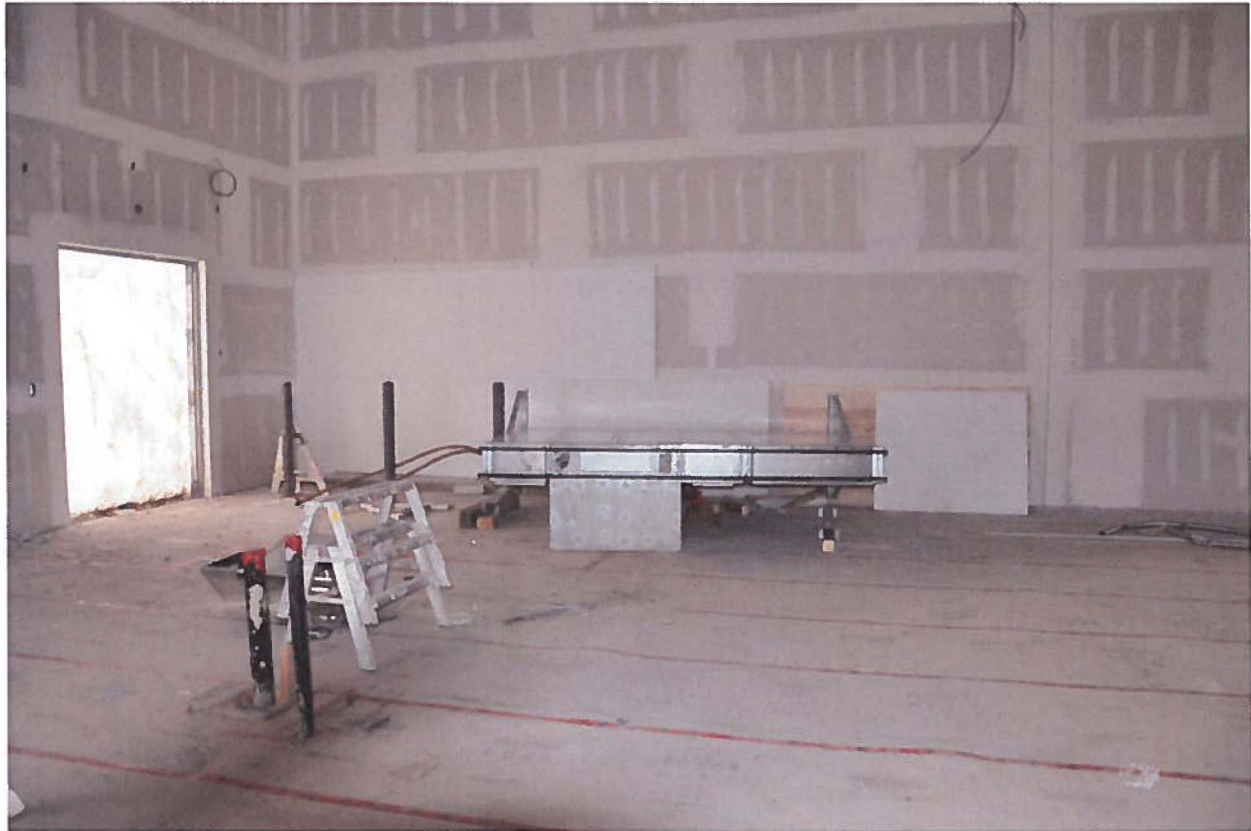
6.10 Site electrical foreman (**** * ***** *) and the apprentice electrician (*****
***** *) attempted to lift the distribution panel. Nearby construction workers, who
heard the incident, came to assist to remove the distribution panel. With their assistance, the
master electrician (***** *) was able to get out from under the transformer
shelf of the distribution panel. (Refer to Attachment C – Photograph 6)

Photograph #6 Post-incident position of the distribution panel, PSV piping, lumber.
