# **RECAPP Facility Evaluation Report**

## **Aspen Regional Health Authority**

### **Bonnyville Health Centre**

**Evaluation Company:** Koliger Schmidt architect engineer  
**Evaluation Date:** June 26 2009  
**Evaluator Name:** Steve Horvath

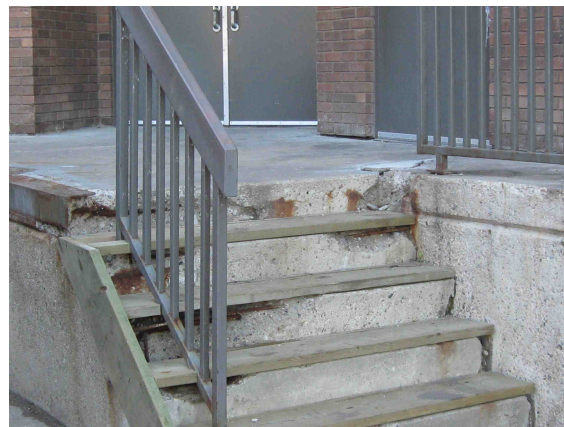
Concrete flaked and deteriorated for two sets of steps at loading dock.

Deteriorated concrete steps.

Replace concrete steps.

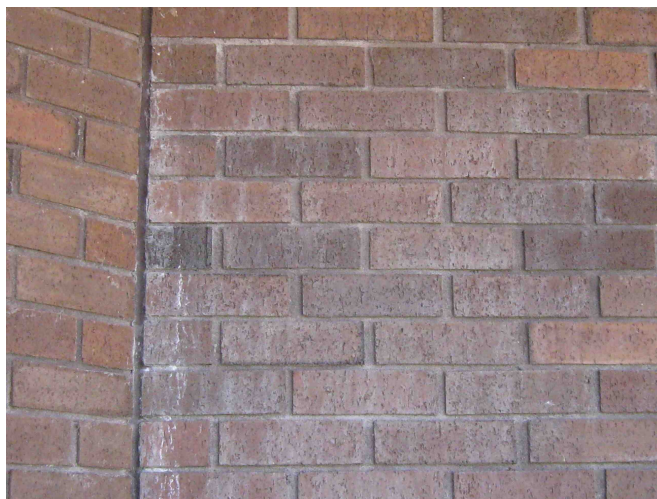
Cracked control joints at brick wall.

Architectural sealant at expansion joints is cracked and brittle.

Replace architectural sealant at expansion joints.

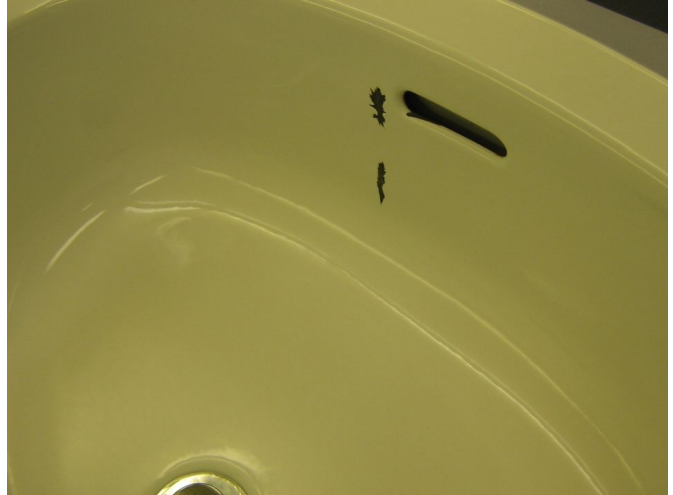
The water closets are flush valve. The urinals are wall hung flush valve. The lavatories are counter mounted, the facility is in the process of replacing the faucet with a single faucet with a Toyo sensor. The lavatories are reaching the end of their life cycle some are chipped. The lavatories have an overflow which is not up to infectious disease control standards.

Lavatory overflow.

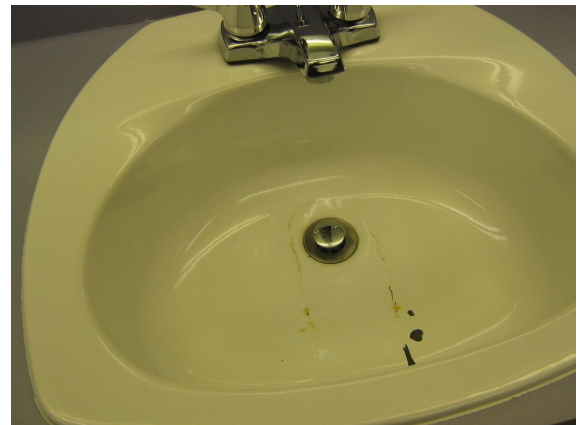
The damaged areas are a place for bacteria to develop.

Chipped lavatory.

Replace the damaged lavatories. When replacing lavatories they should not have overflows.

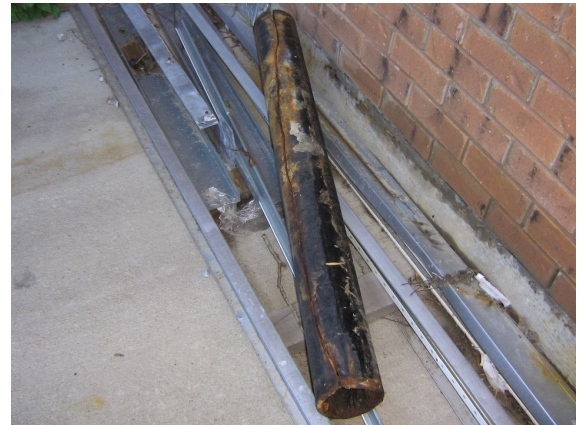
Sewer leaks.

Cracked Sewer Pipe.

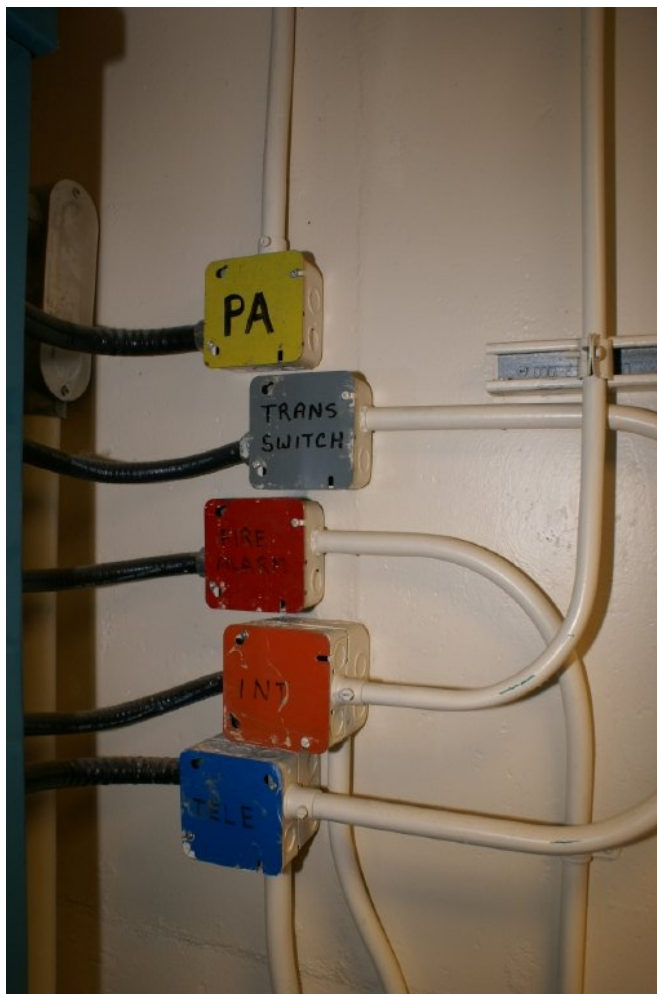
Typical color coded wiring methods for the building

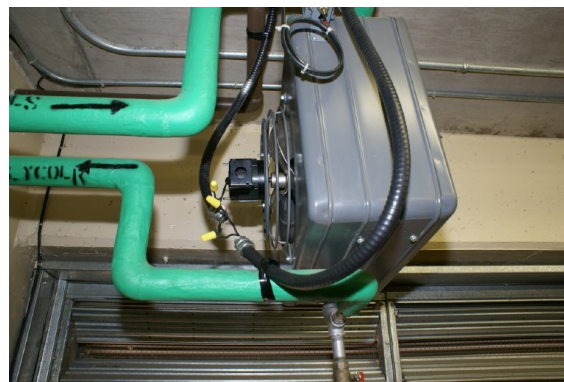
Both situations present risk of electrical shock. Water can penetrate the exposed damaged junction boxes and damage wiring.

Improper wiring of unit heater in the generator room.

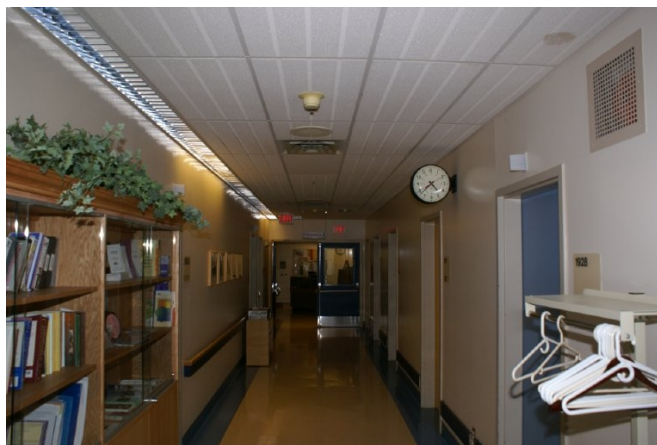
Typical fluorescent valance lighting in corridors

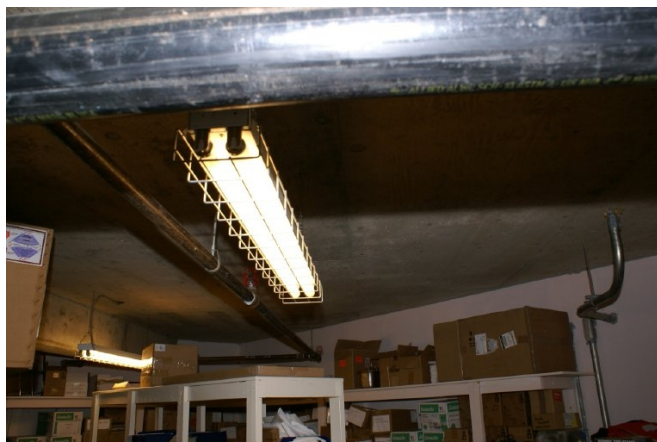
Typical fluorescent strip lights in the Lab basement

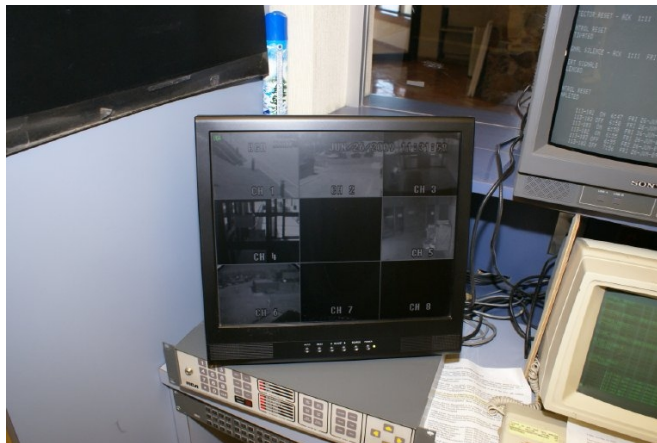
8 Channel DVR surveillance system

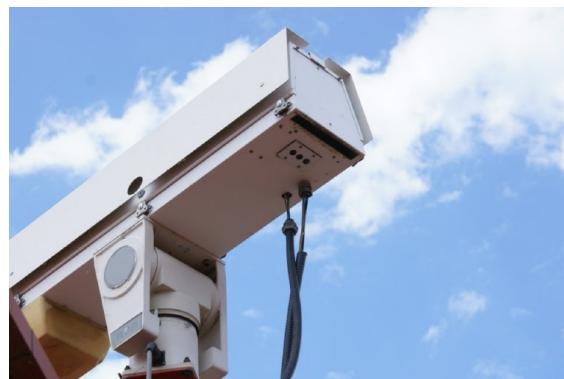
Water and insects can penetrate the conduit system and will damage the wiring and electronics in the camera.

Damaged conduits feeding security camera.

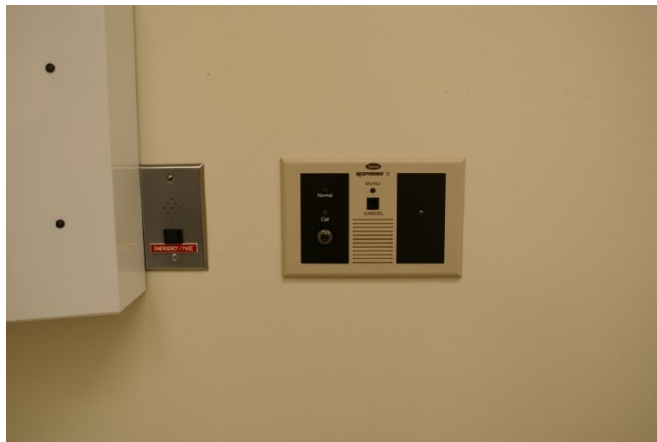
Rauland Responder III call station

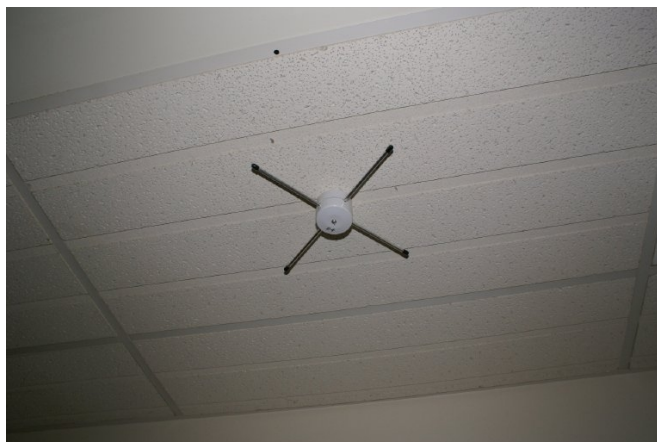
Typical emergency pendant system antenna

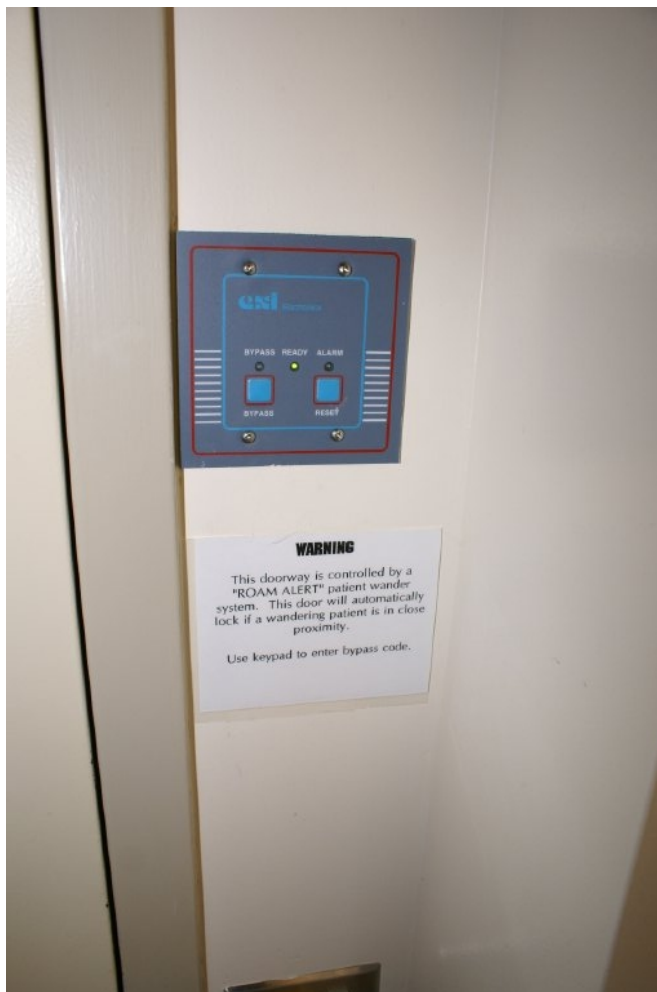
Patient wandering system control adjacent door to corridor.

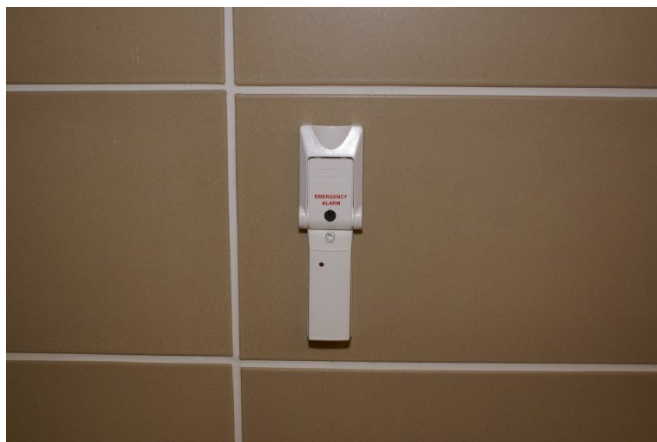
Typical sentrol panic station
