**ENVIRONMENTAL PROTECTION AND ENHANCEMENT ACT**

ENFORCEMENT ORDER No. EO-EPEA-38679

Clover Bar Sand & Gravel Ltd.  
10614 124 St NW  
Edmonton, AB  
T5N 1S3

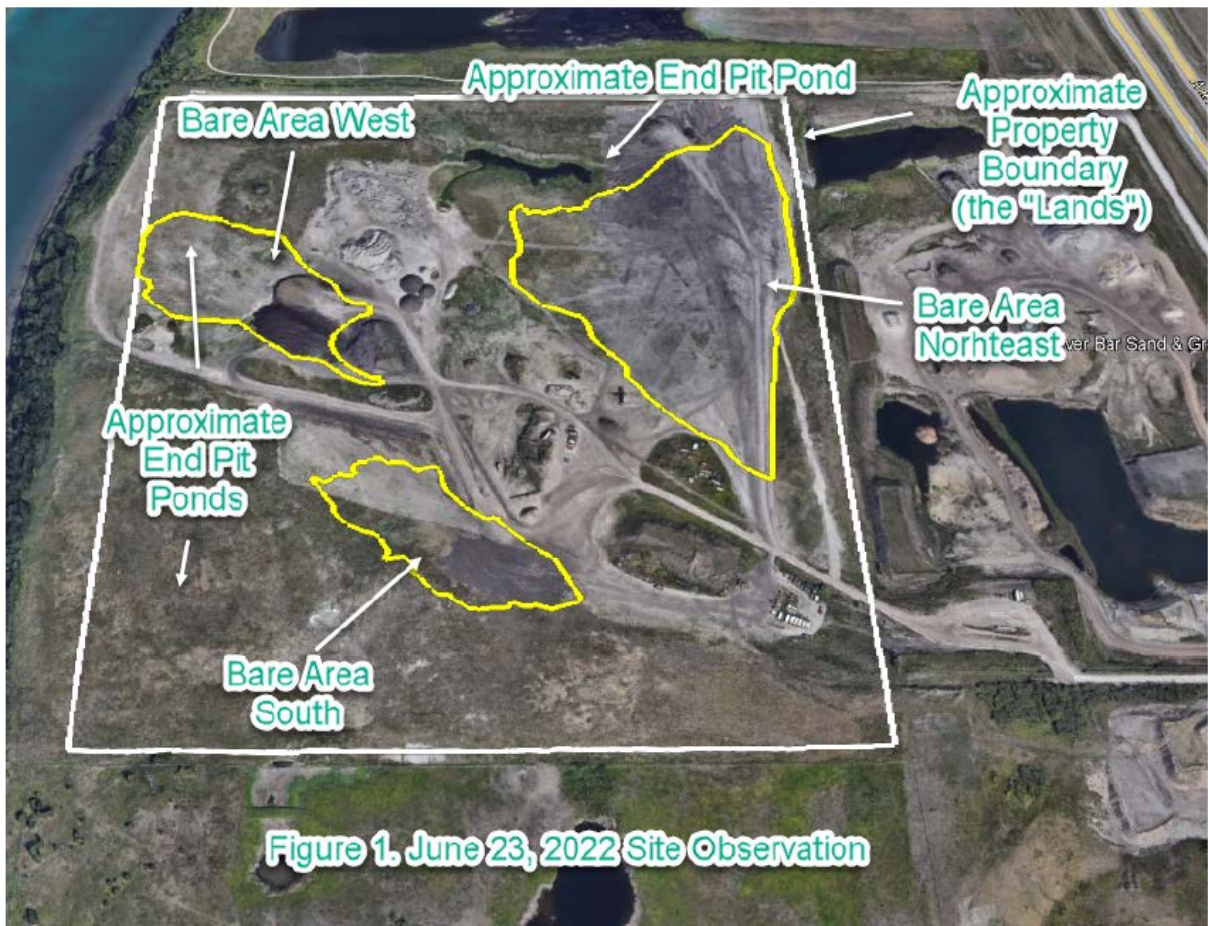
Figure 1. June 23, 2022 Site Observation

- that two end pit lake (ponds) identified in the Activity Plan (Figure 4 - "Reclaimed Conditions") were not present in the reclaimed areas and the topography of these areas appeared to be flat,
- a separate end pit lake location identified in the Activity Plan (Figure 3 - "Mining Plan") was partially infilled with fill material,

- fill material imported to the Clover Bar Pit admixed with degraded concrete pieces, degraded cement pieces, broken plastic tube, various diameter black rubber plastic tube sections, yellow plastic tube sections, various diameter blue plastic tube sections, various diameter green plastic tube sections, degraded geotextile, plastic bags, degraded plastic material, yellow foam pieces, rope, broken pylon, broken roadside barrier, sections of plastic pails, plastic membrane pieces, pieces of snow fence, erosion control fencing sections, broken ceramic pipe pieces, tires on and off the rim, tree trunks, tree and shrub roots, tree and shrub branches, pieces of plywood, pieces of broken lumber, bricks, metal grates, metal water valve cap within the fill material ("June 23 Waste") in the "Bare Area South", "Bare Area Northeast" and "Bare Area West" and throughout the Lands;

**WHEREAS** the location of the June 23, 2022 site observations of the end pit ponds, Bare Area South, Bare Area Northeast and Bare Area West are shown in Appendix A Figure 1.

- c. a description of the equipment and materials that will be used in implementing the site assessment;
  - d. the removal of the June 23 Waste, the August 9 Waste, the October 5 Waste, any other fill material admixed with the types of materials contained in the June 23 Waste, the August 23 Waste and/or the October 5, 2022 Waste and any other waste as defined in Section 1.1.2(x) of the Code within and on the Lands,

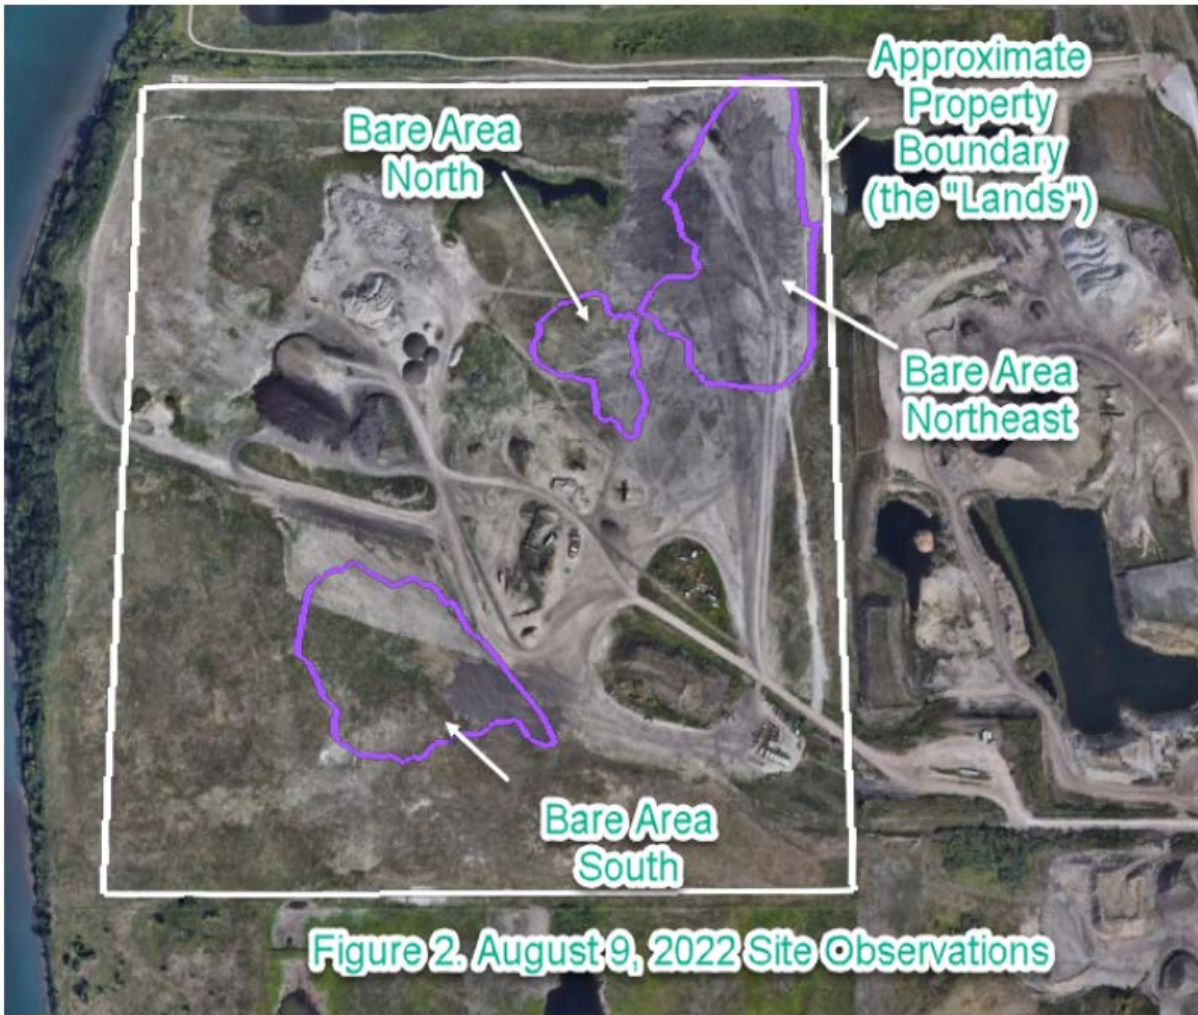
Figure 2. August 9, 2022 Site Observations

- two bare areas (Bare Area South and Bare Area Northeast) observed in the June 23, 2022 site inspection with the imported fill material present,

- one new bare area (“Bare Area North”) with mounded imported fill material present that was not observed during the June 23, 2022 inspection,
- one bare area (Bare Area West) with no new imported fill material present but the material was admixed with degraded plastic bags and pieces of plastic buckets,

- fill material imported to the Clover Bar Pit admixed with degraded concrete pieces, sections of cement riser ring from manholes, degraded cement pieces, broken blue water plastic tubes, various diameter black rubber plastic tube sections, broken white plastic tube, plastic signage, degraded geotextile, plastic bags, degraded plastic material, broken white roadside delineator, sections of broken plastic pails, landscape plastic edging pieces, plastic membrane pieces, sections and pieces of snow fence, erosion control fencing sections, parts of hockey skate boots, broken ceramic pipe pieces, tires, tree trunks, tree and shrub roots, tree and shrub branches, pieces of plywood, pieces of broken lumber, broken shovel, fake brick siding, bricks, metal brackets, metal pipe, a metal tooth from a machinery bucket, metal pin flags, metal engine block pieces, and a metal fire hydrant pipe within the fill material (“August 9 Waste”) in the Bare Area South, Bare Area Northeast, and Bare Area North,

**WHEREAS** the location of the August 9, 2022 site observations of the Bare Area South, Bare Area Northeast and Bare Area North are shown in Appendix A Figure 2.

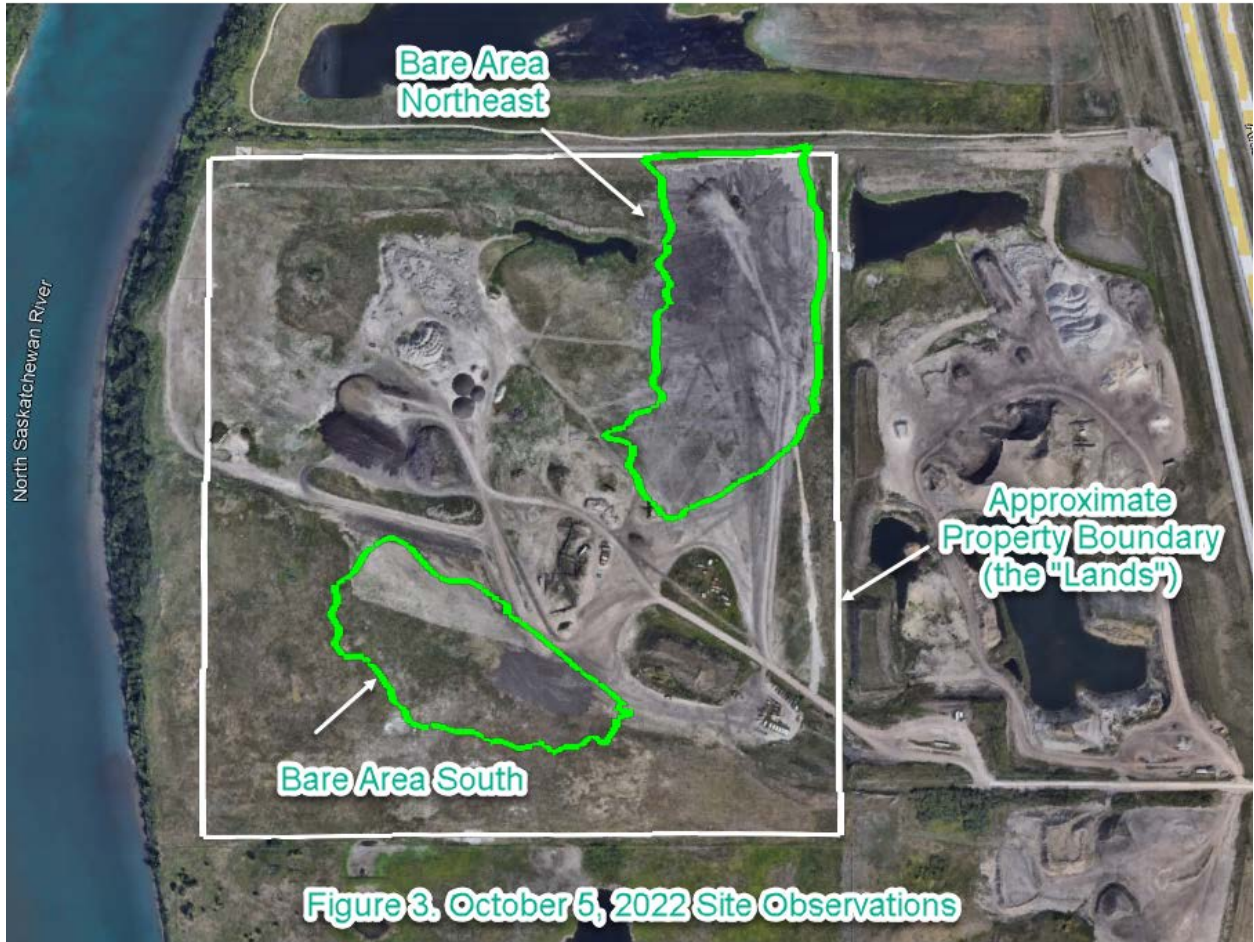
- two bare areas (Bare Area South and Bare Area Northeast) observed in the June 23, 2022, and August 9, 2022 Site Inspections with the imported material present,
- two bare areas (Bare Area North and Bare Area Northeast) identified in the August 9, 2022 site inspection were incorporated into one bare area (Bare Area Northeast),

- one bare area (Bare Area West) with no imported material present,
- fill material imported to the Clover Bar Pit admixed with degraded cement pieces, bricks, asphalt pieces, cement plugs from fence poles, cement plugs from fence pole with metal post, pin flags, flagging tape, sections of degraded landscape fabric, degraded geotextile pieces, degraded and buried plastic bags, plastic jug, broken pieces of random plastic, snow fence, white road delineator, broken clay pipe piece, broken green and blue water pipe pieces, white plastic tube pieces, buried black plastic tube, red plastic tubing, buried bungie cord, blue pipe wrap, plastic vacuum tube, metal rebar pieces, metal pipe pieces, sections of wire with plastic coating, fence wire, metal wire guards, bent metal fence and sign posts, metal strapping, broken shoe, broken lumber, and woody debris present within the fill material, (“October 5, Waste”) in the Bare Area South and Bare Area Northeast;

**WHEREAS** the location of the October 5, 2022, site observations of the Bare Area South and the Bare Area Northeast are shown in Appendix A Figure 3;
