Investigation Report

Worker Fatally Injured While Welding a Tire Rim

April 25, 2016

Final Report

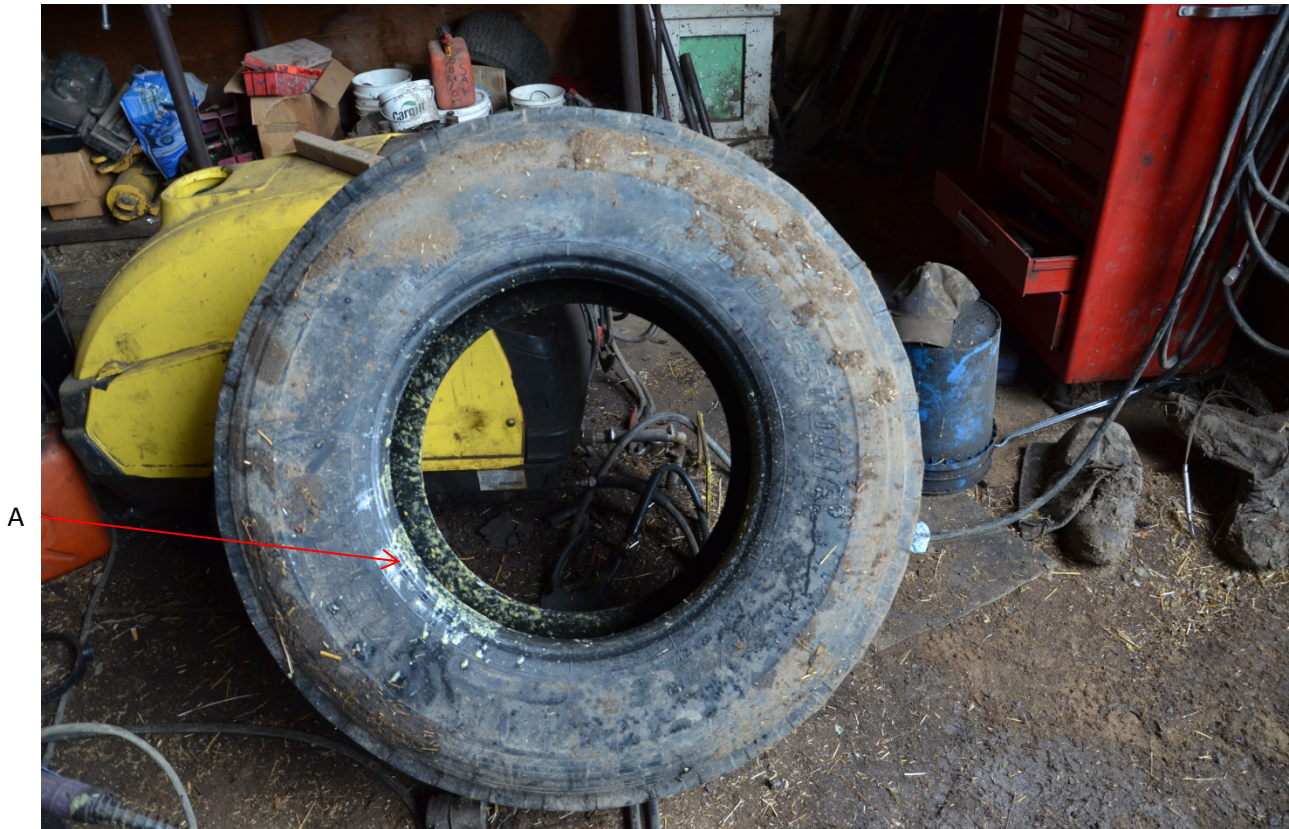
Figure 1 – Tire from the incident

The tire involved in the incident was an M844. It was a commercial tire, manufactured by Bridgestone, and was classified as a “Truck Bus Radial.” The specifications of the tire were 425/65R22.5 rated with a maximum inflation pressure of 827 kilopascals (kPa) (120 pounds per square inch (p.s.i.)) and a maximum load of 5600 kilograms (kg) (12 345 pounds) (Figure 1).

A – Yellow Residue Tire Sealant

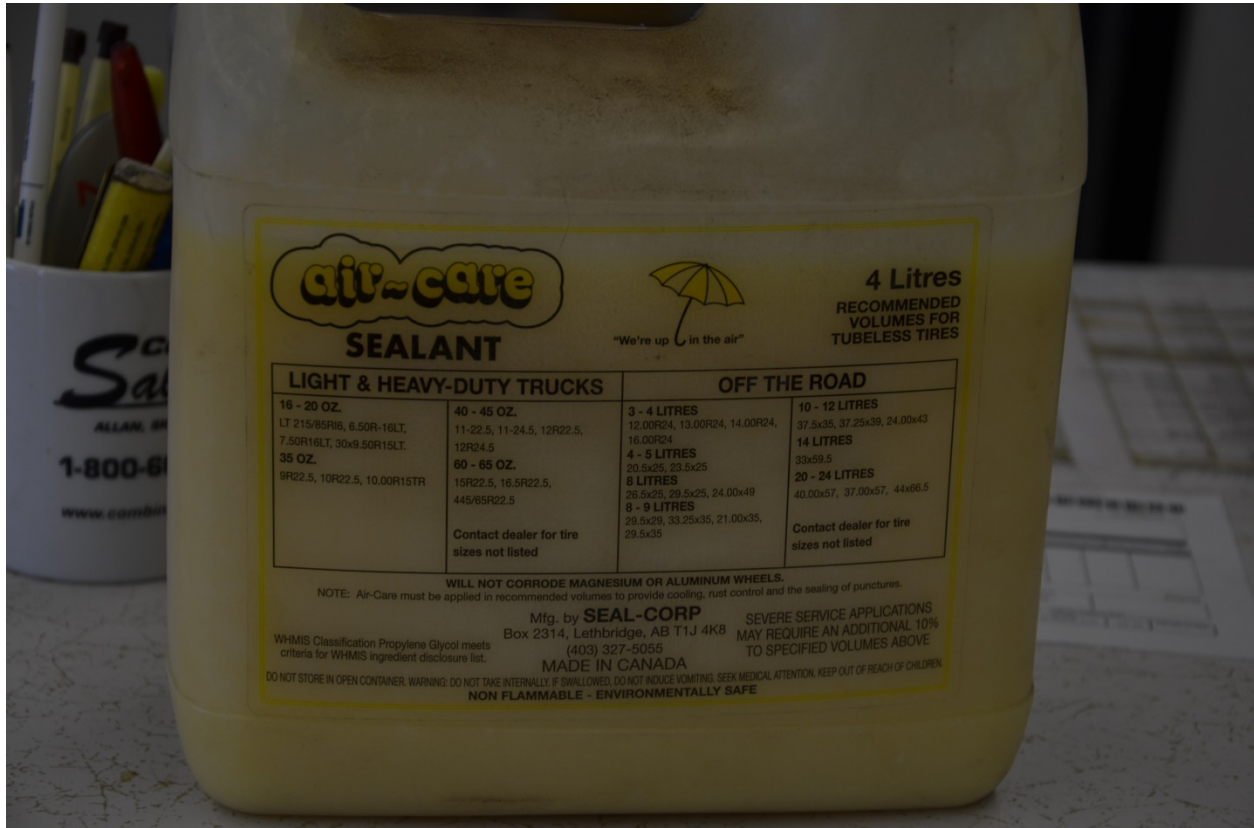
Figure 2 – Tire sealant use in the incident

The tire sealant used in this incident was a product called “air-care sealant” made by the Seal-Corp company in Lethbridge, AB (Figure 2). The sealant was a non-flammable, environmentally safe product, used to seal leaks up to 6 millimetres (mm) in diameter. The tire sealant was purchased from OK Tire in Coronation, AB.

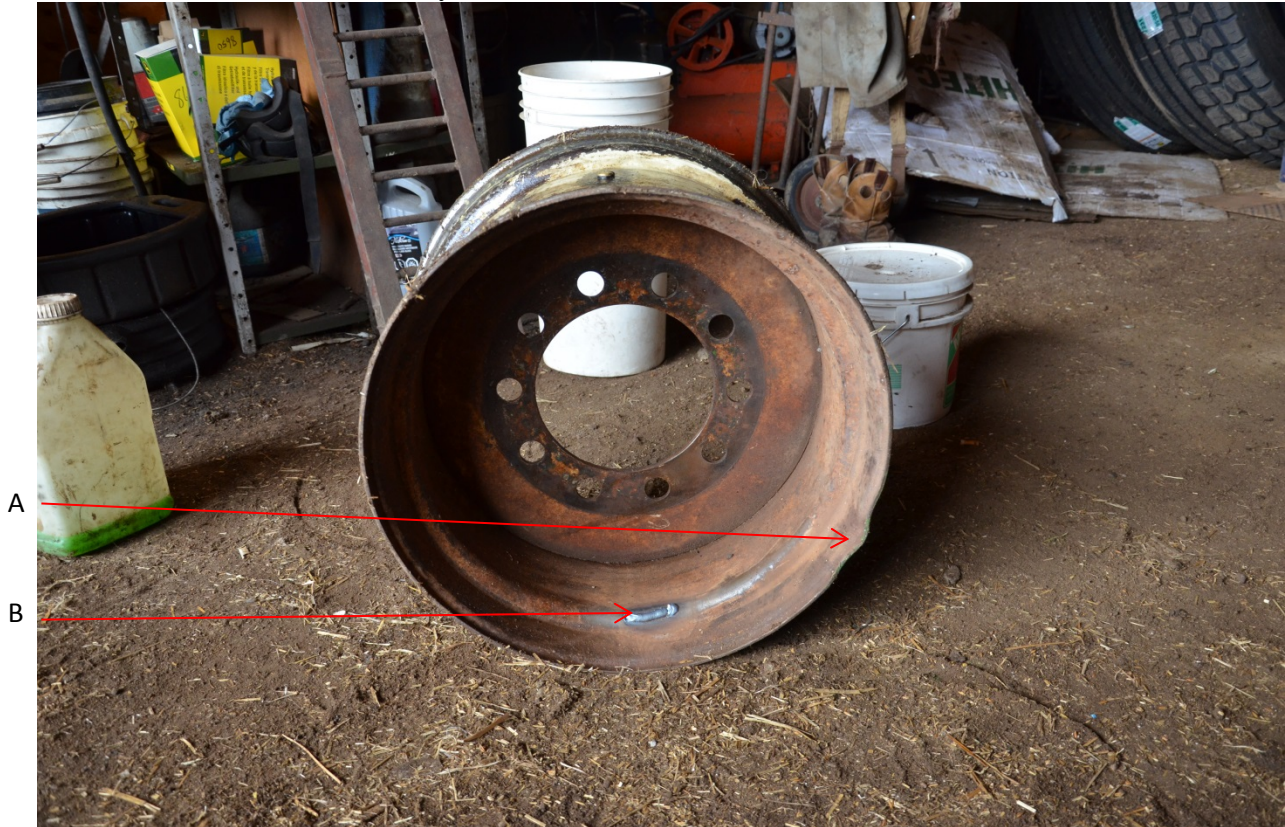
The rim was made from steel and measured 58.42 centimetres (cm) (23 inches) wide and 38.1 cm (15 inches) deep (Figure 3). The rim from the incident had a crack in it that caused the tire to deflate. The rim/tire assembly was removed from a Henke 515 feed/mixer wagon the day before the incident. The rim had been previously welded on by the farm hand. OK Tire refused to work on the rim/tire assembly because of the condition of the rim.

*Figure 3 – Rim from the incident
A – Damage caused by the incident
B – The weld*

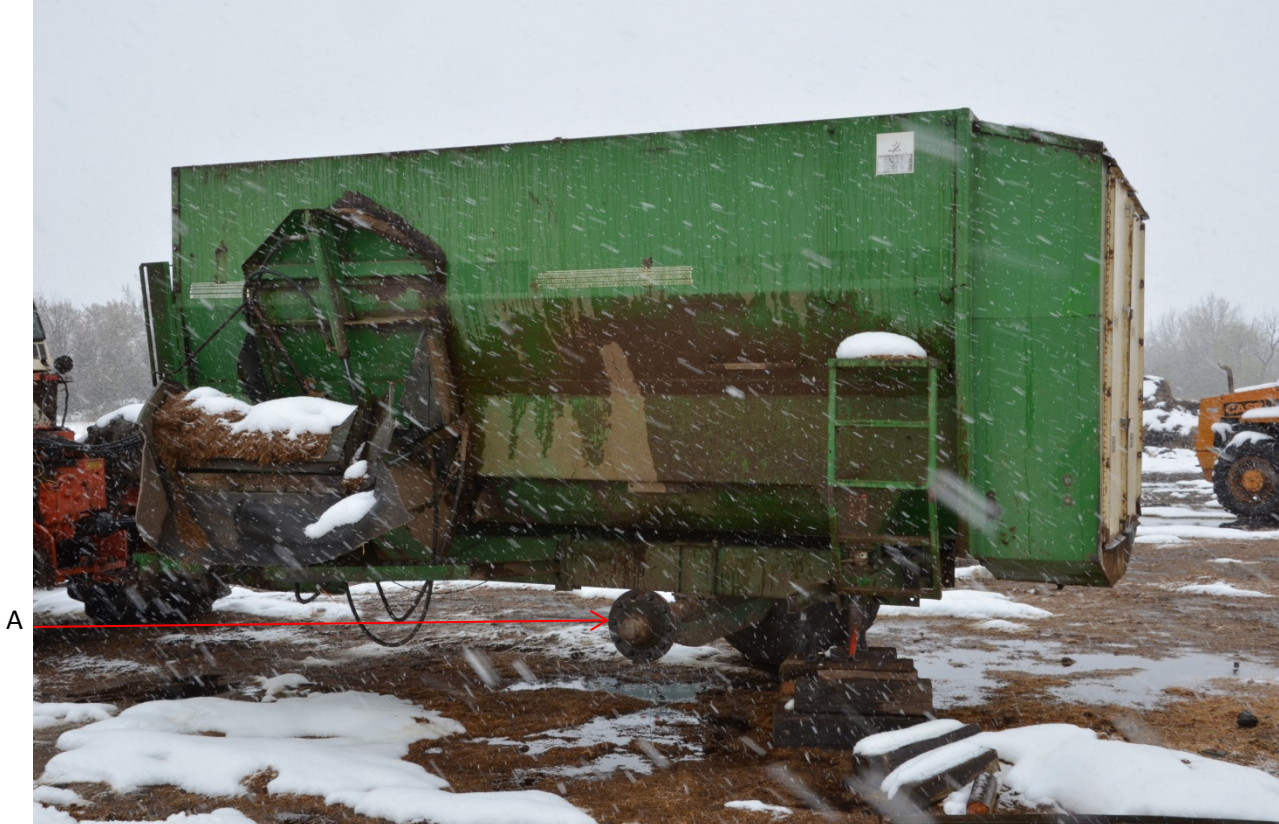
Figure 4 – Henke wagon with the tire assembly removed

A – Hub for wheel assembly
