Investigation Report  
Worker Fatally Crushed by Genie Lift  
March 18, 2013

Report No-F-OHS-038619-C9699  
May 2019  
Page 1 of 14

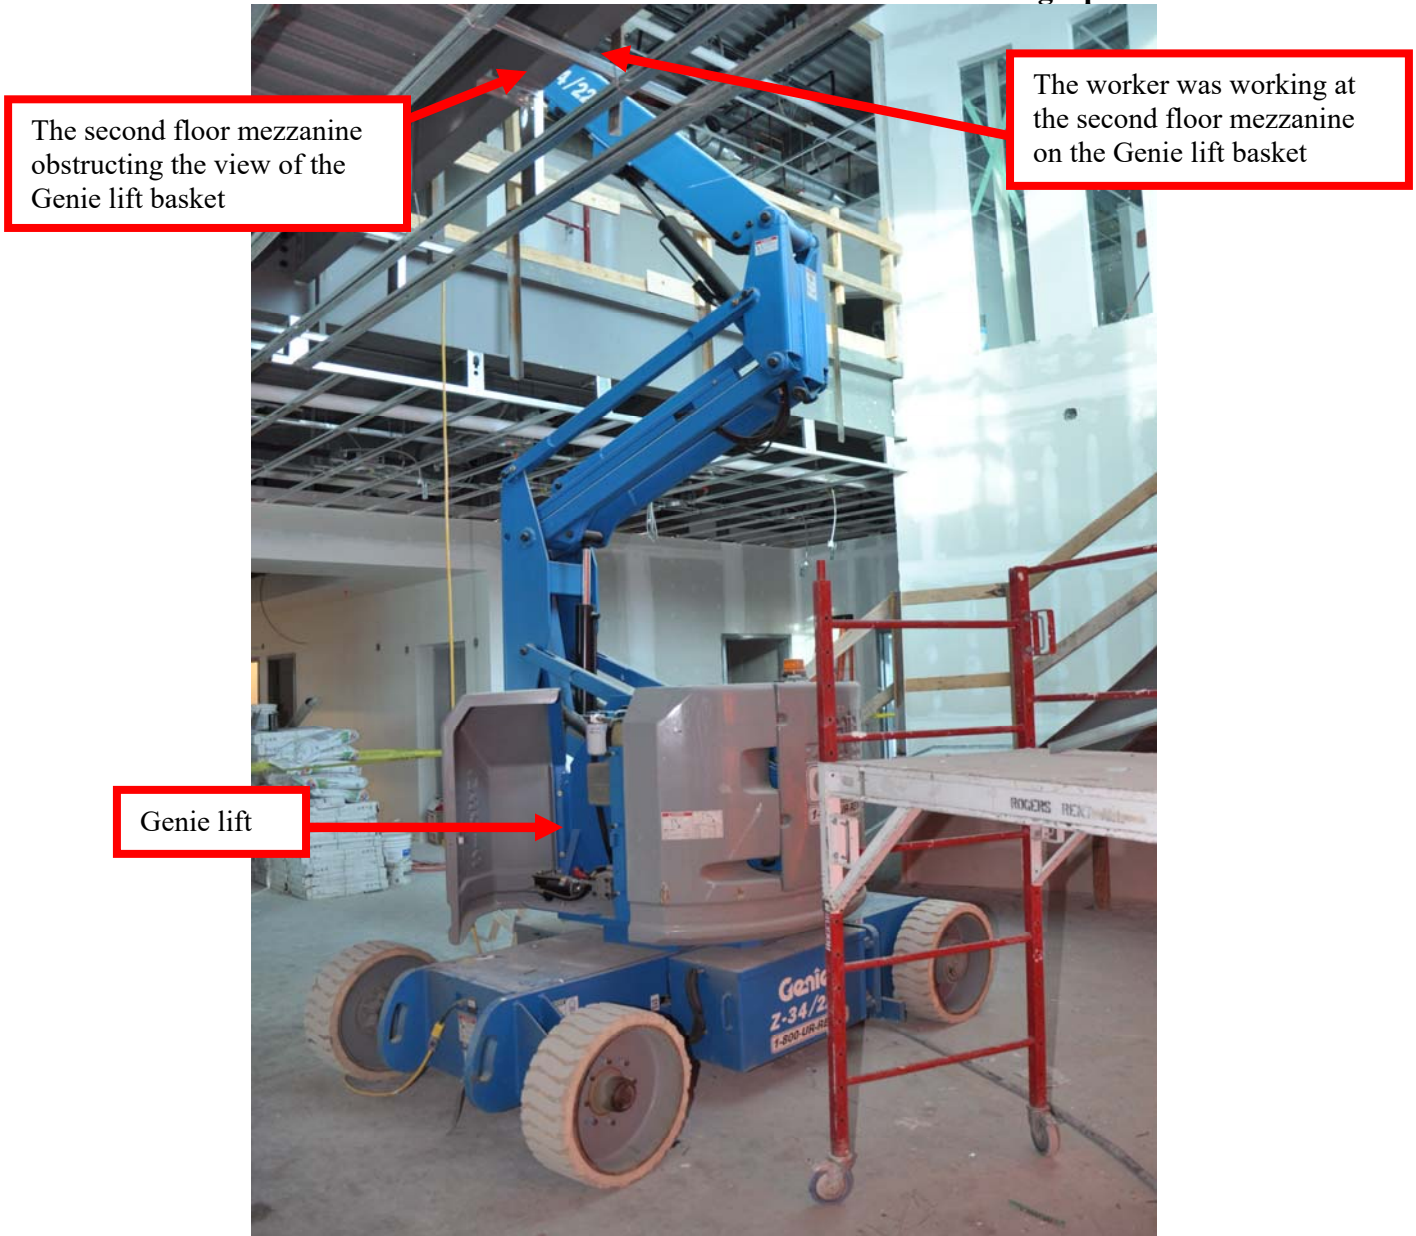
6.2.15 The area where the Genie lift was situated on the main floor was level and had adequate space to manoeuvre. When this equipment had an extended jib boom, due to the configuration of the second floor ceiling architecture details, it created a congested work area at the ceiling. (Reference Attachment A – Photographs 1-3). The POS taper (\*\*\*\*\* \*\*\*\*\*) became trapped against the ceiling bulkhead.

**Photograph 1** - Shows the Genie lift, located on the main level of the incident location, with the primary boom and jib boom extended where the POS worker was working in the lift platform between the second floor mezzanine and ceiling bulkhead. (NOTE: The lift platform is not visible due to the second floor mezzanine obstructing the view.)

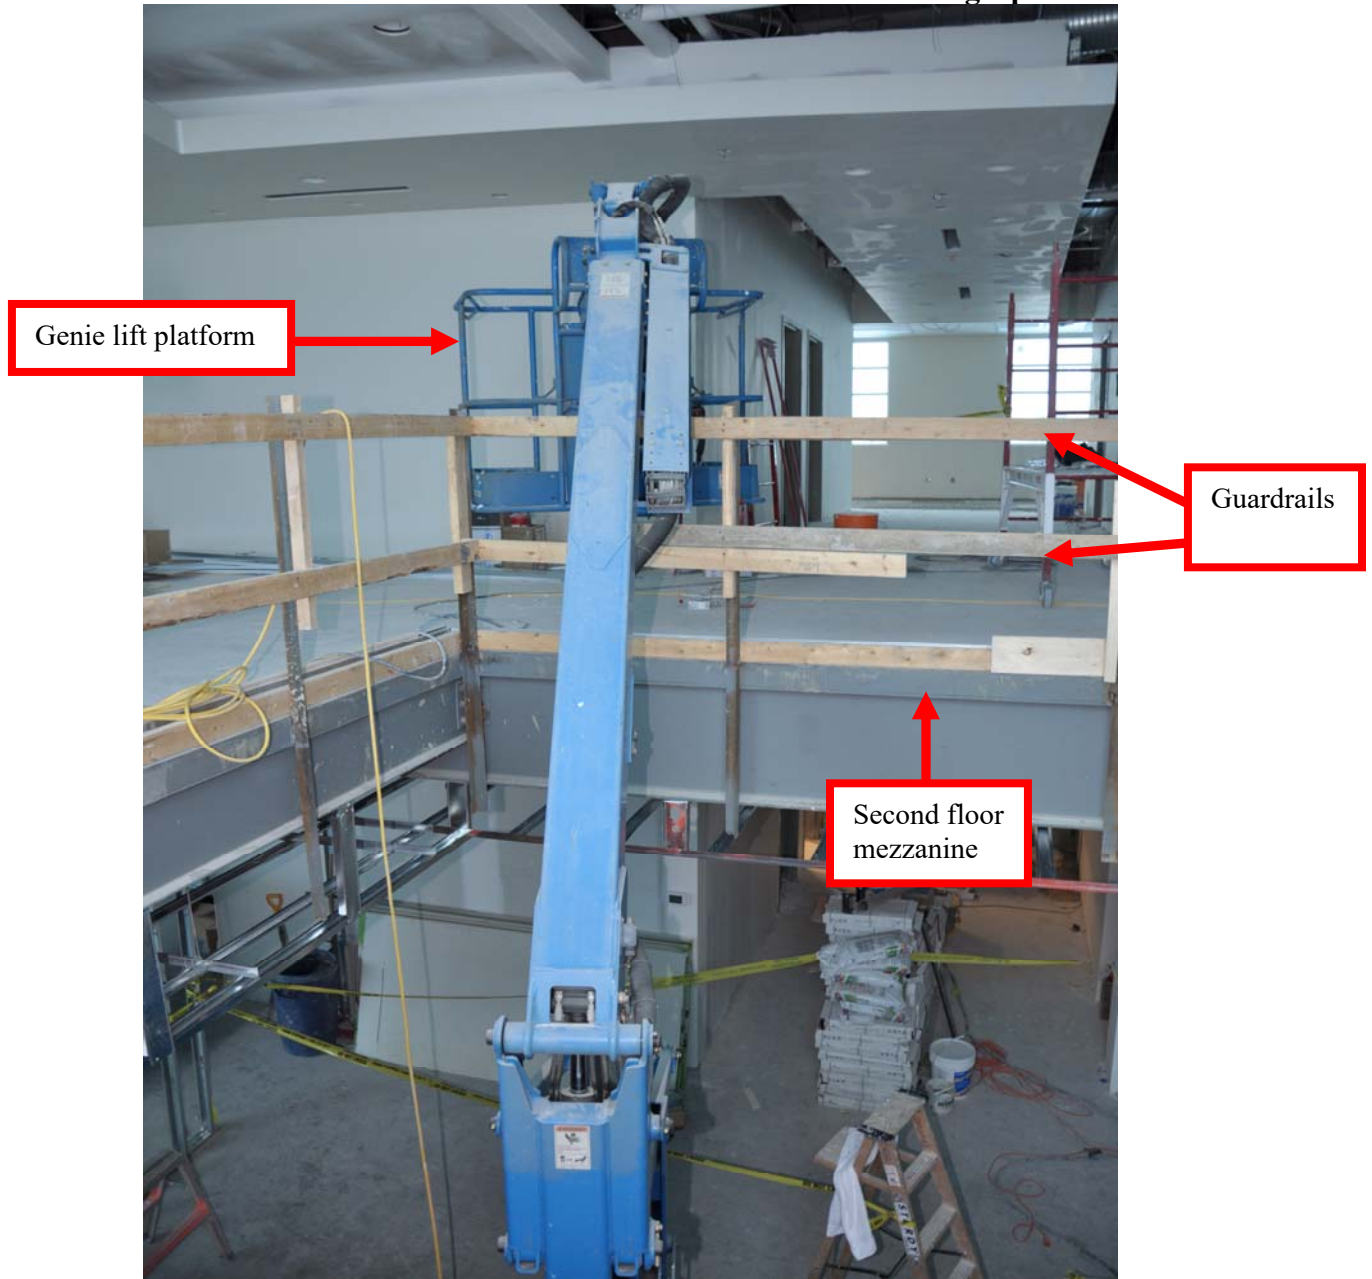
**Photograph 2** - Shows the Genie lift, located on the main level of the incident location, with the primary and jib boom extended where the POS worker was working in the lift platform between the second floor mezzanine and ceiling bulkhead. (NOTE: The ground control panel located on the main level is not visible due to the boom obstructing the view.)

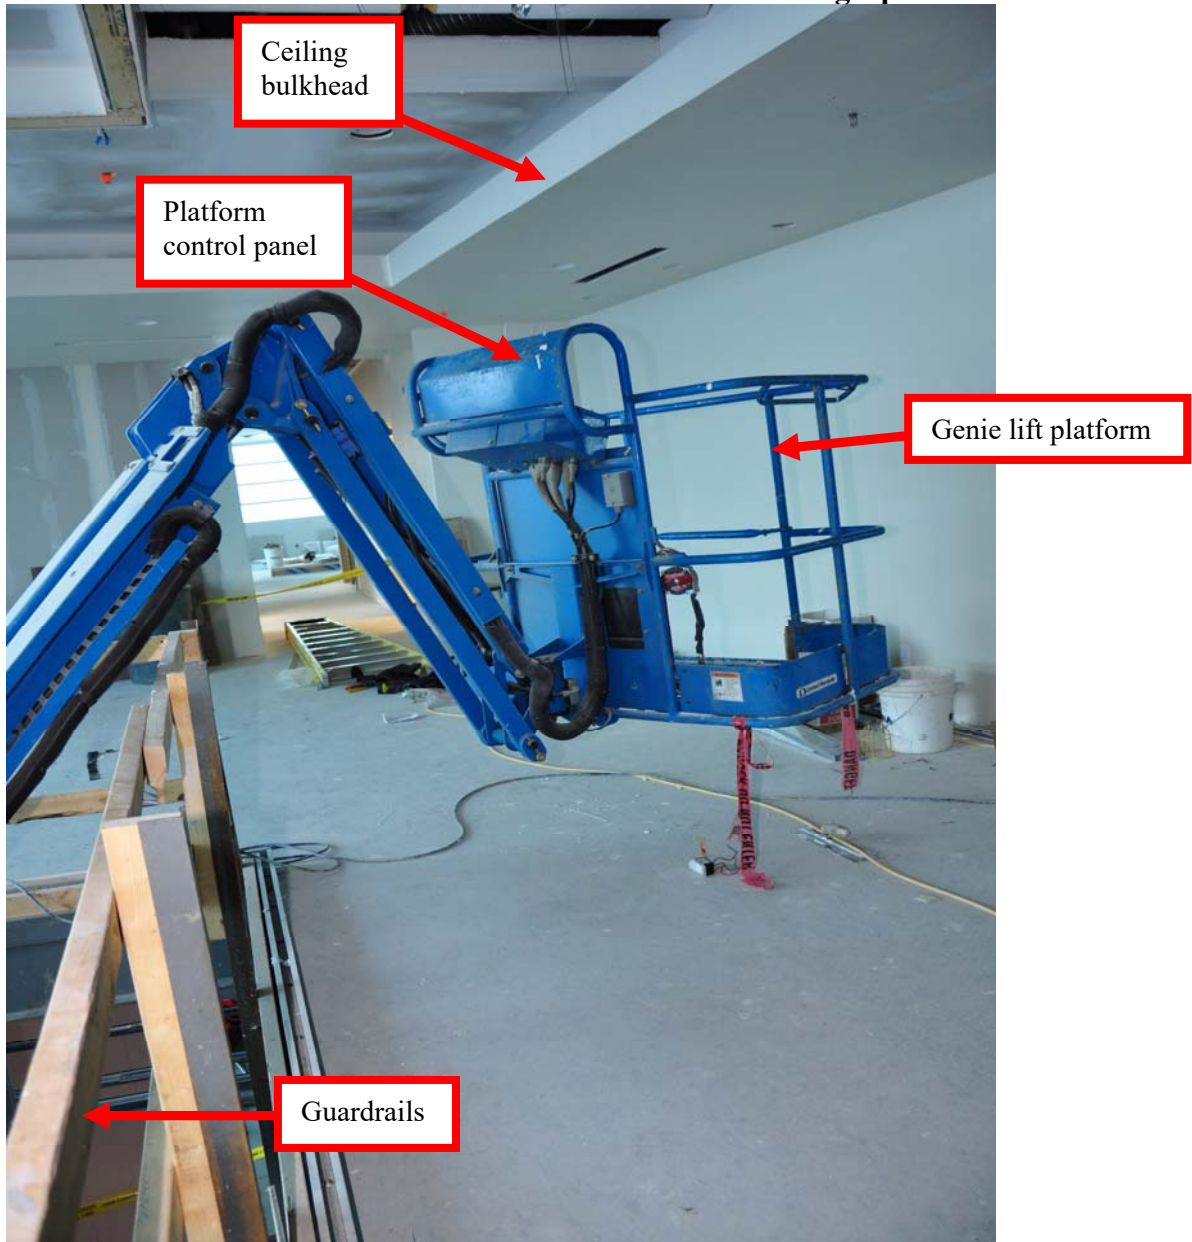
- 6.1.6 At approximately 3:45 p.m., the Westland first year electrical apprentice (\*\*\*\*\*) was conducting electrical work in the second floor men's washroom. The Westland first year electrical apprentice (\*\*\*\*\*) observed that the Genie lift was close to the ceiling bulkhead and that there was no movement. The Westland first year electrical apprentice (\*\*\*\*\*) went to investigate and observed that the POS taper (\*\*\*\*\*) was unresponsive and pinned by the neck between the ceiling bulkhead and the platform control panel, cutting off oxygen. (Reference Attachment A – Photographs 3 and 4).

- 7.1.1 On March 18, 2013, the POS taper (\*\*\*\*\* \*) was found unconscious when pinned by the neck between the main control panel of the Genie lift platform and the ceiling bulkhead, cutting off oxygen flow. POS taper (\*\*\*\*\* \*) fatally

**Photograph 3** – Shows the Genie lift platform in the vicinity of where the POS worker was working in the lift platform between the second floor mezzanine and ceiling bulkhead when the POS worker was found pinned by the neck between the ceiling bulkhead and the platform control panel.

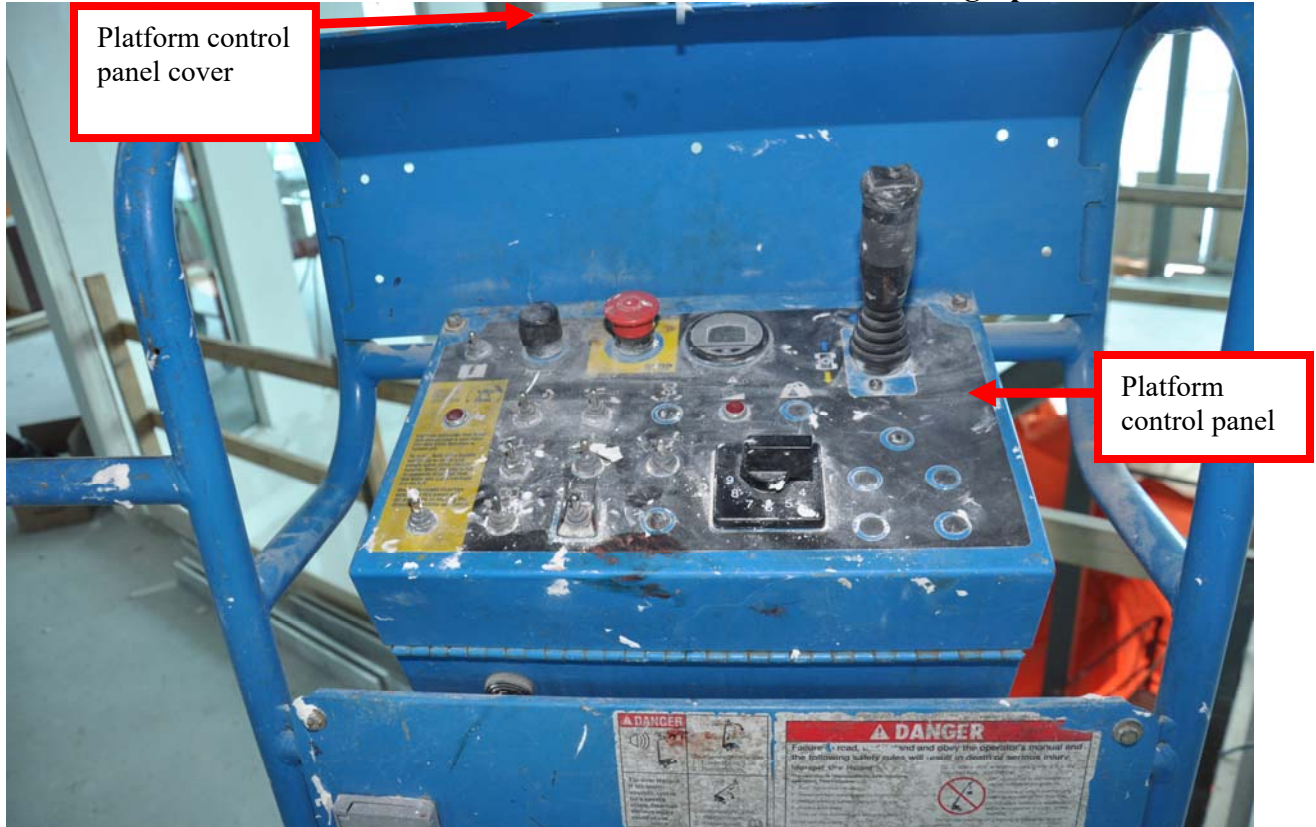
**Photograph 4** – Shows the Genie lift platform with the platform control panel and cover that the POS worker was utilizing in the lift platform between the second floor mezzanine and ceiling bulkhead when the POS worker was found pinned by the neck between the ceiling bulkhead and the platform control panel.

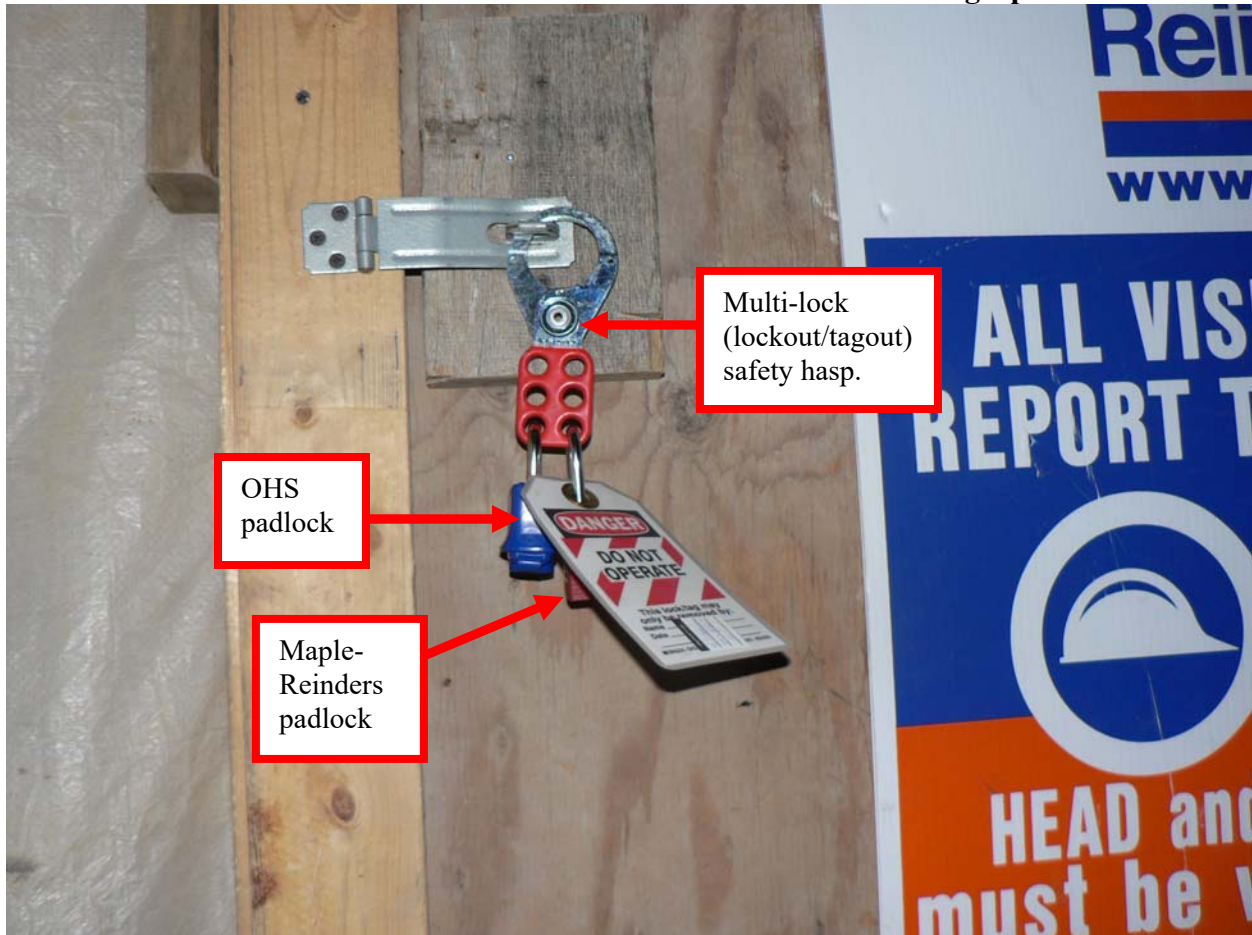
- 8.1.3 On March 18, 2013, POS voluntarily removed the Genie lift, involved in the incident, from service.
- 8.1.4 On March 18, 2013, OHS placed padlocks on the 3 doors of the commercial construction project, the Maple Reinders office complex, to ensure that no one could enter the site and access the Genie lift when OHS left the property. (Reference Attachment A – Photograph 5).

**Photograph 5** – Shows a multi-lock (lockout/tagout) safety hasp belonging to Maple-Reinders. A padlock belonging to OHS and a padlock belonging to Maple-Reinders were placed onto this multi-lock (lockout/tagout) safety hasp; the locked out doors to the commercial construction project, the Maple Reinders office complex, ensured that no one could enter the site and access the Genie lift. Each of the 3 doors to access the building had this multi-lock system put in place to prevent entry.
