Investigation Report
Worker fatally injured falling from truck
October 16, 2018

Report No-F-OHS-155652-57996
November 2020
Page 1 of 8

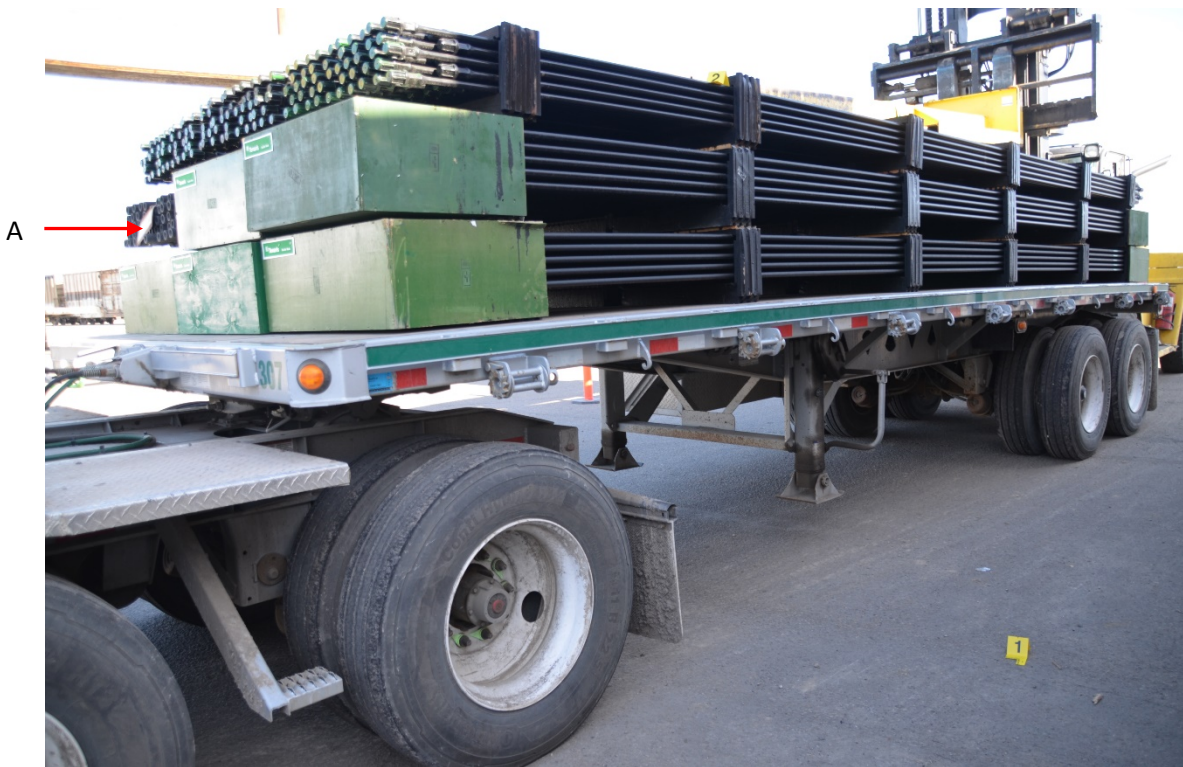
Figure 2. Trailer 307. Photo taken at Arrow Reload yard.

The sucker rods were stacked three bundles high, on the rear section (Figure 2). The height of both the trailer and bundles of sucker rods was approximately 2.36 m

A. Incorrect bundle of sucker rods. The bundle was to be removed and replaced with a correct bundle.

Two bundles, including the incorrect bundle of sucker rods (Figure 2), needed to be removed from the trailer. The correct bundle would be returned to the trailer and the incorrect bundle would be replaced.

The worker accessed the trailer from the south side, climbed up to the top of the bundles of sucker rods and walked north toward the boom. The worker may have lodged their foot in-between the rods (irregular channels existed between the stacked rods within the bundles), and in an attempt to correct their position, the worker slipped and fell. The worker fell approximately 2.36 m to the pavement surface striking their head.

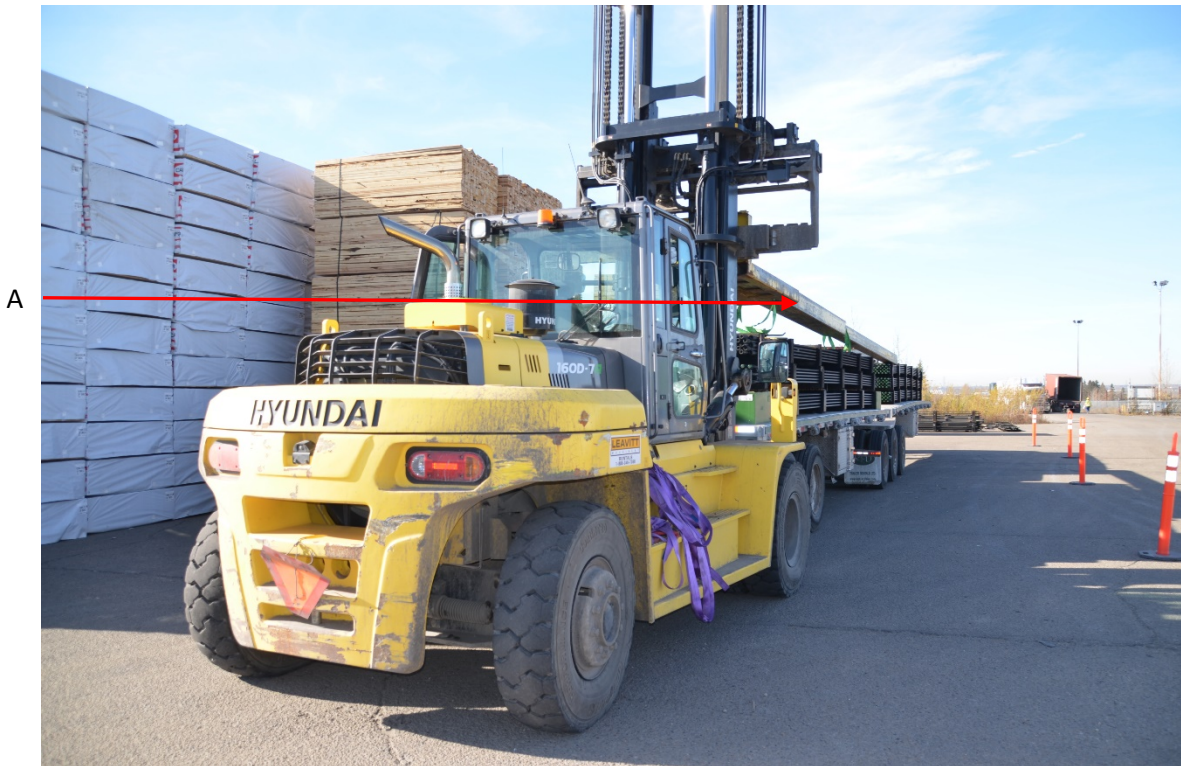
Figure 3. Forklift with boom. Photo taken at Arrow Reload yard.

The forklift was utilizing a Fortis Manufacturing (Unit SD-555-01) 12.2 m pipelift fork attachment (boom) with a rated load capacity of 4.5 metric tonnes (MT). The bundles of sucker rods were moved by strapping the bundles to the boom utilizing synthetic fibre slings (Figure 3).

A. Boom

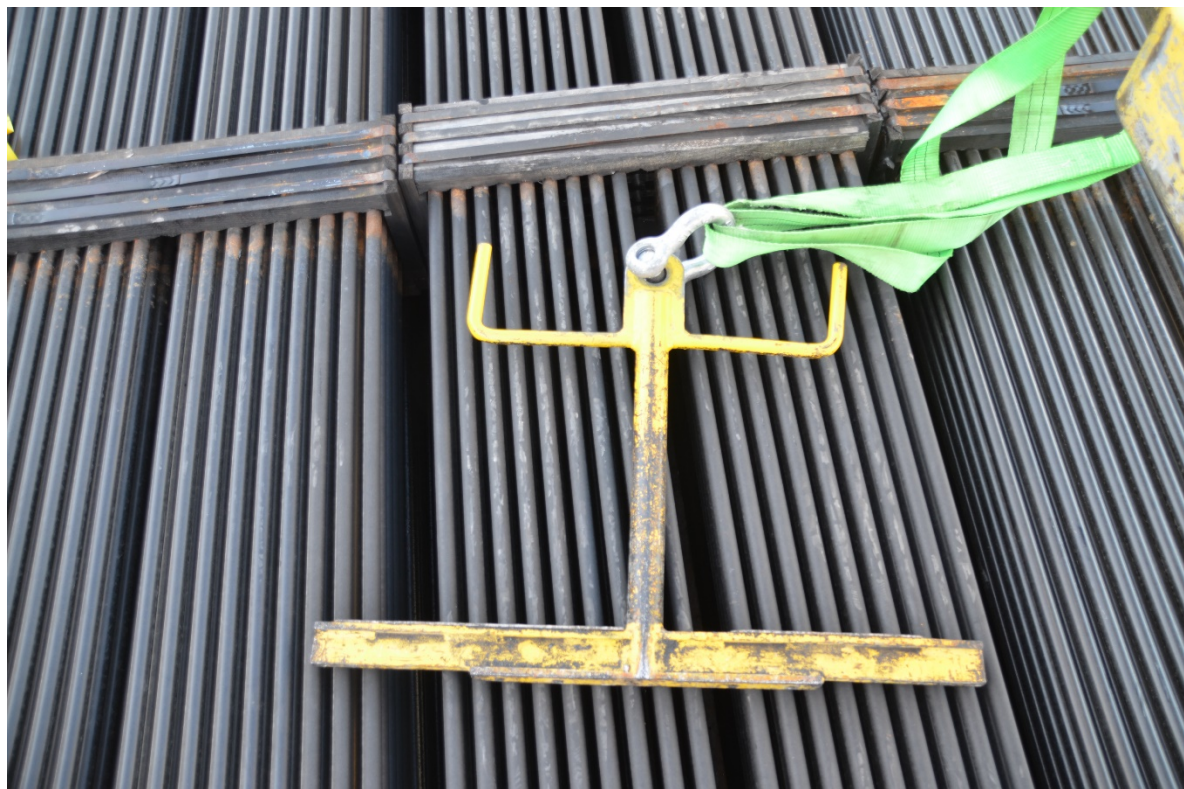
Figure 4. T-Bar resting on sucker rod bundles. Photo taken at Arrow Reload yard.

A commercially manufactured Sucker Rod Lifting T-Bar (T-Bar) was used to hook underneath the bundles of sucker rods. The T-Bar included a 0.59 m bar with an upper T-bar section of 0.5 m and a lower T-bar section of 0.78 m (Figure 4).
