WORKER CRUSHED BY FORKLIFT

Type of Incident: Fatality

Date of Incident: October 17, 2012

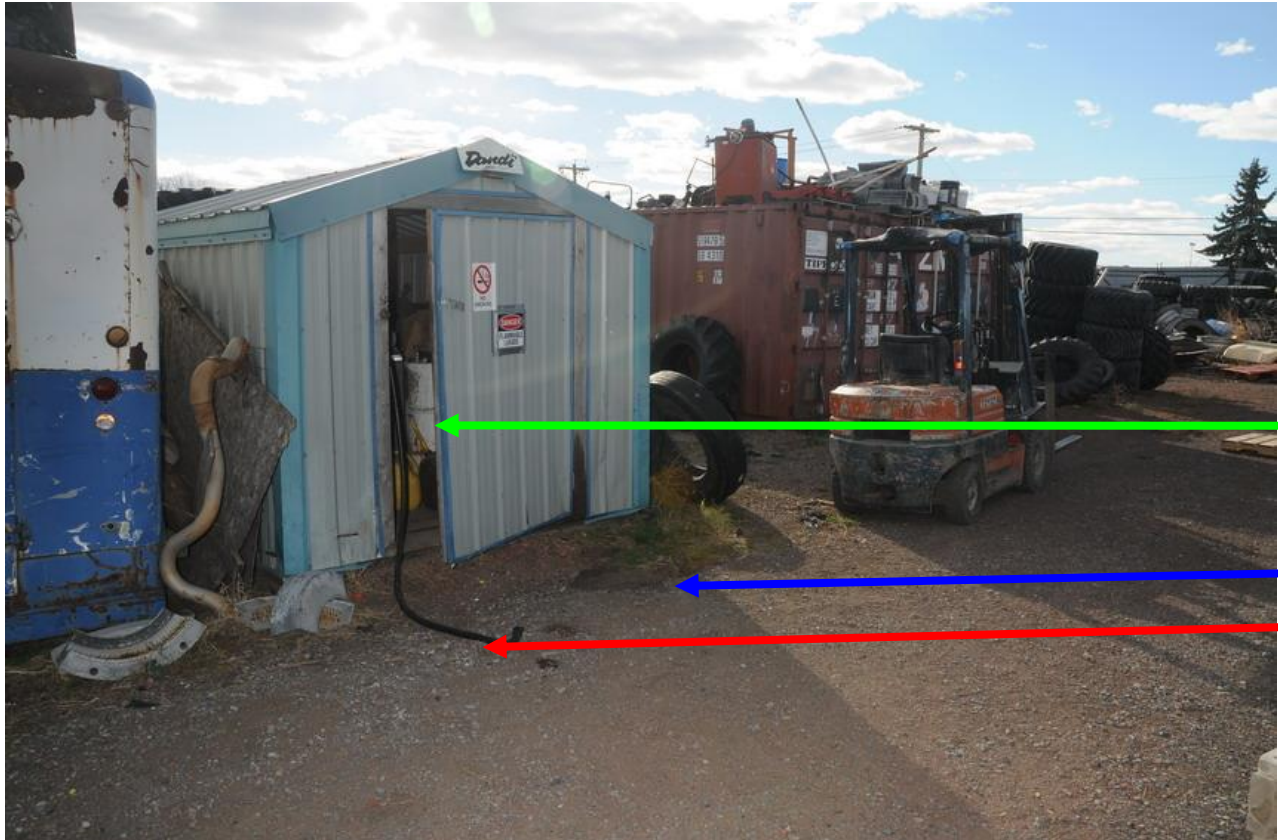
- 5.2.1 Prior to OHS responding to the work site, the forklift had been moved west of the incident location to facilitate first aid and Emergency Medical Service (EMS) response.
- 5.2.2 There was a tire indentation in the ground and a build up of gravel behind where the left front tire of the forklift had been sitting at the time of the incident.

7.2.3 The angle of the forklift in relation to the partially open shed door created a pinch point.

Photograph 2 – Shows the shed located in the southwest yard of Mo-Tires Ltd. truck service center. Green arrow shows the edge of the partially open shed door that Worker 1 (*****) was pinned against at the time of the incident. Blue arrow shows where the forklift’s front left tire had dug into the gravel. Red arrow shows the gasoline refueling hose.

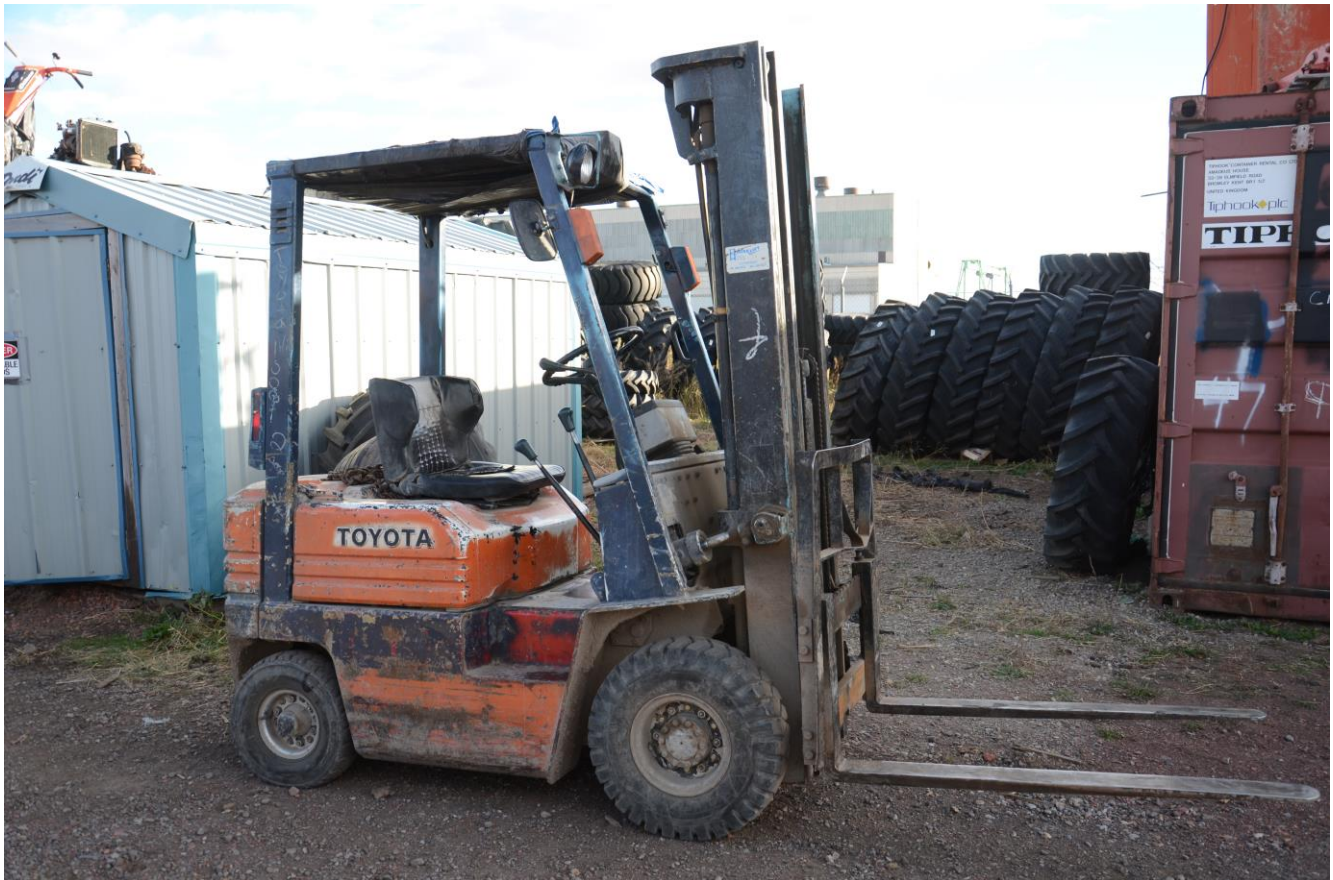
**File: F-16739
ATTACHMENT B
PHOTOGRAPH 3 of 5**

- 5.2.3 The forklift had broken welds on the backrest extension, was leaking hydraulic fluid on the mast lift cylinder, had a broken rear signal/stop light and no seat belt.

7.2.2 The forklift brake was out of adjustment and did not hold while the forklift was running and in gear.

Photograph 3 - Shows the Toyota, Model 5FG15 (Serial Number [REDACTED]) forklift that was involved in the incident.

- Conduct an incident investigation and prepare a report outlining the circumstances surrounding the incident as well as preventive measures.
- Stop Use of the forklift until it has been inspected and repaired in accordance with the manufacturer’s specifications (tag # 7537).
- Ensure forklift operators are trained in the safe operation of forklifts they are required to operate.

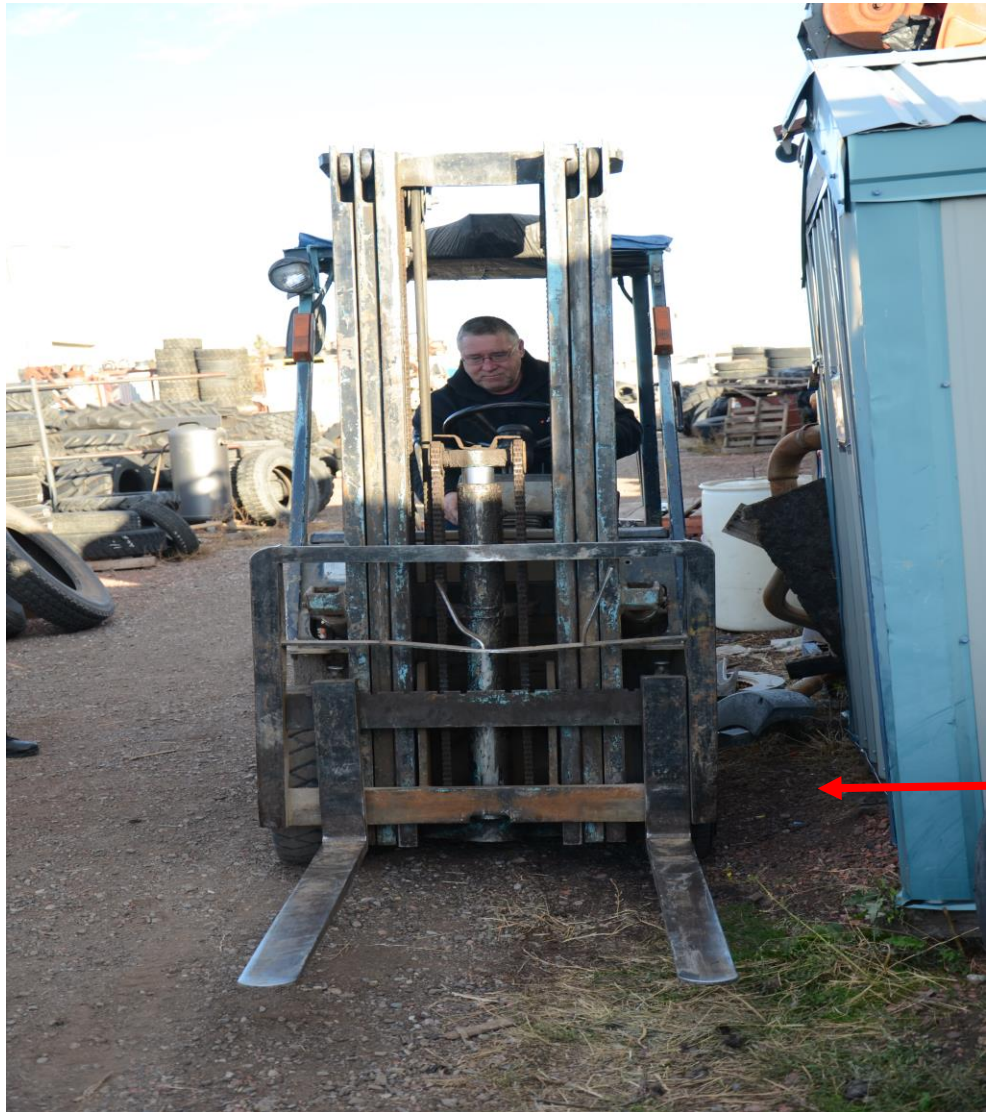
7.1.1 Worker 1 (*****) was crushed between the forklift and the door of the shed.

Photograph 4 - Shows the approximate location of the forklift during the refueling process. Red arrow shows the location of Worker 1 (*****) when the incident occurred.

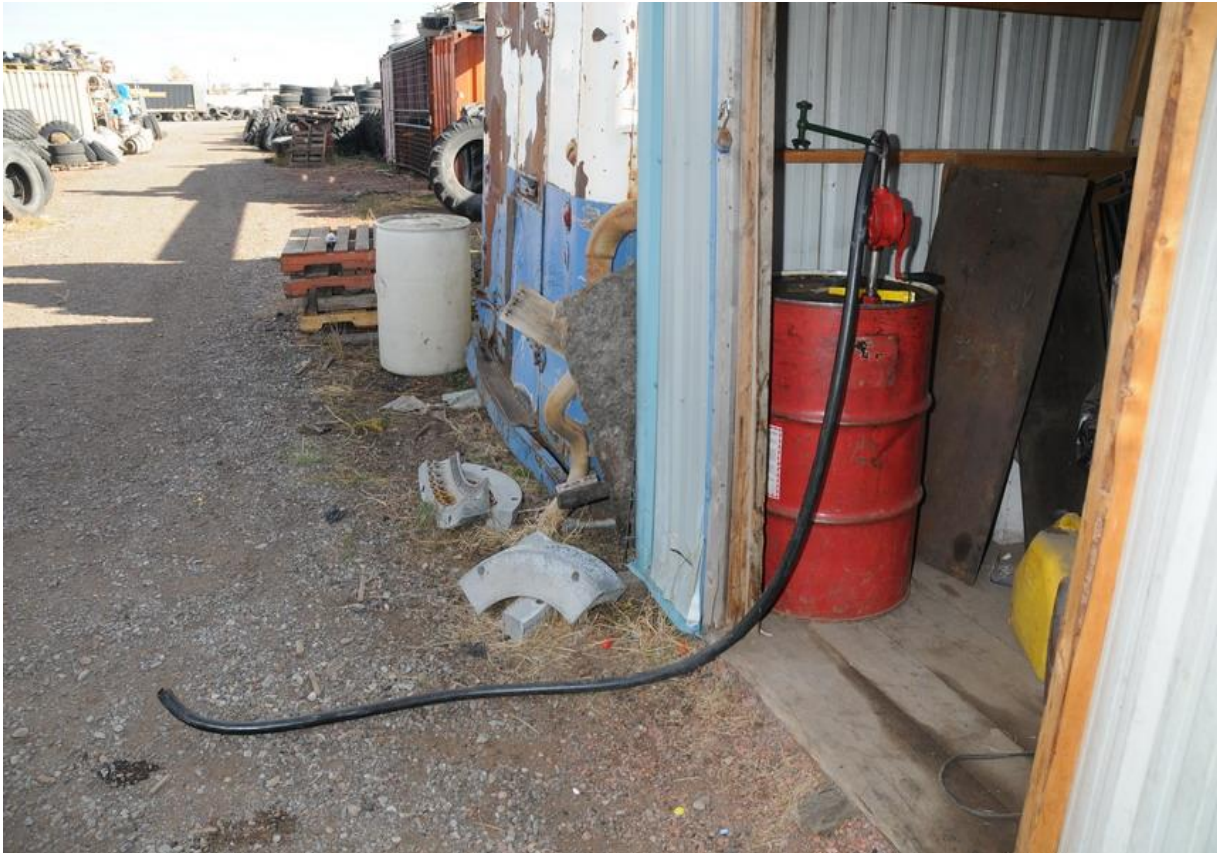
Photograph 5 – View from the west of the shed, 205 liter drum of gasoline with barrel pump, and the hose used to refuel the Toyota, Model 5FG15 forklift. The hose extended 1.62 meters outside of the shed.
