Investigation Report
Worker Struck by Pipe and Fatally Injured
October 17, 2013

A worker was struck by a pipe on a conveyor system causing fatal injuries.

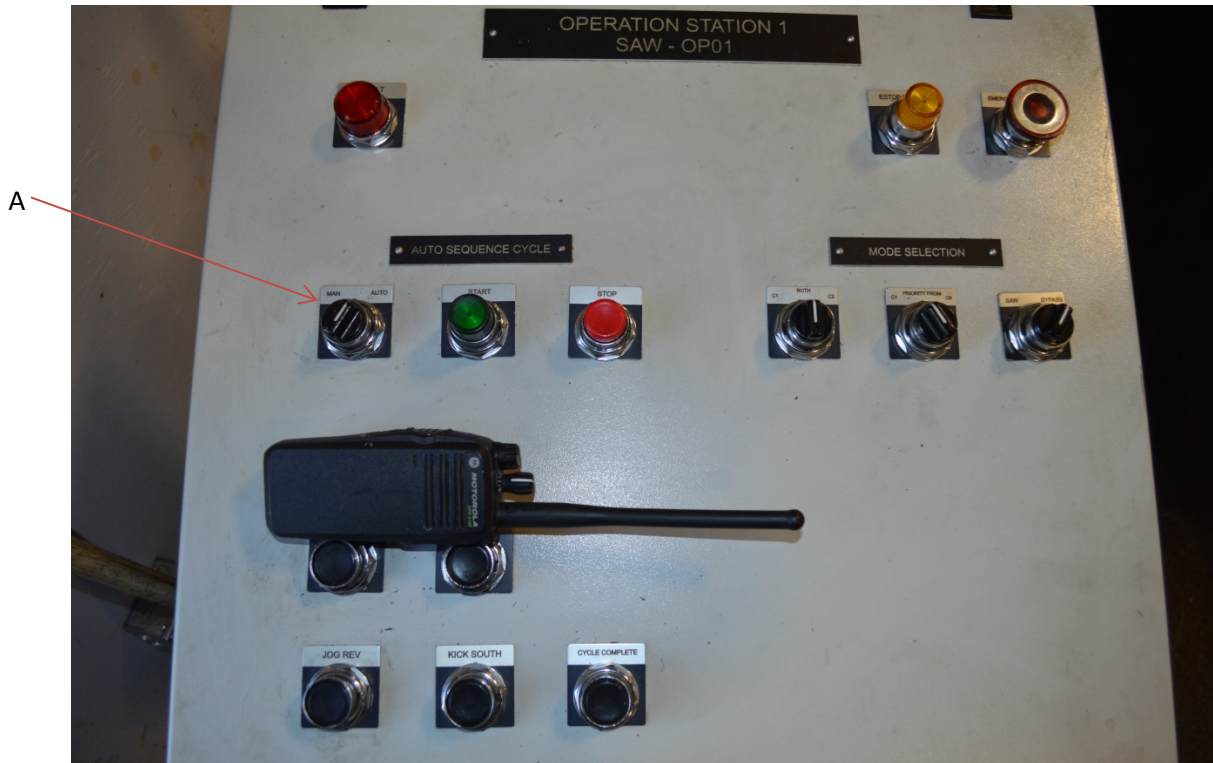
The pipe conveyor system could be operated in an automatic or manual mode. When in manual sequence, the operator had complete control over the pipe movement process. When in automatic sequence, the internal software controlled the movement of pipe (Figure 2).

Figure 2 shows the controls for the pipe conveyor system. A-shows the conveyor set to “auto” mode.

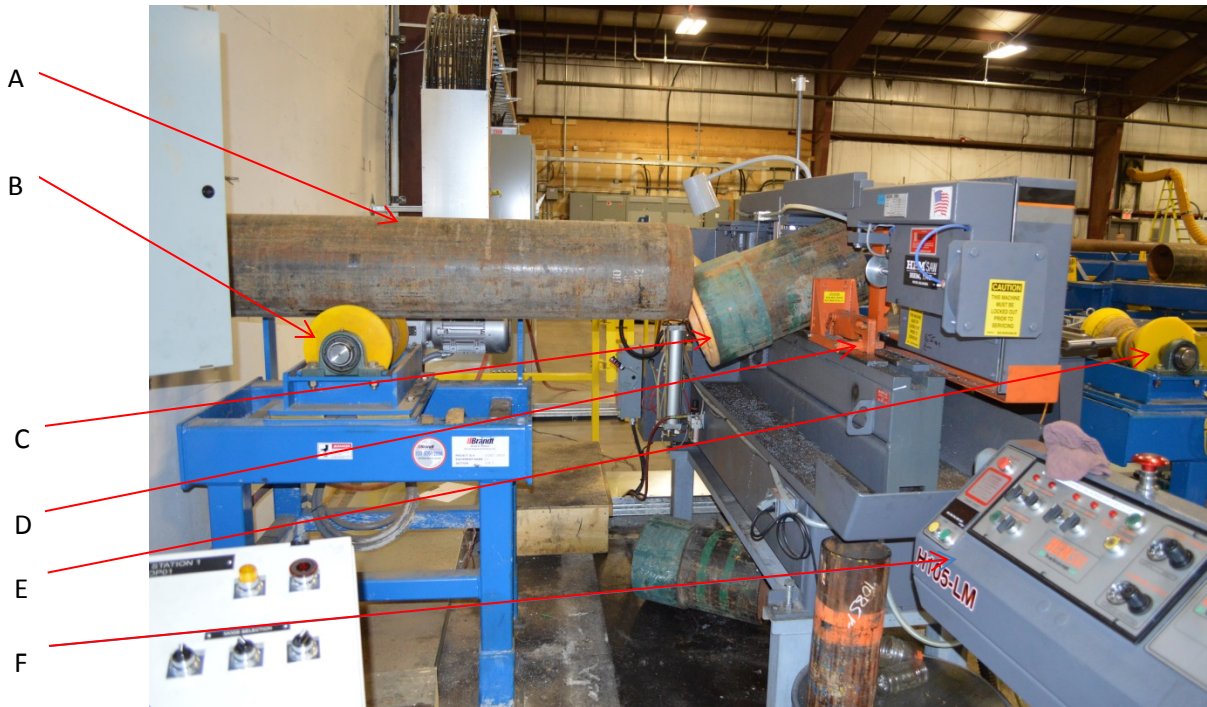
The HEM saw (bandsaw), model H105LM, was manufactured by HEM Inc. The bandsaw was placed between C1 and C2 of the conveyor system and was used to cut pipe that was brought in from outside to be rethreaded. The controls for the bandsaw were separate from the conveyor controls. The bandsaw used air pressure to move the arm of the bandsaw up and down during the cutting process. The bandsaw could be operated in “saw” mode or “bypass” mode. When operated in “saw” mode, the pipe coming in using the C1 conveyor would stop at the bandsaw to be cut. When operated in “bypass” mode, the pipe would continue past the saw onto the C2 conveyor (Figure 3/Figure 5).

Figure 3 shows the overview of the incident scene involving the C1 conveyor and C2 conveyor.

A-Shows the start of the 33.97 cm wide x 13.41 m long pipe as it entered the building from outside.

B-Shows C1 conveyor that was continued from outside of the TMK facility and moved the pipe that was involved in this incident.

C-Shows the end piece of pipe 33.97 cm wide x 59.69 cm long that was cut by the bandsaw and was being held up by the production worker at the time of the incident.

D-Shows the bandsaw in the “down” position after cutting a pipe.

E-Shows the start of C2 conveyor that moved pipe after it had been cut by the bandsaw.

F-Shows the controls for the bandsaw.

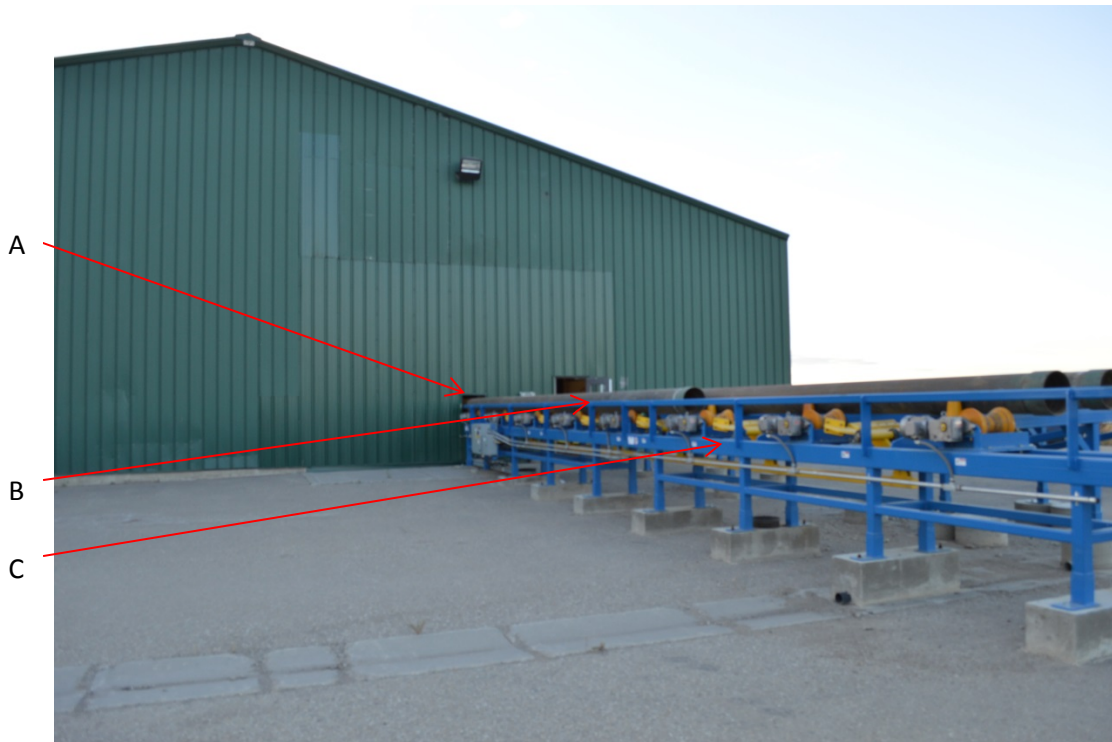
The pipe involved in this incident was 33.97 cm wide x 13.41 m long with an estimated weight of 1067 kilograms (kg). This pipe was on conveyor C1 at the time of the incident (Figure 4).

*Figure 4 shows C1 conveyor that had a pipe that had been kicked onto the conveyor and brought into the building through the hole in the wall by the controls that were in “auto.”
A-Shows the opening used to move pipes into the building using conveyor C1.
B-Shows the pipe that was involved in the incident.
C-Shows C1 conveyor that had the pipe that was kicked onto conveyor C1 from the pipe stand while in “auto” mode.*

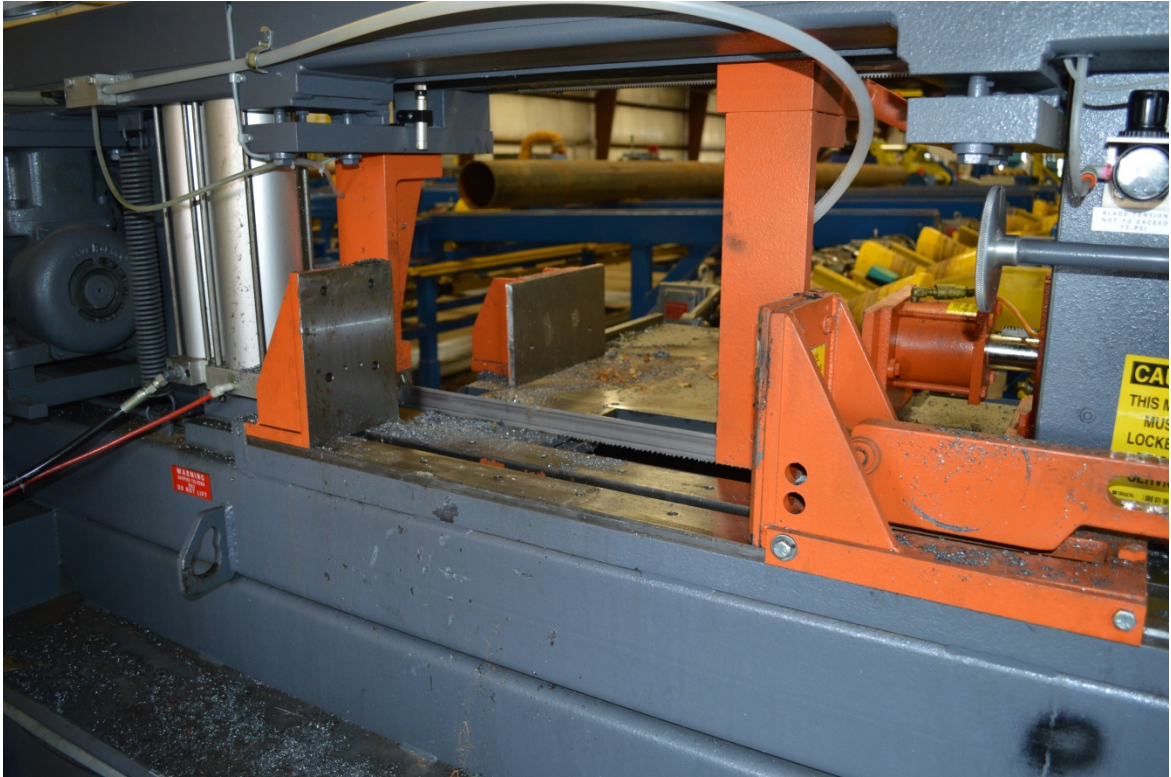
Figure 5 shows a close up of the bandsaw in the “down” position with the cut pipe removed.

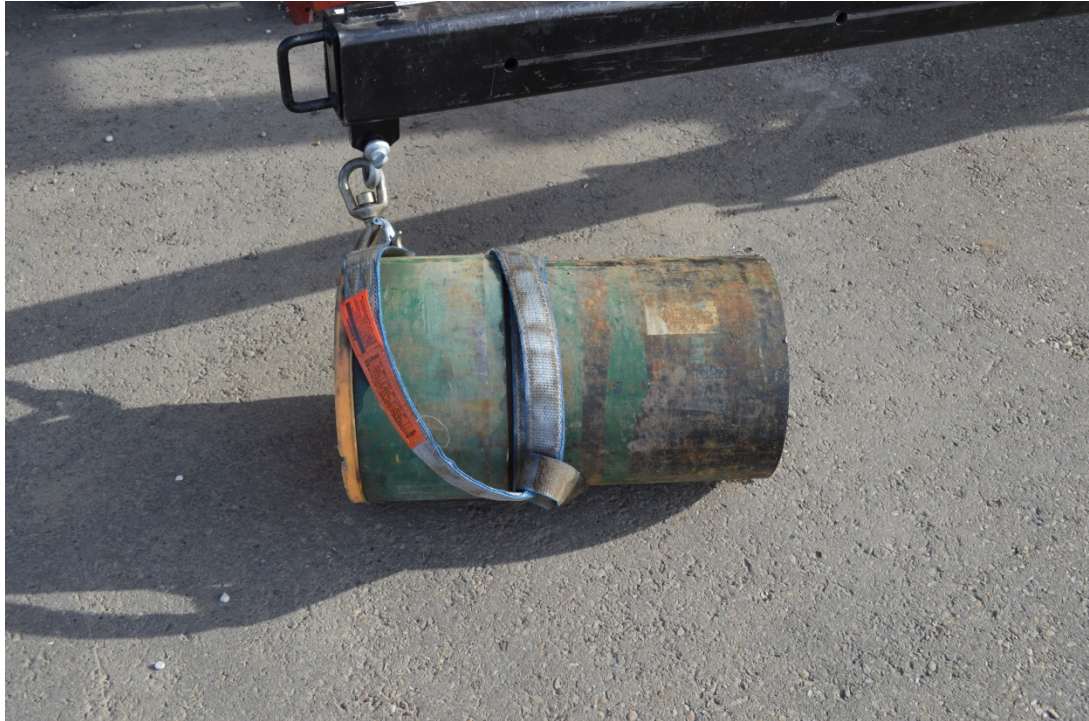
A piece of scrap pipe, which had recently been cut by the bandsaw, was being held up by the production operator at the time of the incident. The piece of pipe being held was 33.97 cm wide x 59.69 cm long and weighed an estimated 69.39 kg (Figure 6).

Figure 6 shows the cut piece of pipe that was removed from the bandsaw that the production worker was holding up
