**FLEXIBLE PIPE SECTION RUPTURES AND
STRIKES WORKER IN LEG**

Type of Incident: Fatality

Date of Incident: March 6, 2012

- 4.1 The incident occurred at Wellpad B ('B Pad') at the MEG Energy Christina Lake Regional Project, Phase II is located approximately 150kms south of Fort McMurray. LSD # 11-16-77-05 W4M.

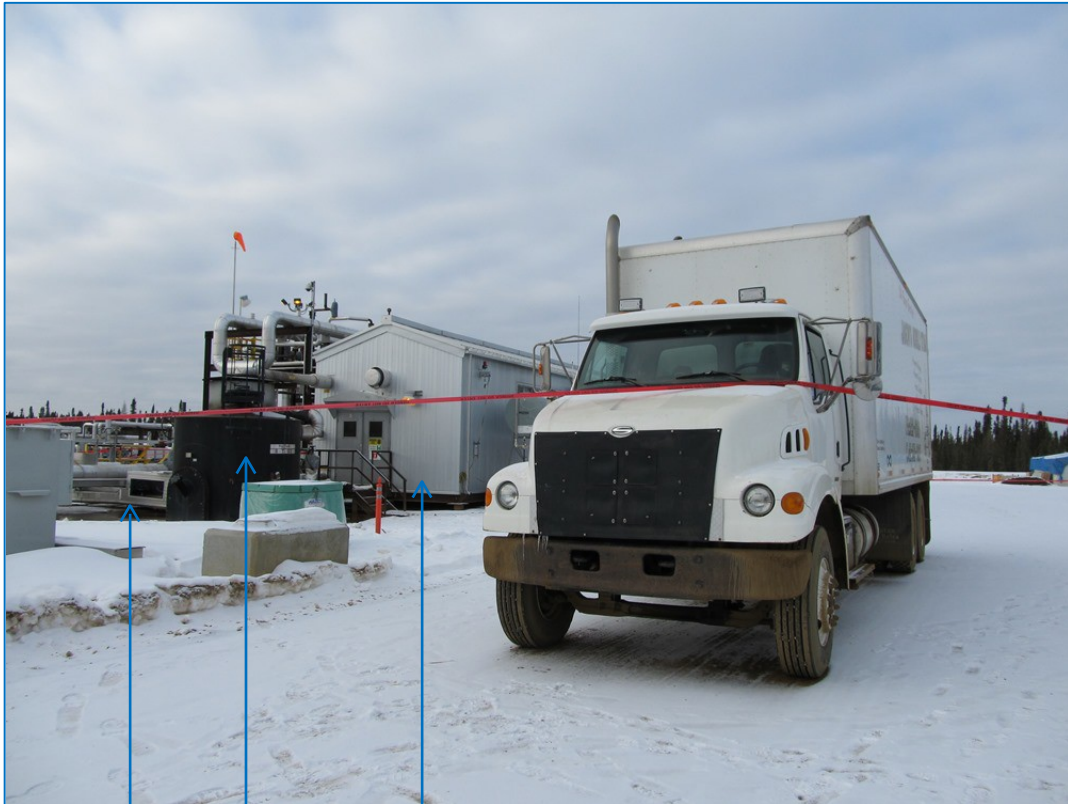
Photograph #1

Incident Scene

- A- Valves located inside the utilidor
- B- Storage tank "pop tank"
- C- Nearby building

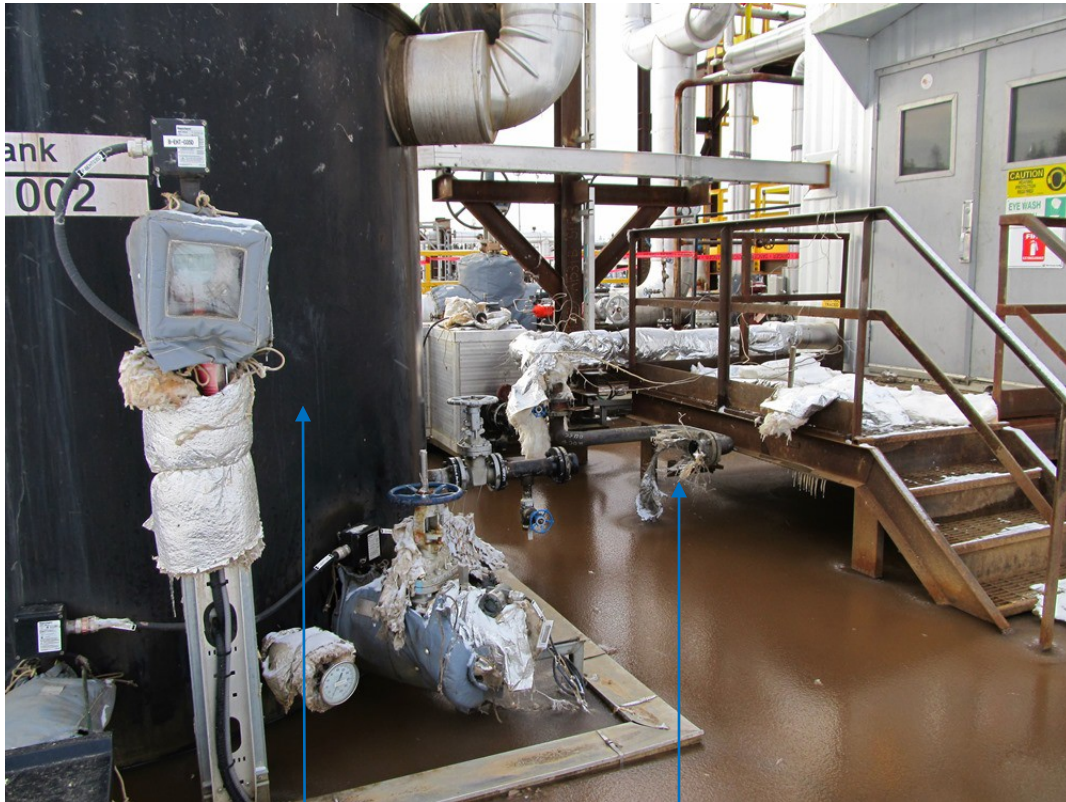
Photograph # 2

- 5.2.2 The Occupational Health and Safety investigators observed that a section of inlet piping had ruptured and was damaged. Several pieces of corrugated cladding sections were found in the vicinity of the pop tank.

- 6.7 As the MEG operator was closing valve D, the flexible pipe section located upstream of the valve over pressured and ruptured, striking the MEG Operator.

- 7.1.1 The MEG Operator closed the pop tank inlet valve, causing the flex hose to over-pressure and rupture. The ruptured hose struck the worker in the right leg causing fatal injuries.

Incident Scene

- A- Storage tank "pop tank"
- B- Remains of damaged piping

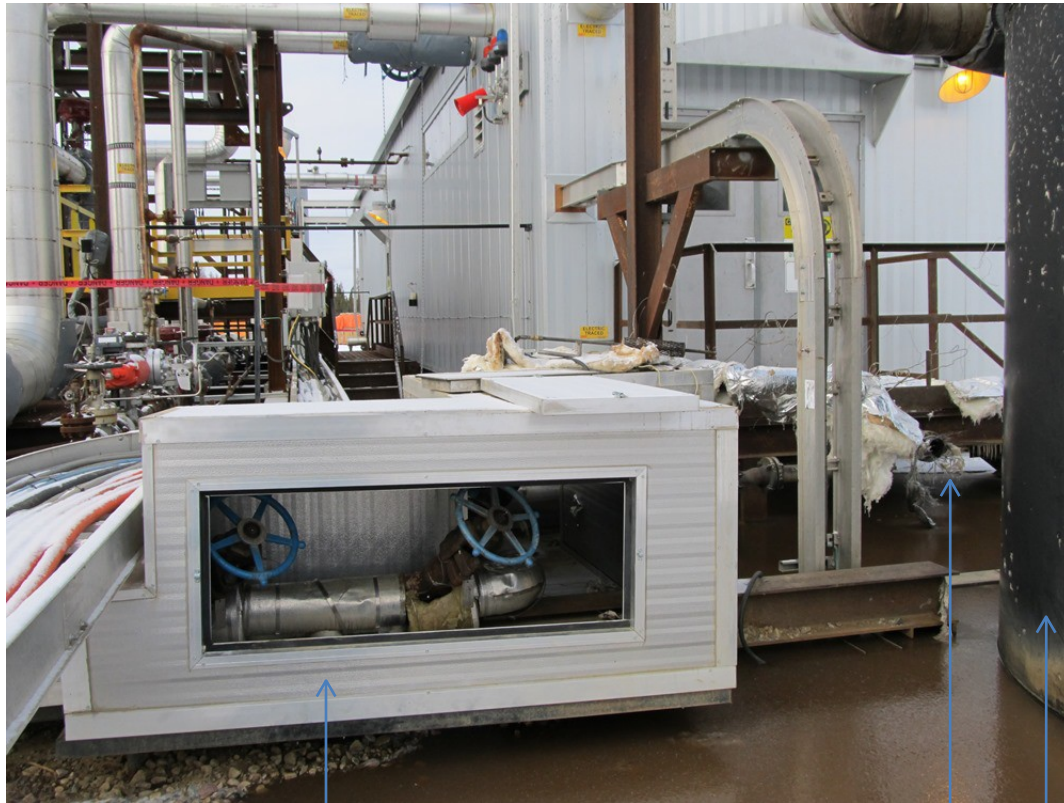
Photograph # 3

View from the steam header

- A- Valves located inside the utilidor
- B- Remains of damaged piping
- C- Storage tank "pop tank"
