# Occupational Health and Safety

# Fatality Report

**Worker Pinned By Feller Buncher**  
**Date of Incident: January 6, 2007**  
**Type of Incident: Fatal**

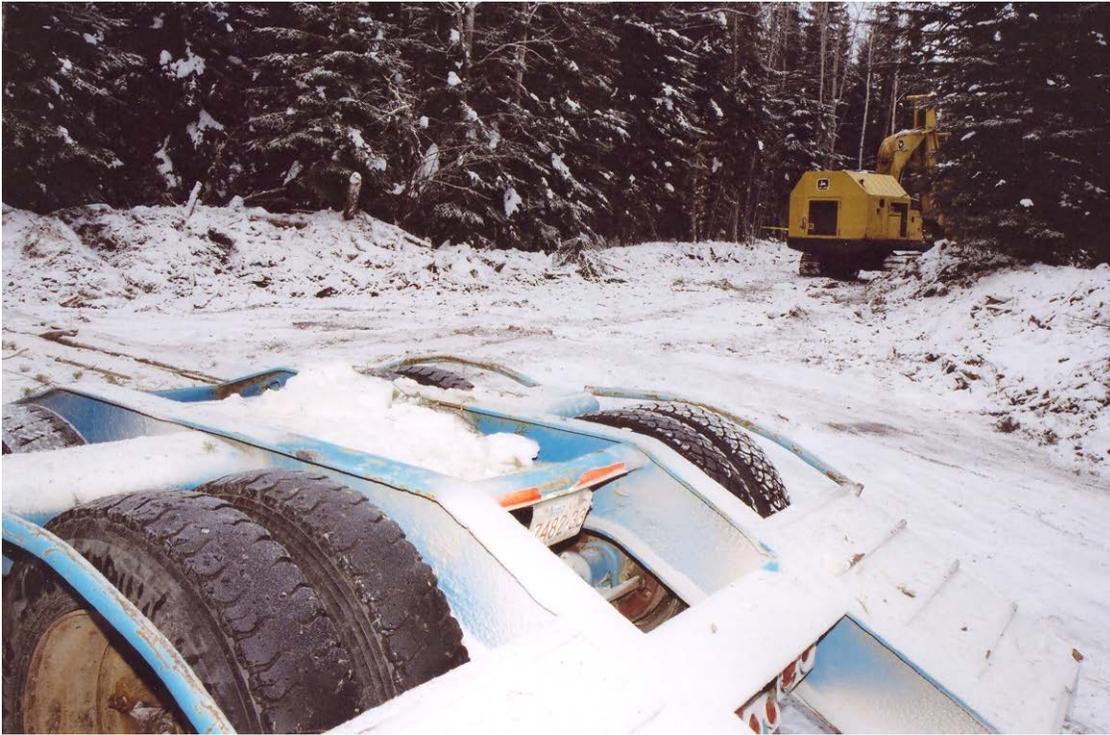
Photograph #1 Identifies the rear of the low bed trailer and a partial view of the feller buncher located north of the low bed trailer.

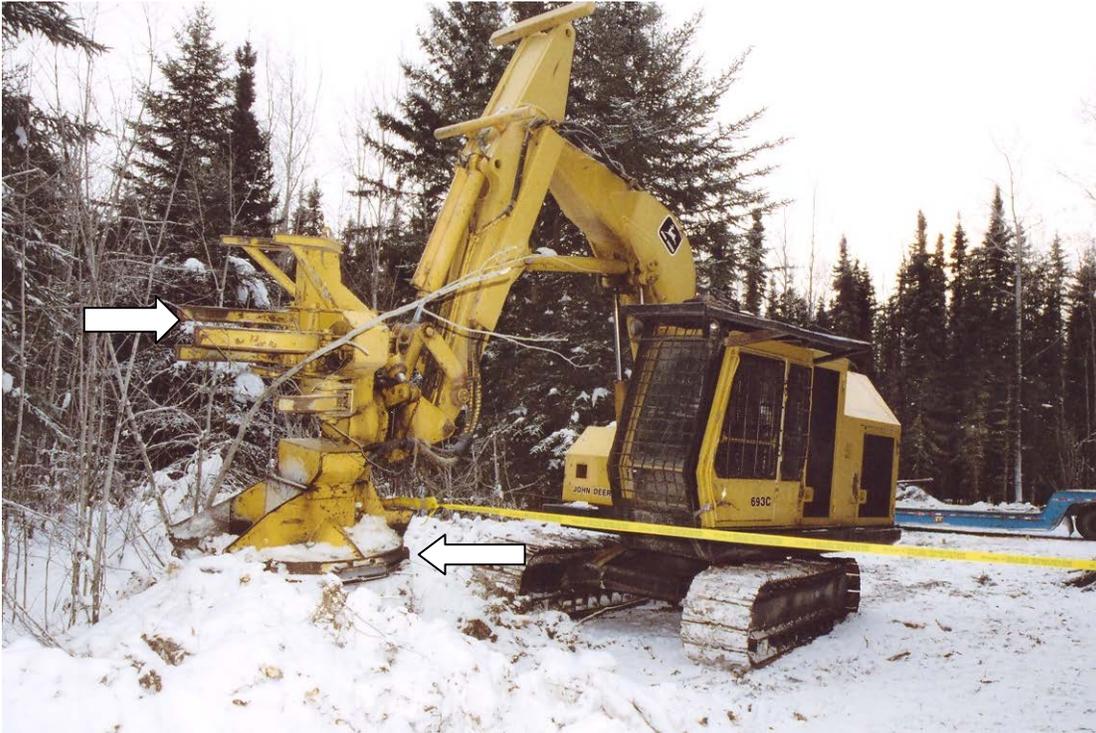
Photograph #2 Identifies the feller buncher involved in the incident. The top arrow identifies the hydraulic arms, used to secure a tree and the lower arrow indicates the circular saw used to cut the tree off at ground level.

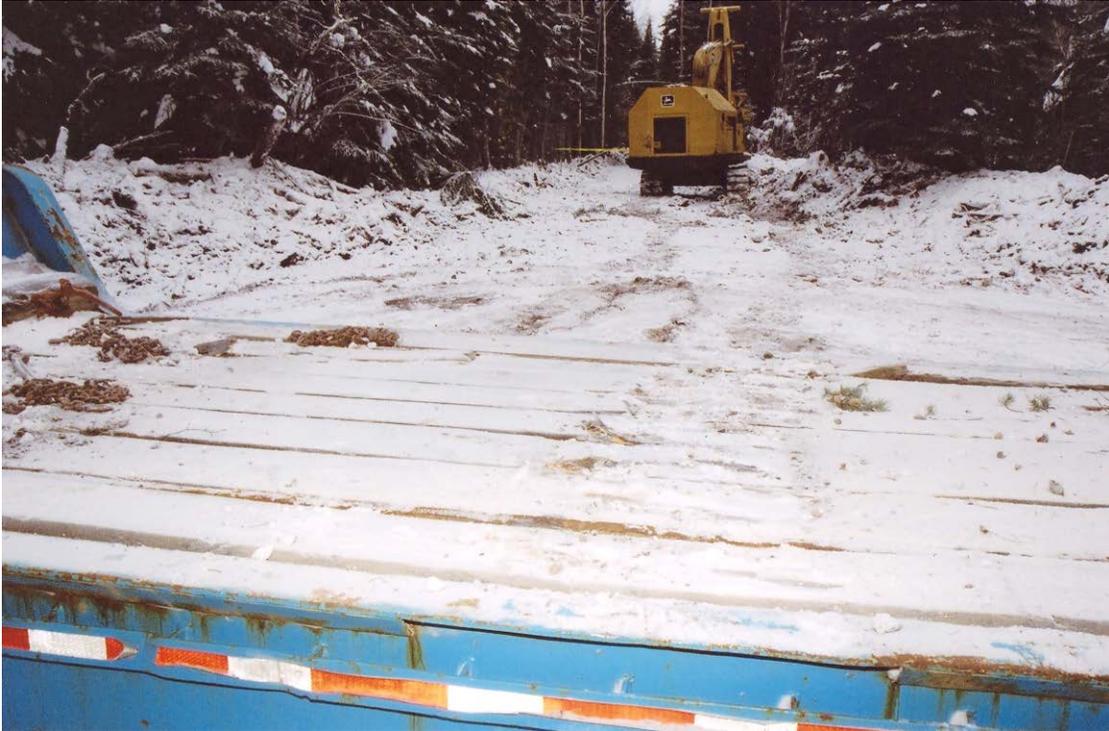
Photograph #3 Identifies the feller buncher after it was moved away from the low bed trailer.

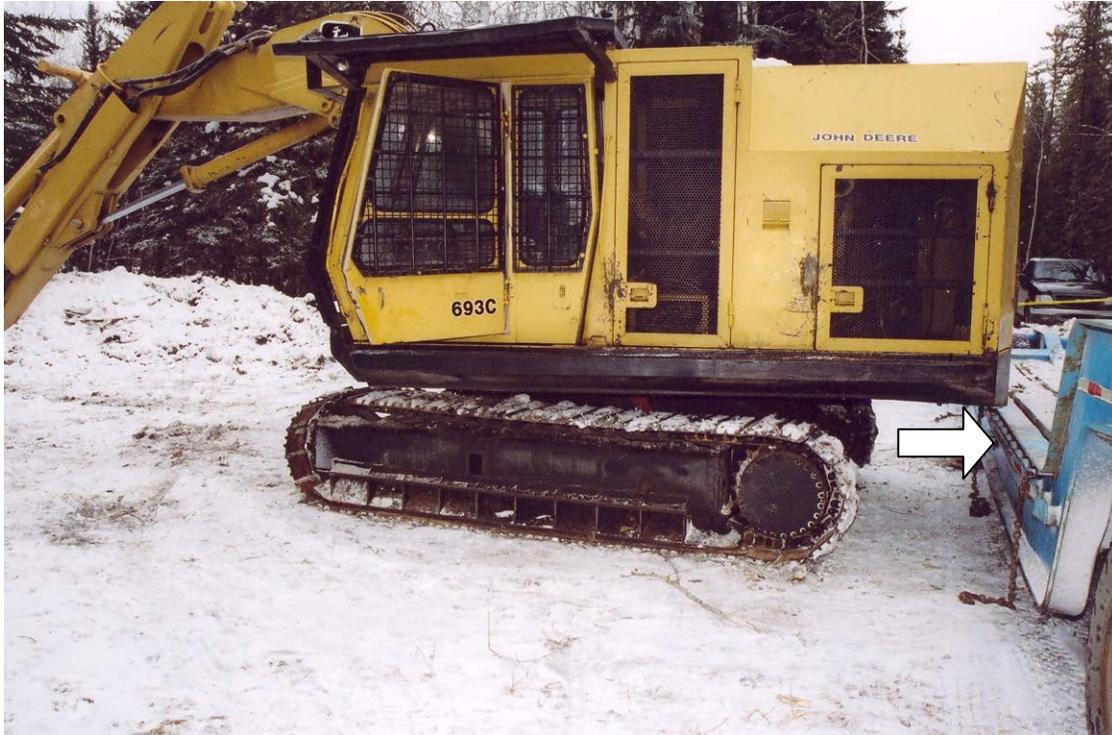
- 7.1 The direct cause of the fatal injuries Worker 2 received was a result of being pinned between the low bed trailer and the feller buncher (Attachment “A”, Photograph 4).

- 7.5 Worker 1 re-entered the cab of the feller buncher and Worker 2, for reasons unknown, entered the swing clearance area between the counterweight on the rear of the feller buncher and the low bed trailer (Attachment “A”, Photograph 4). When Worker 1 raised the vertical boom off the ground to move the feller buncher forward, Worker 2 was pinned against the low bed trailer as the machine deck of the feller buncher rotated and reduced the swing clearance area where Worker 2 was located.

- 7.7 There was no discussion between the workers regarding the hazard of the swing area between the counterweight of the feller buncher and the low bed trailer. There was no hazard assessment performed for the work site by either employer.

Photograph #4 The arrow identifies the contact location between the feller buncher and the low bed trailer where worker 1 sustained his fatal injuries.

- 9.1 **Alberta Employment, Immigration and Industry**
- 9.1.1 A stop use order was issued to 1114374 Alberta Ltd. for the feller buncher as the unit's operating condition did not meet its manufacturer's specifications. 1114374 Alberta Ltd. was also ordered to develop a control measure to ensure workers remained in a safe location when powered mobile equipment was moved or off-loaded.
- 9.2 **Industry**
- 9.2.1 1114374 Alberta Ltd. complied with the orders issued to them.
- 9.3 **Additional Measures**
- 9.3.1 Not applicable at this time.

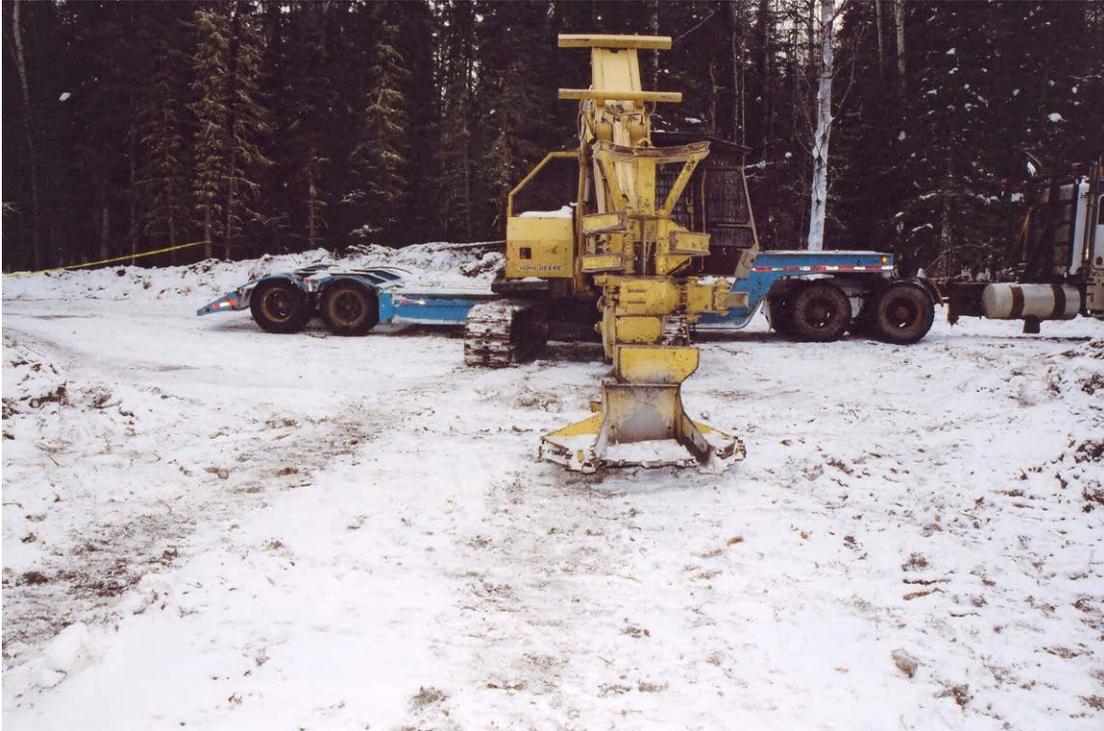
Photograph #5 Identifies the front portion of the feller buncher as the unit is positioned next to the low bed trailer.
