Investigation report

F-OHS-129630-54B95

Worker fatally injured after being struck by a section of  
road barrier during unloading activities  
September 12, 2017

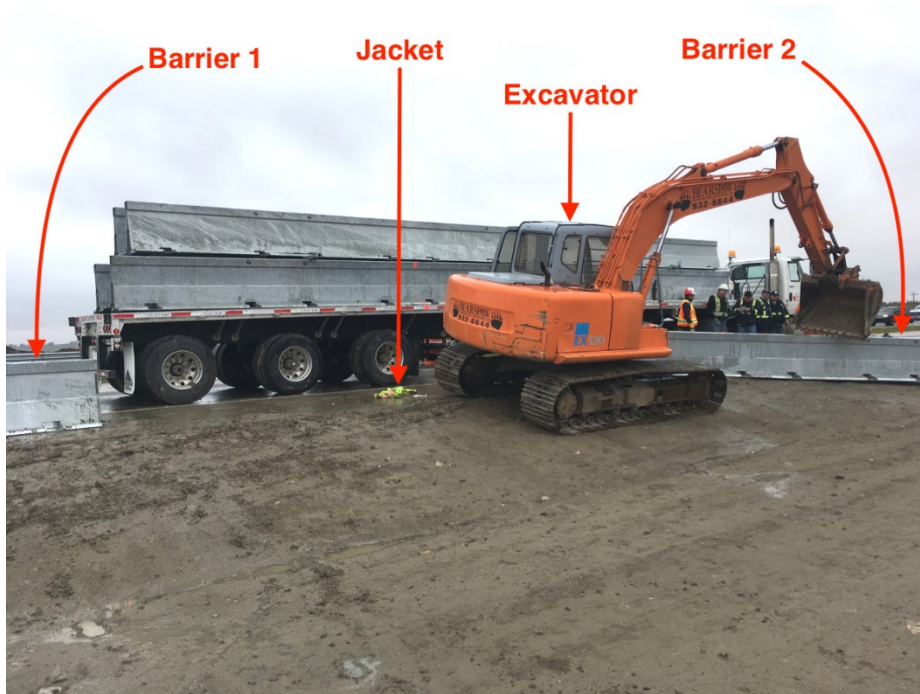
Figure 3. Diagram and site description provided to Occupational Health and Safety by Anderson Associates Consulting Engineers Inc. (Note: Barrier 2 struck Swamper 1)

- Reference Figure 3, Label: Barrier 1 and Barrier 2
- Weight: +/- 1 404 kilograms (kg) (3 097 pounds)
- Length/Depth/Width: +/- 15.24 metres (m) (50 feet) long, +/- 1.83 m (6 feet 3/16 inch) wide at top, +/- 0.68 m (2 feet 9/16 inch) wide at bottom and +/- 0.81 m (2 feet 8 inch) high

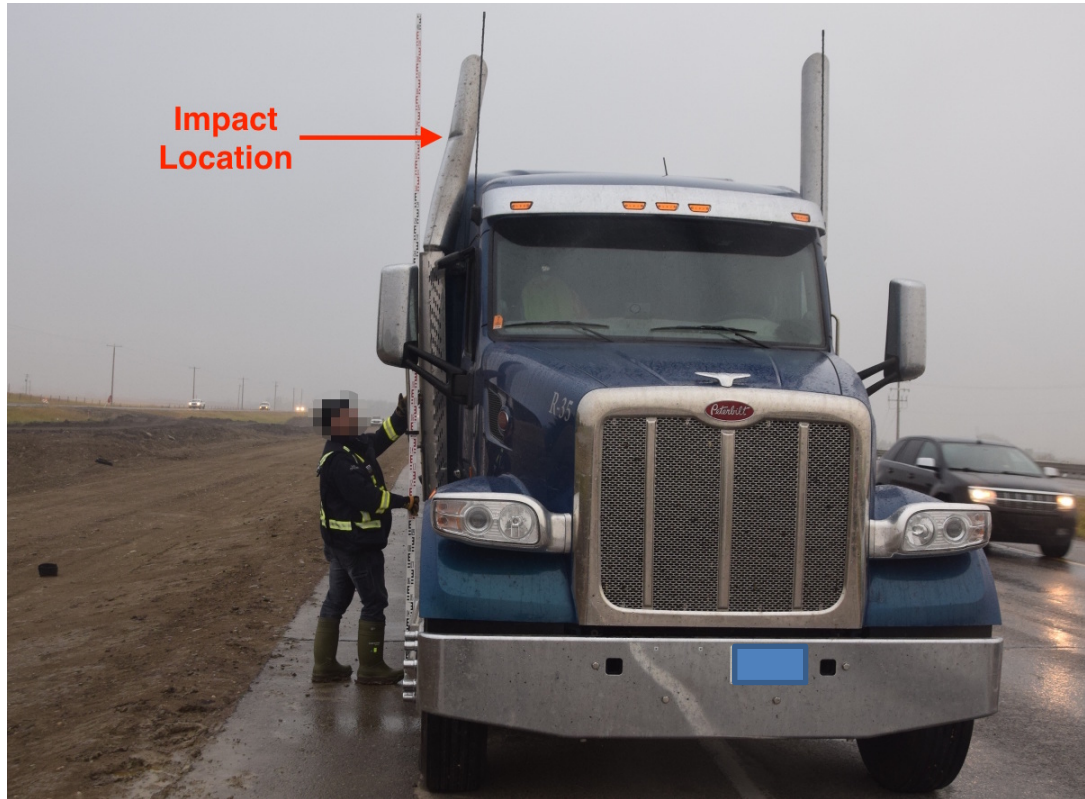
Figure 4. Continental Sales & Rentals Ltd. truck involved in incident, showing damage on the passenger side exhaust stack (Image provided by Anderson Associates Consulting Engineers Inc.)

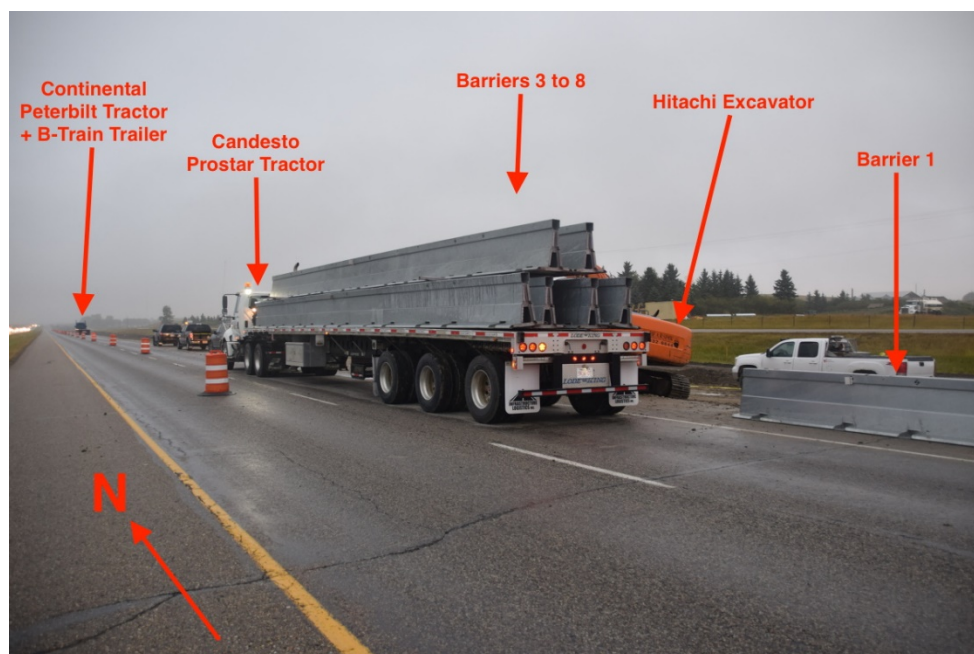
Figure 5. Diagram and site descriptions for the incident area on northbound Highway 2 (Image provided by Anderson Associates Consulting Engineers Inc.)

As the Excavator Operator lifted the second section of 'Zone Guard' barrier, the load shifted and swung outwards into the live/active traffic lane. Swamper 1, who was on the trailer, went to the passenger side of the trailer in order to try and control the swinging 'Zone Guard' barrier section. Meanwhile, a semi-truck operated by Continental Sales & Rentals Ltd., which was passing the Candesto work site, made contact with the part of the "Zone Guard' barrier which had swung over the live/active traffic lane. When the 'Zone Guard' barrier made contact with the semi-truck, it spun back towards the passenger side of the trailer and struck Swamper 1; the worker subsequently fell to the ground.
