RECAPP Facility Evaluation Report

Claresholm Care Centre - Services B

B1008G
Claresholm

Evaluation Details	
Evaluation Company:	Golder Associates Ltd.
Evaluation Date:	January 16 2013
Evaluator Name:	Sebastien Derkzen van Angeren

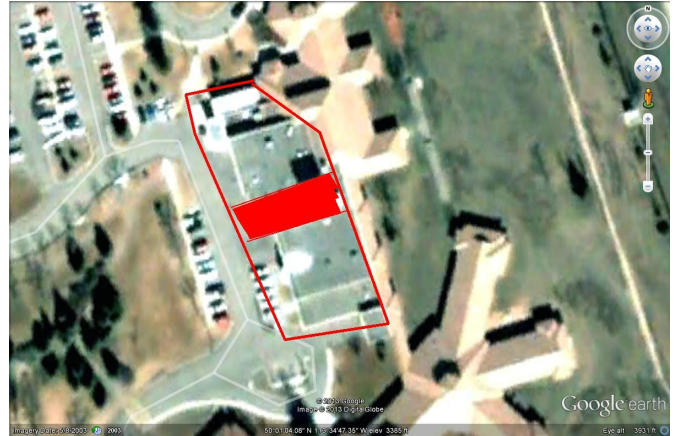
The B1008G Claresholm Care Centre - Administration / Clinical Services building is located at 139 - 43 Avenue West, Claresholm, Alberta. The main entrance faces west and is accessed via a concrete sidewalk and steps. The building is surrounded by grassed areas and mature trees/bushes.

View of the Services B building.
