Workplace Health and Safety Fatality Report

WORKER BURNED BY GASOLINE FIRE

Date of Incident: October 29, 2007

Type of Incident: Fatal

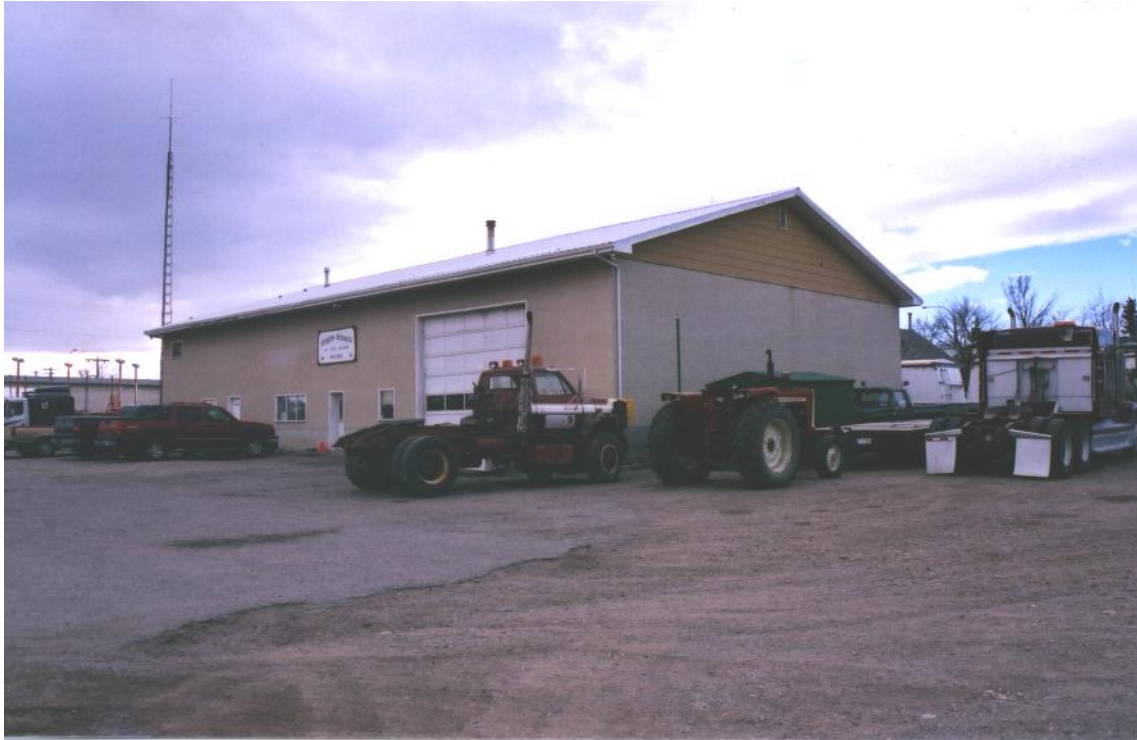
4.1 The incident occurred inside the truck service facility located at 1619 - 20th Avenue, Nanton, Alberta (Refer to Appendix A-Map and Appendix B-Photographs 1 and 2).

Photograph 1: Shows the truck service facility.

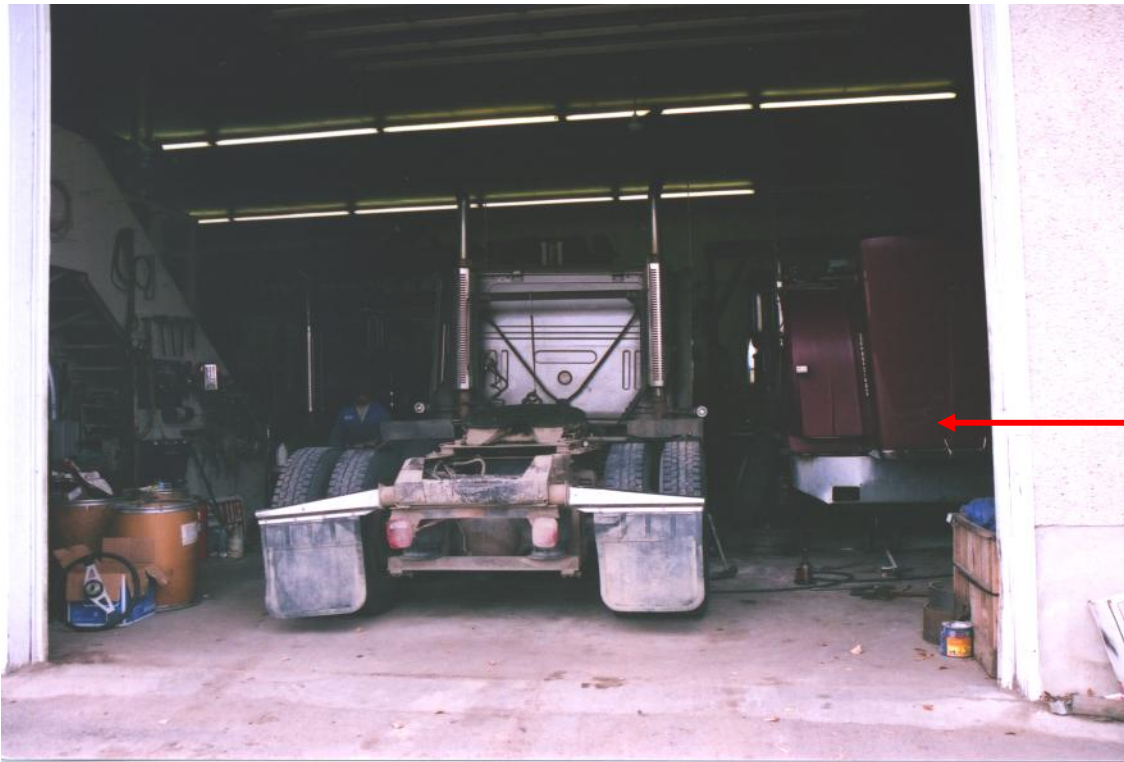
Photograph 2: Shows an inside view of the service facility where the truck was parked at the time of the incident.

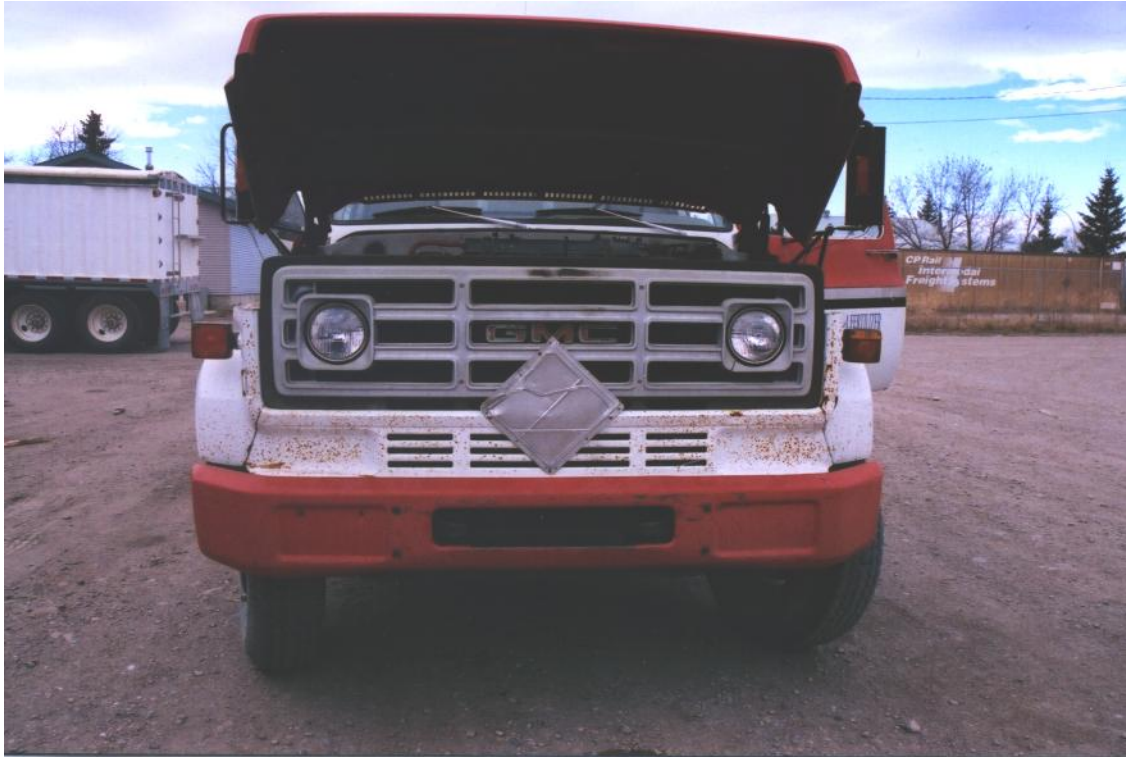
- 5.1.1 The truck involved in the incident was a 1976 GMC C6500 equipped with a fertilizer dispensing unit. The vehicle owned by Parkland AGRI Services Corp. of Didsbury, Alberta had identification number TCE676V578259. The gross weight of the truck was 11500 Kilograms (Refer to Appendix B-Photographs 3, 4 and 5).

Photograph 3: Shows the front view of the truck involved in the incident.

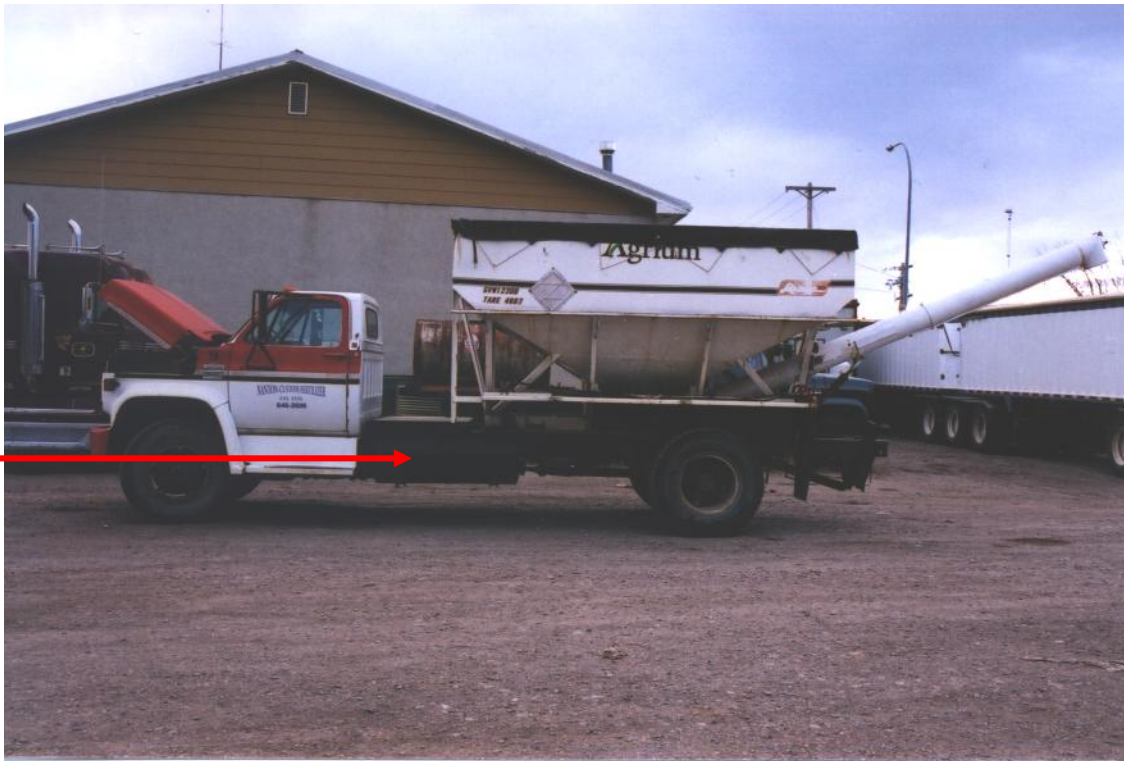
Photograph 4: Shows the driver's side of the truck
Arrow shows the gasoline tank.

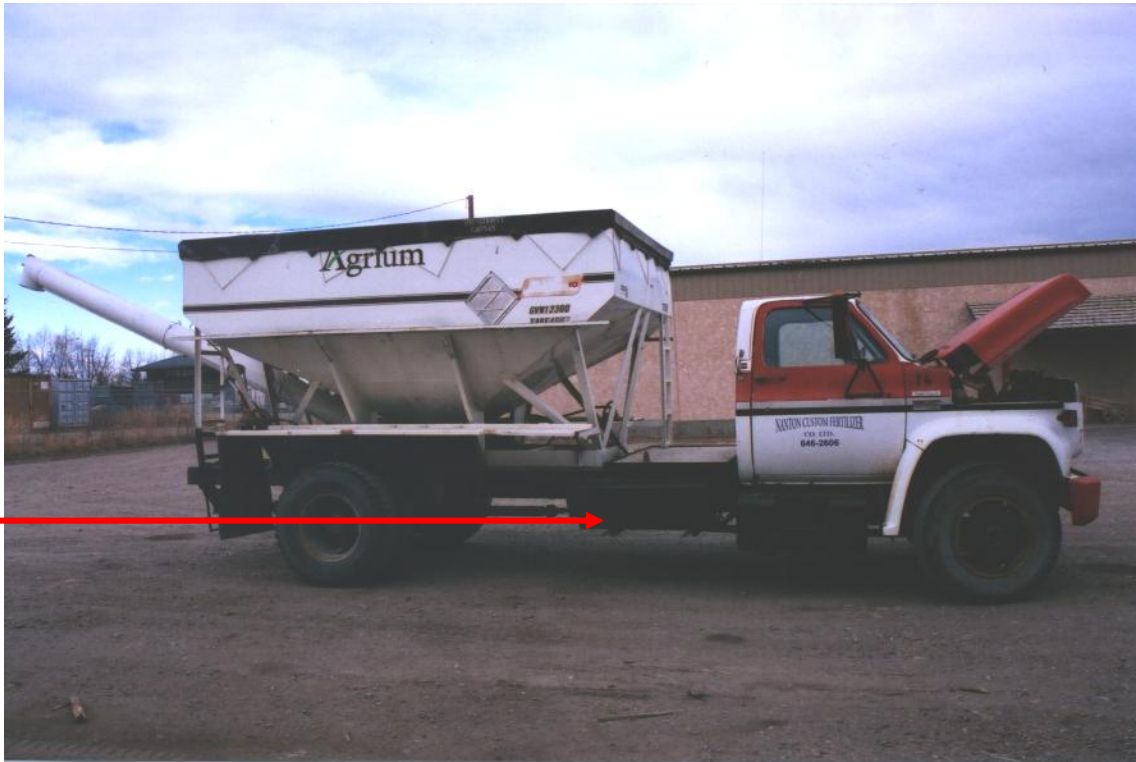
Photograph 5: Shows the passenger's side of the truck
Arrow shows the gasoline tank.

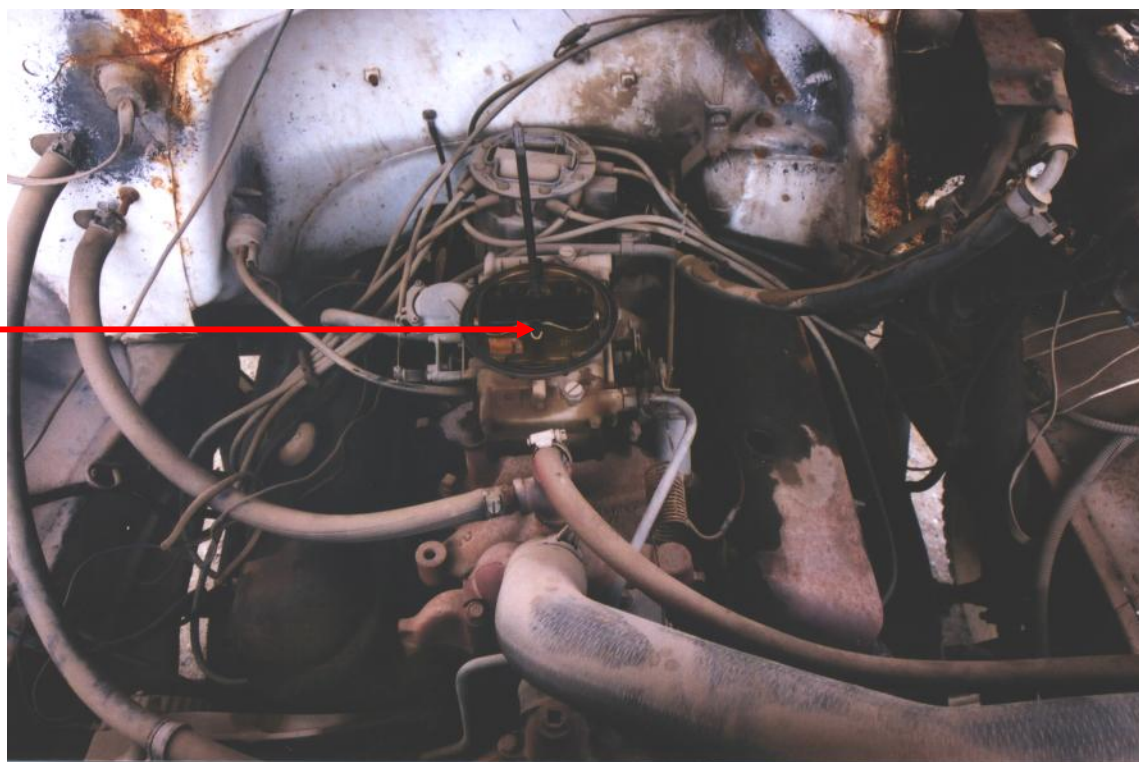
- 5.1.2 The truck was powered by a gasoline engine and had a double barrel carburettor. The truck was equipped with two gasoline tanks located either side of the chassis. The gasoline line connecting tanks to the carburettor was equipped with a 3 way manually operated valve. The valve could be turned to two different positions to control the gasoline flow from the passenger's side or driver's side tanks. In the third position, gasoline flow to the carburettor from either tank was turned off (Refer to Appendix B-Photographs 6, 7, 8, 9, and 10).

7.2.1 When mechanic #1 turned the ignition key on, the truck engine backfired, igniting the gasoline that had been poured into the open carburettor.

Photograph 6: Shows the twin barreled carburetor to which gasoline was poured.

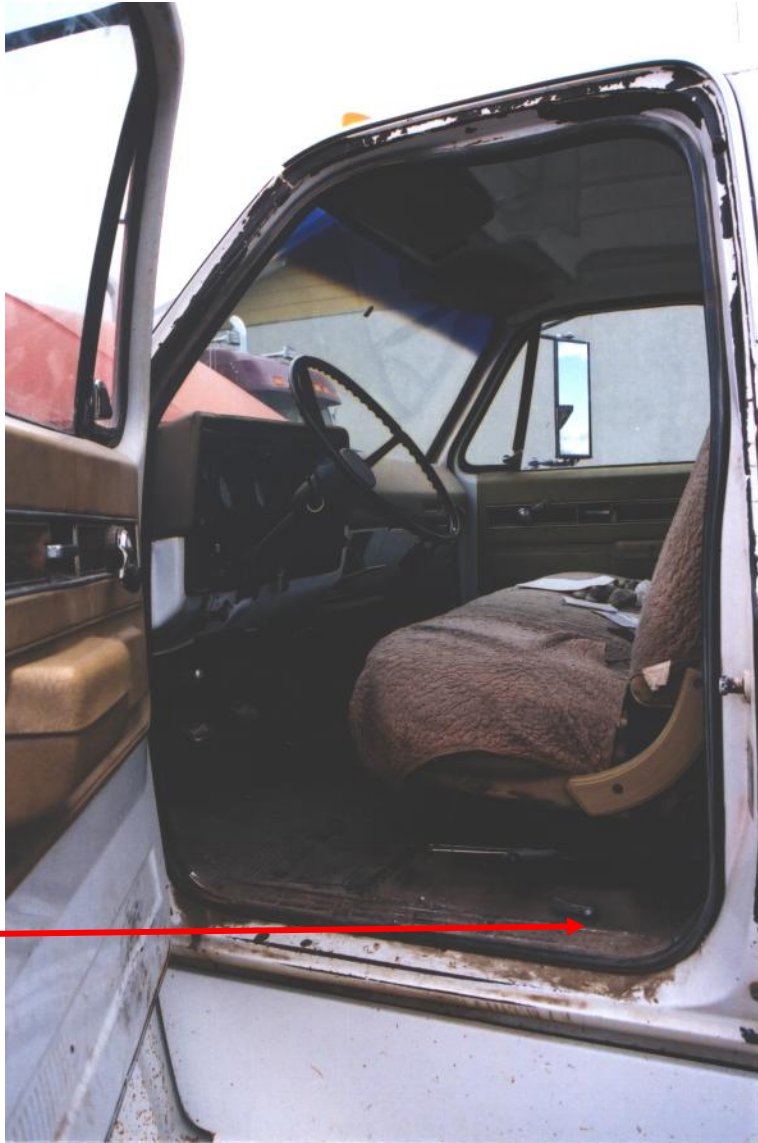
- 5.2.1 The 3 way valve was located beside the driver's seat, on the floor of the truck.
- 5.2.2 The manager indicated that pouring gasoline into a carburettor to start an engine had been used previously on other vehicles, without experiencing any problems.
- 5.2.3 The truck had been moved out of the garage, into the yard, prior to the arrival of WHSC.

Photograph 7: Shows the driver's side location of the 3 way valve.

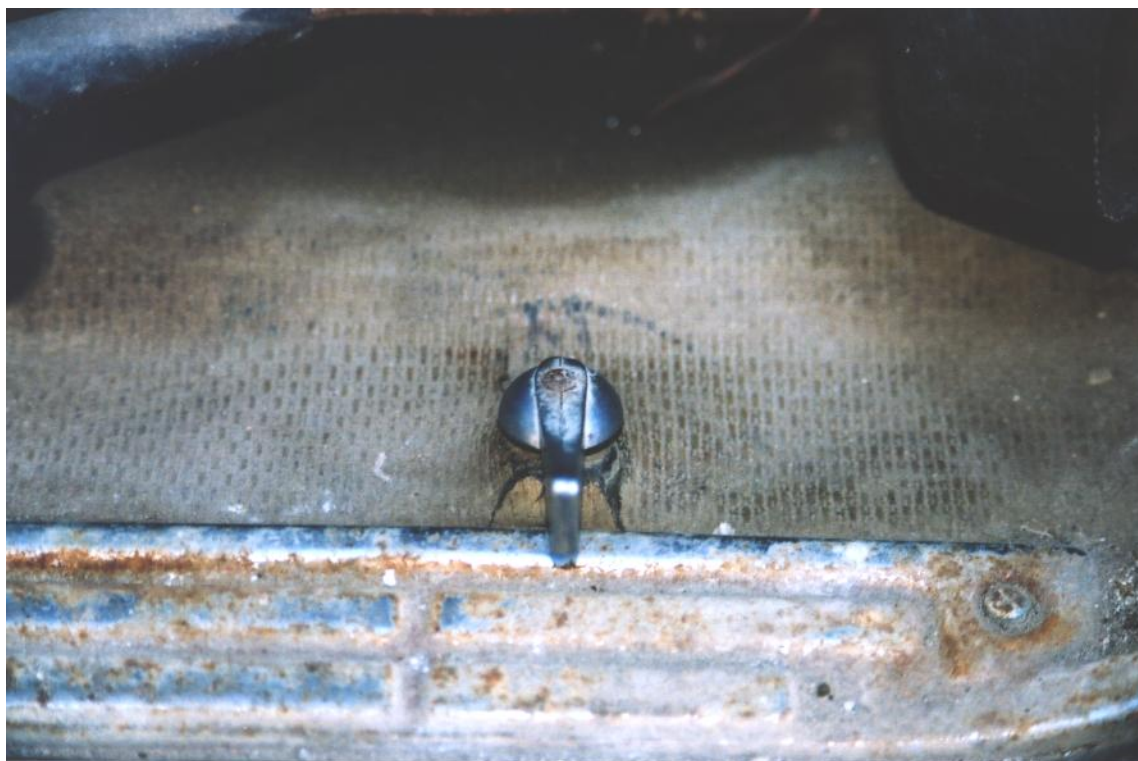
Photograph 8: Shows the 3 way valve turned to open gasoline flow from the driver's side gasoline tank.

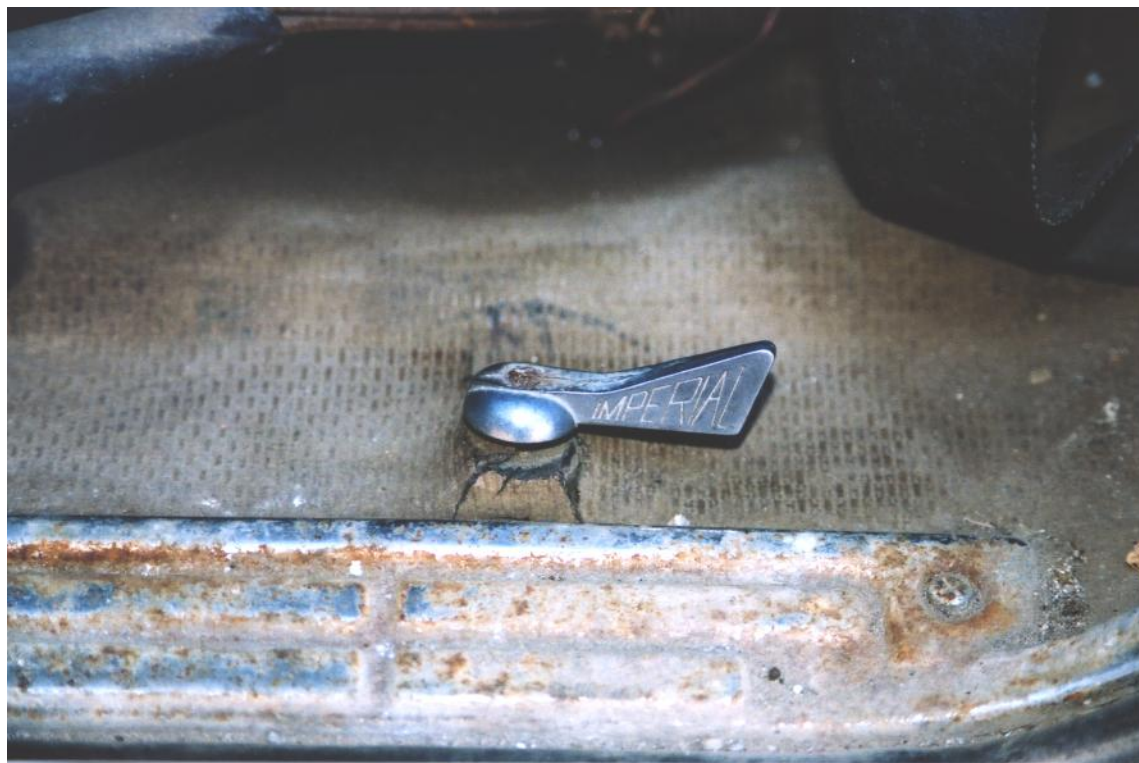
Photograph 9: Shows the 3 way valve turned to open gasoline flow from the passenger's side gasoline tank.

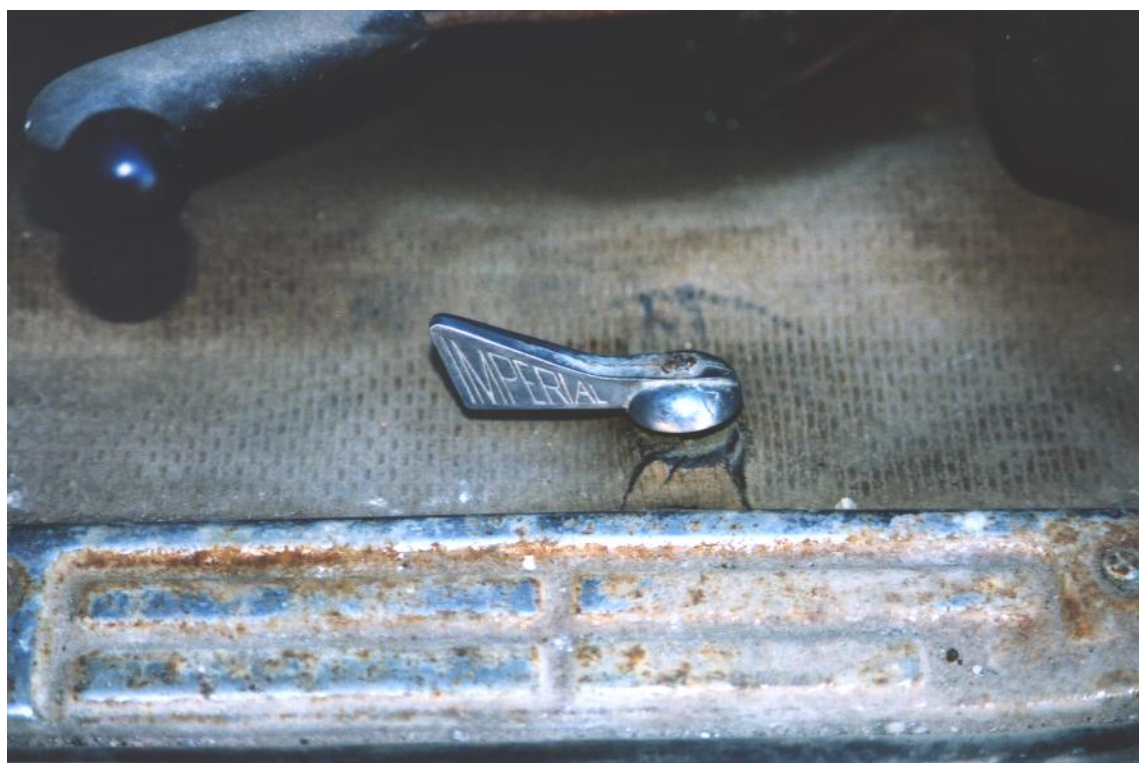
- 5.1.3 At the time of the incident the 3 way valve was in the third position, turning off the gasoline flow to the carburettor. The mechanics were unaware of the existence of the 3 way valve that controlled the gasoline flow to the carburettor. The 3 way valve was found after the incident.

7.2.3 Both mechanics were unaware of the existence of the 3 way valve controlling flow of gasoline to the carburettor.

7.2.4 The 3 way valve was in off position.

Photograph 10: Shows the 3 way valve turned to close gasoline flow from either of the two tanks.

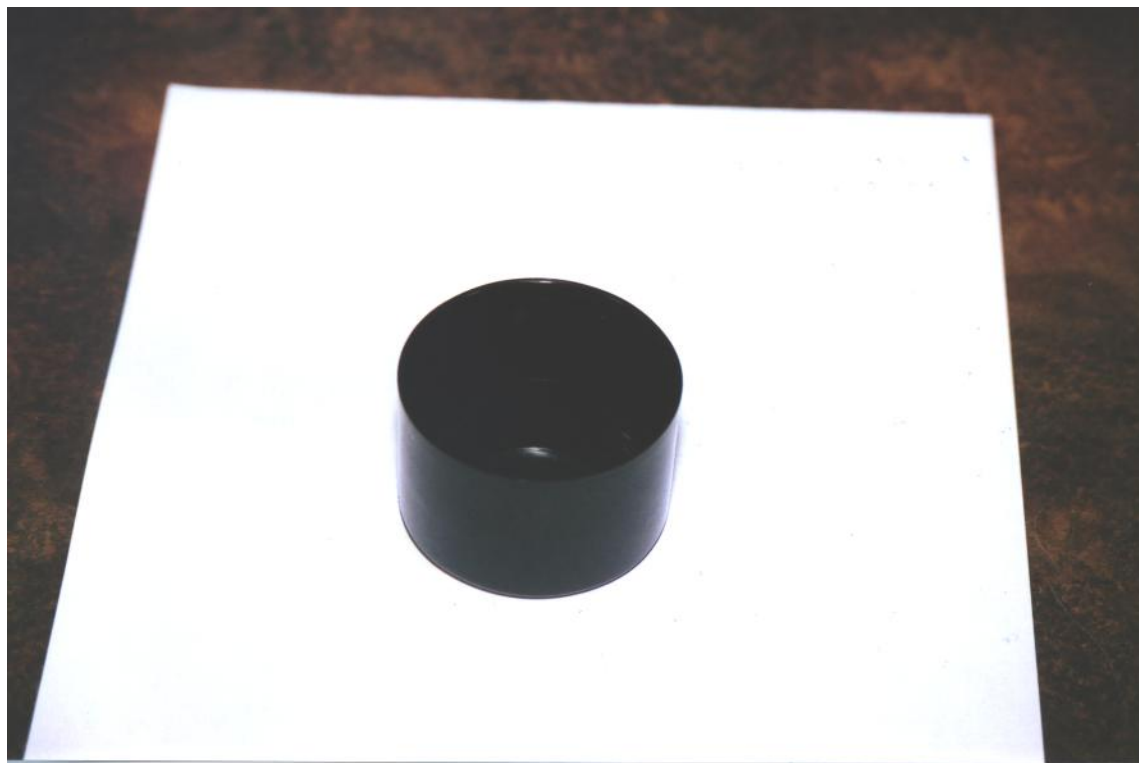
- 5.1.4 The plastic cap of an aerosol can was used to pour gasoline into the open carburettor. The total volume of the cap was approximately 0.113 litres (Refer to Appendix B-Photograph 11).

Photograph 11: Shows an aerosol can cap, similar to the one used to pour gasoline into the carburetor.

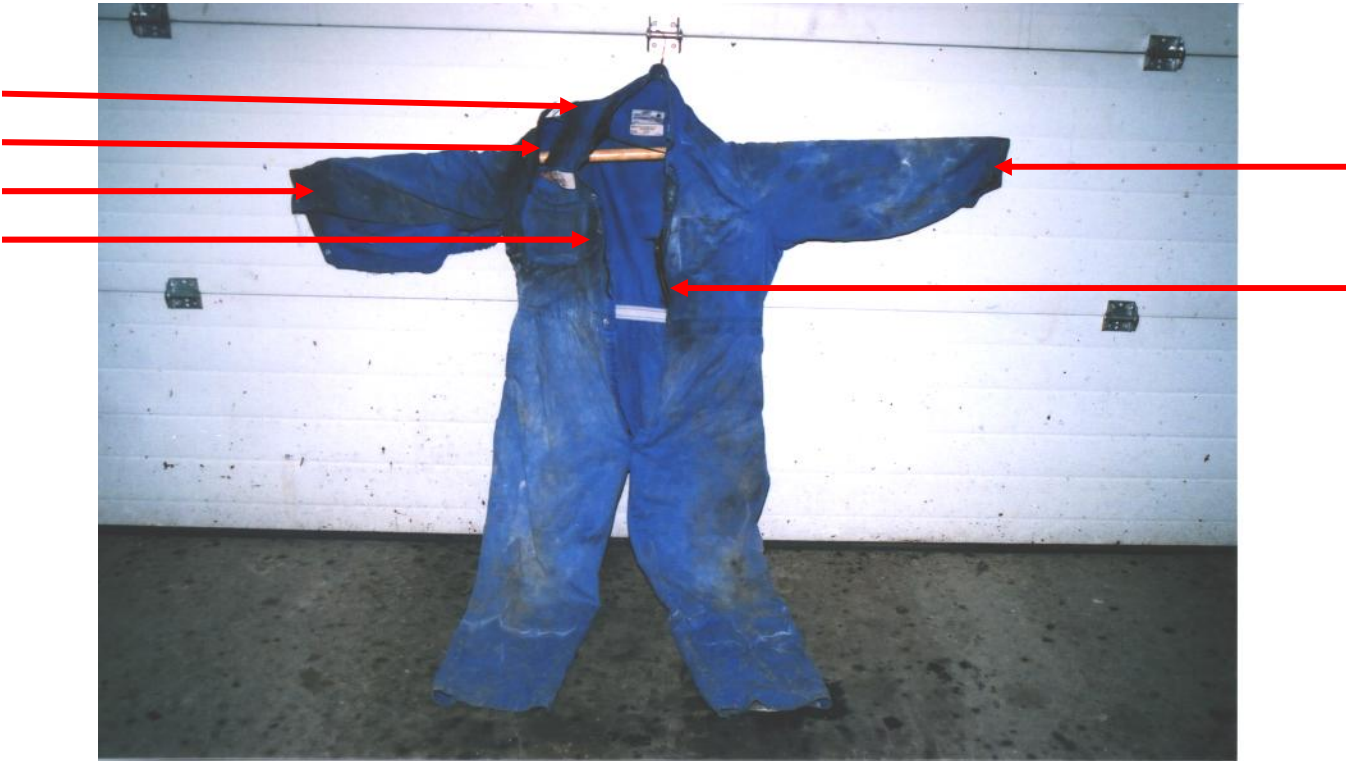
- 5.1.5 The mechanics were wearing blue coveralls at the time of the incident. The coveralls were not fire resistant (Refer to Appendix B-Photograph 12).

Photograph 12: Shows the coverall worn by the mechanic #2
Arrows show the burned areas.
