Investigation Report
Worker Drowned After Falling Into a Water Tank
September 25, 2012

Incident summary

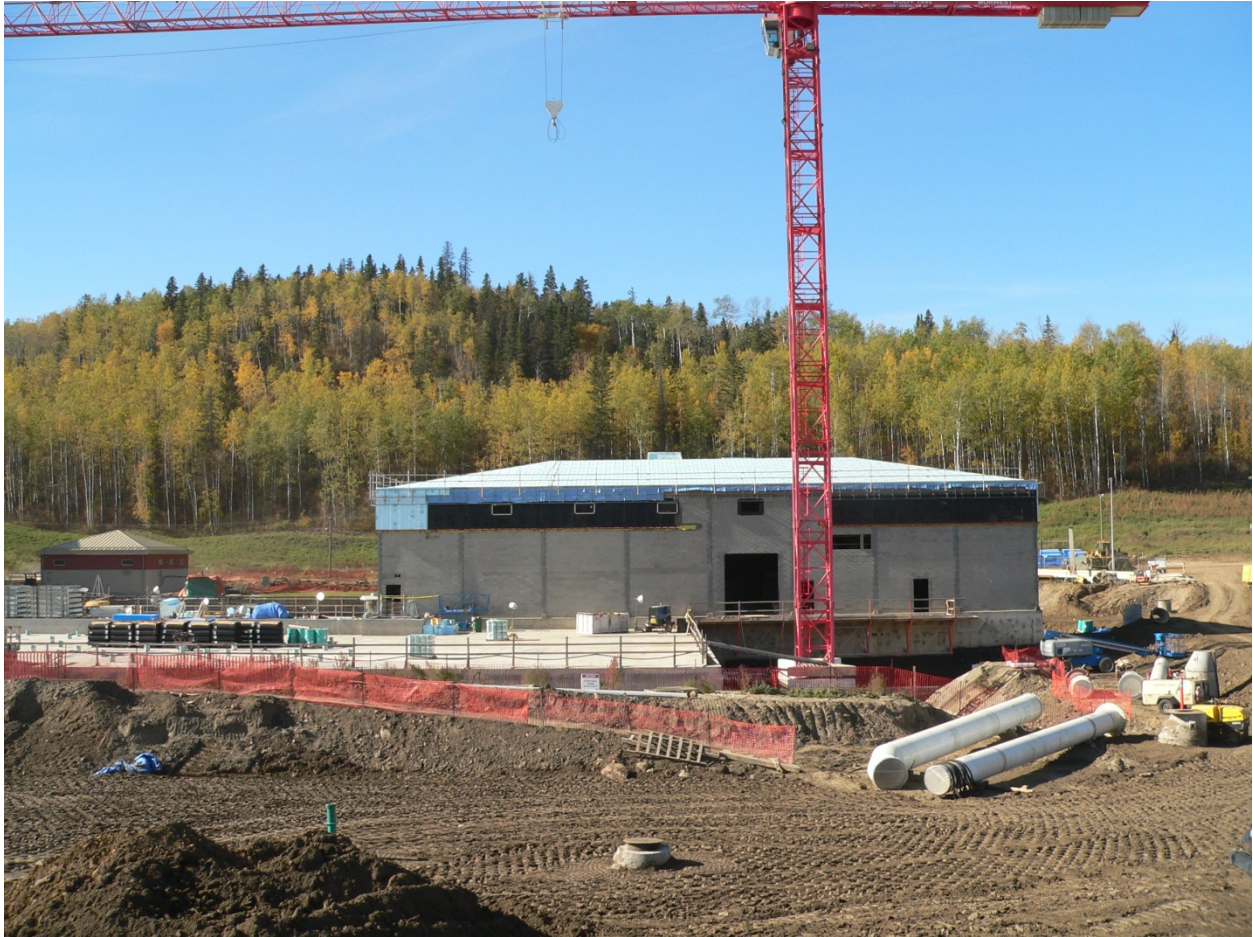
Figure 1 – High Lift Pump Station (HLPS)

The High Lift Pump Station's (HLPS) purpose was to pump potable water from the concrete reservoir to the residents in the northern portions of the city of Fort McMurray (Figure 1). The HLPS included bases for seven pumps that were located over a concrete reservoir. At the time of the incident, a hydrostatic test was in progress to test the integrity of the concrete reservoir below the building. The hydrostatic test was started approximately ten days before the incident, and consisted of approximately seven days to fill the tank and approximately three days of visual leak detection.

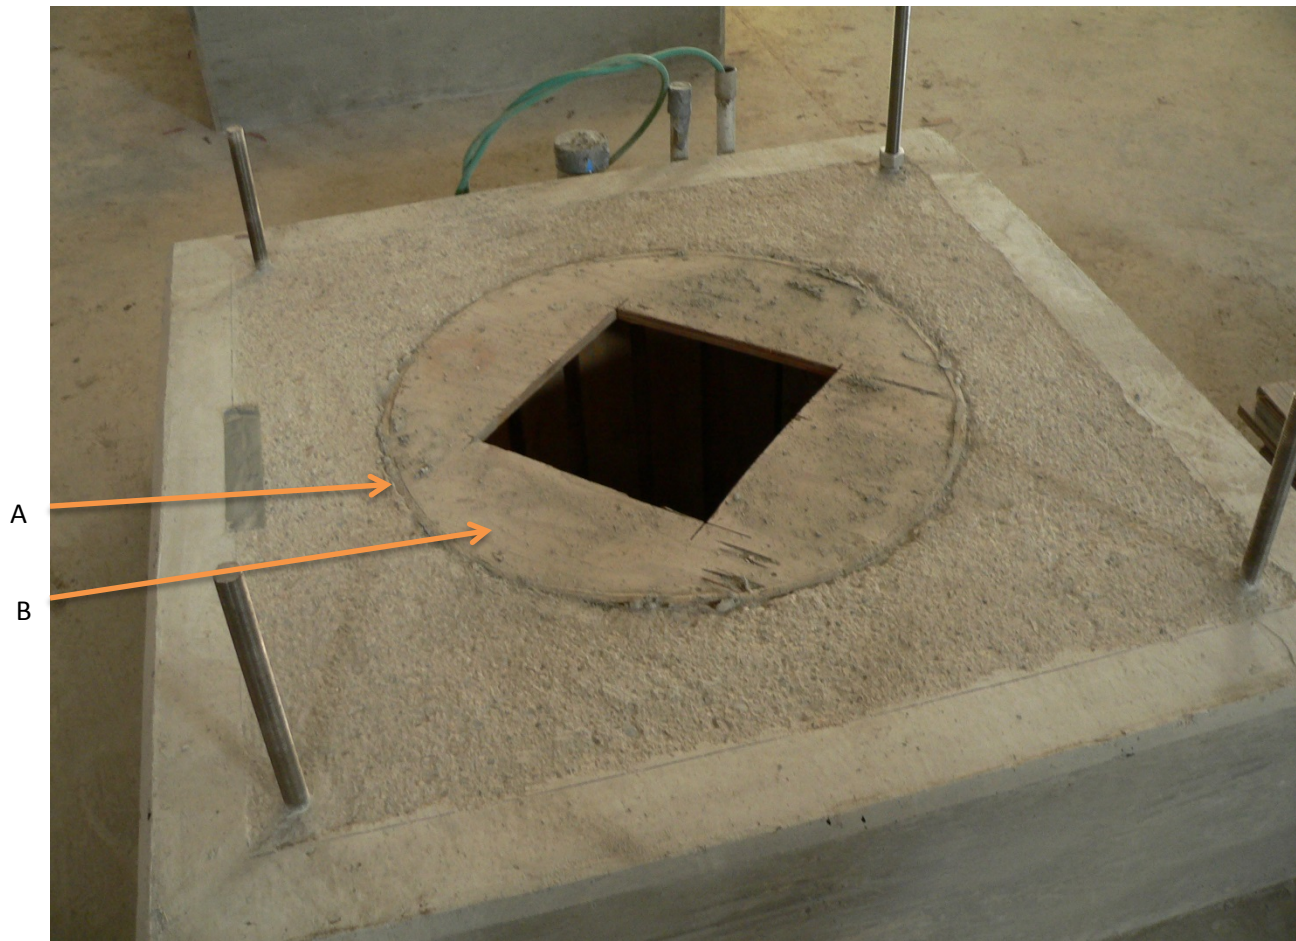
Figure 3 – Concrete pump base

This arrangement provided the support for the sonotube to allow concrete to be poured around it so a hole would be formed in the centre of the pump base without the sonotube collapsing. The resulting hole in the pump base was for the pump shaft to fit through to access the water in the reservoir.

A – Sono tube embedded in the concrete base

B – Plywood formwork (not yet removed)

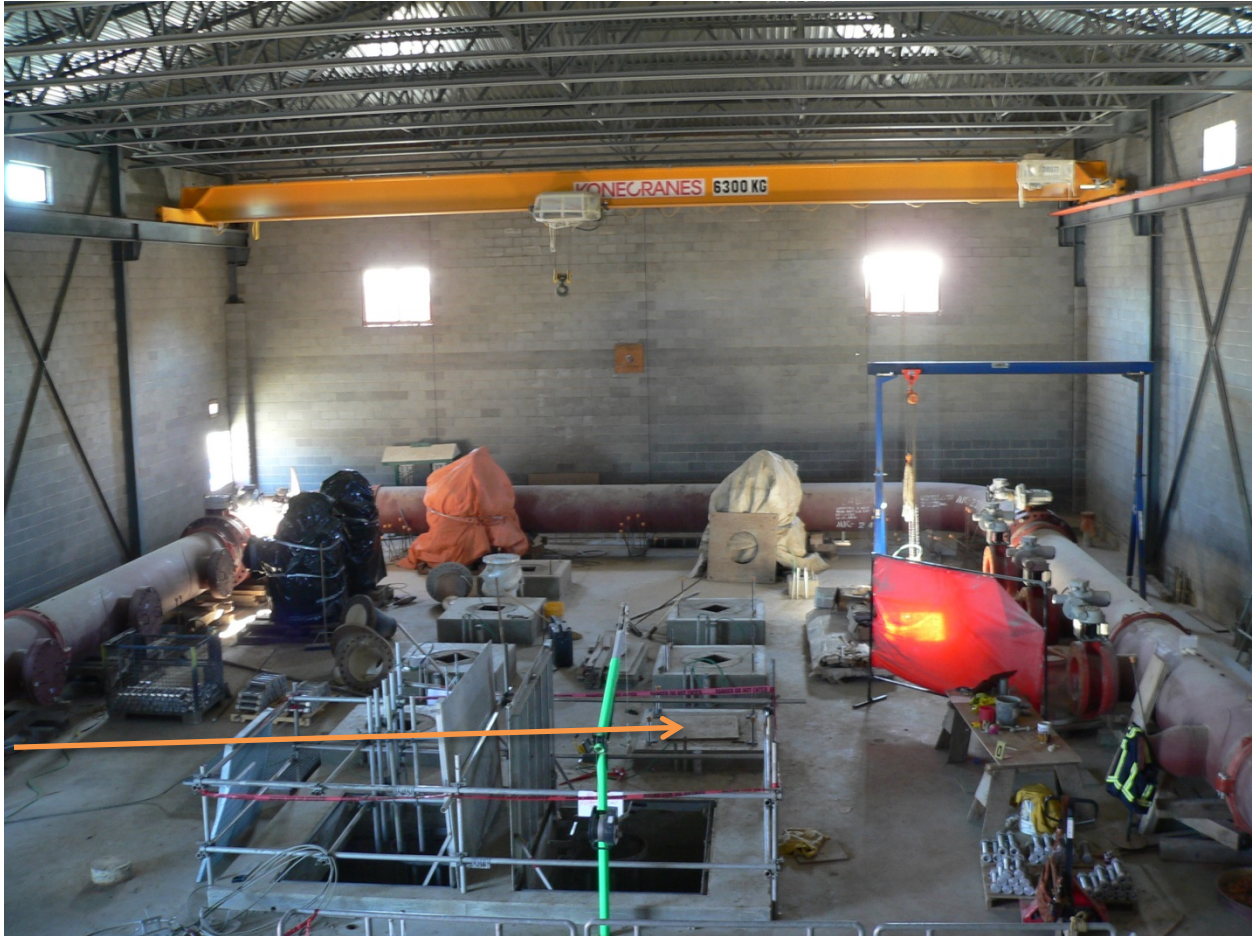
Figure 4 – Inside of the HLPS where the pump bases were located.

A – Plywood cover over pump base worker fell through

Between 3:30 p.m. and 4:00 p.m., labourer 1 continued to work on the removal of the sonotube and fell through the hole in the pump base, landing in the water below in the reservoir, and subsequently drowned. As labourer 1 was working alone, there were no witnesses to these events.

When the millwrights finished their work on the pump base, they covered the open hole in the pump base with a piece of plywood. They left the site at approximately 4:30 p.m.

Bird Construction Company pled guilty to Section 139(1)(c) of the Occupational Health and Safety Code in which the employer failed to ensure that its worker used a fall protection system at a work area where a worker may fall into a hazardous substance or through an opening in the work surface.
