Investigation Report

Worker fatally injured after being struck by vehicle

July 3, 2019

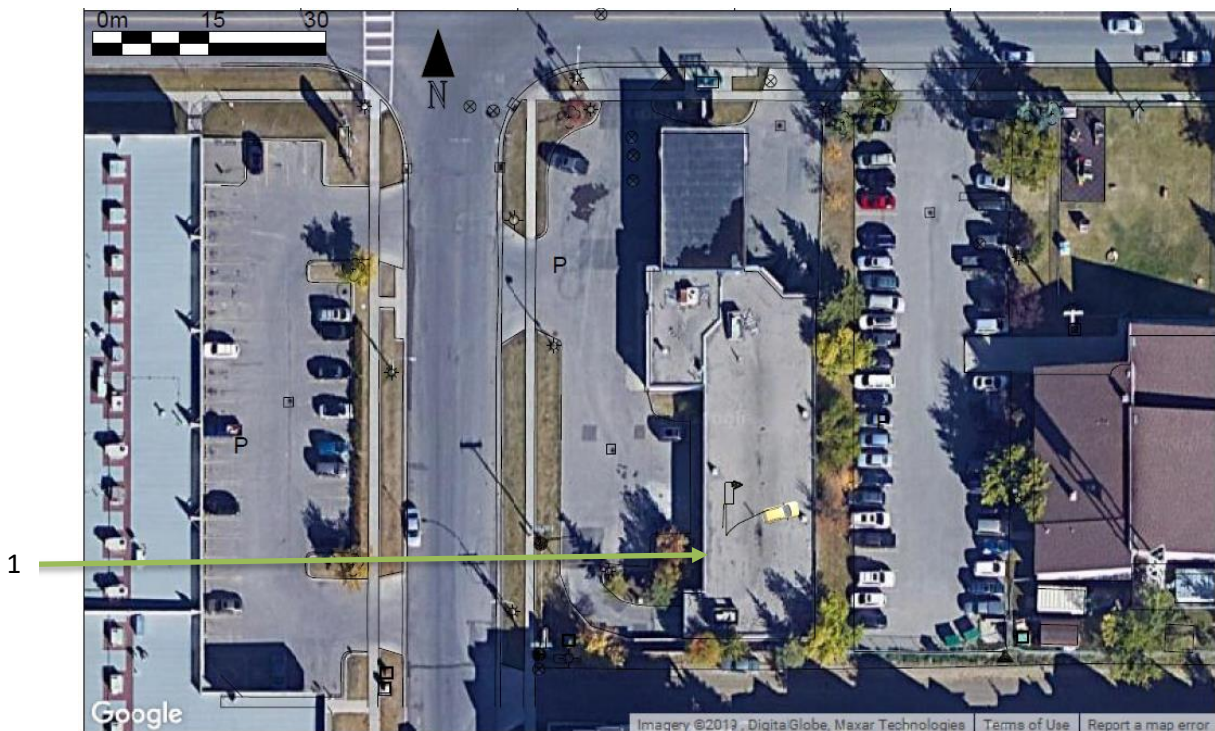
Figure 1. Service station from above with an overlaid diagram of the vehicle path and sump pit (1). Picture courtesy of Calgary Police Services.

During this cleaning process, the car wash was not closed to customers. A vehicle entered the car wash, and the driver proceeded to use the second bay from the entrance to clean their vehicle. Once they were finished, they backed out of the bay and attempted to proceed to the exit. The vehicle drove partially into the open sump pit at 12:29 p.m., striking and pinning the co-owner/manager of the car wash against the sump pit side. The co-owner/manager had been standing on the ladder in the sump pit, partially above the ground level.

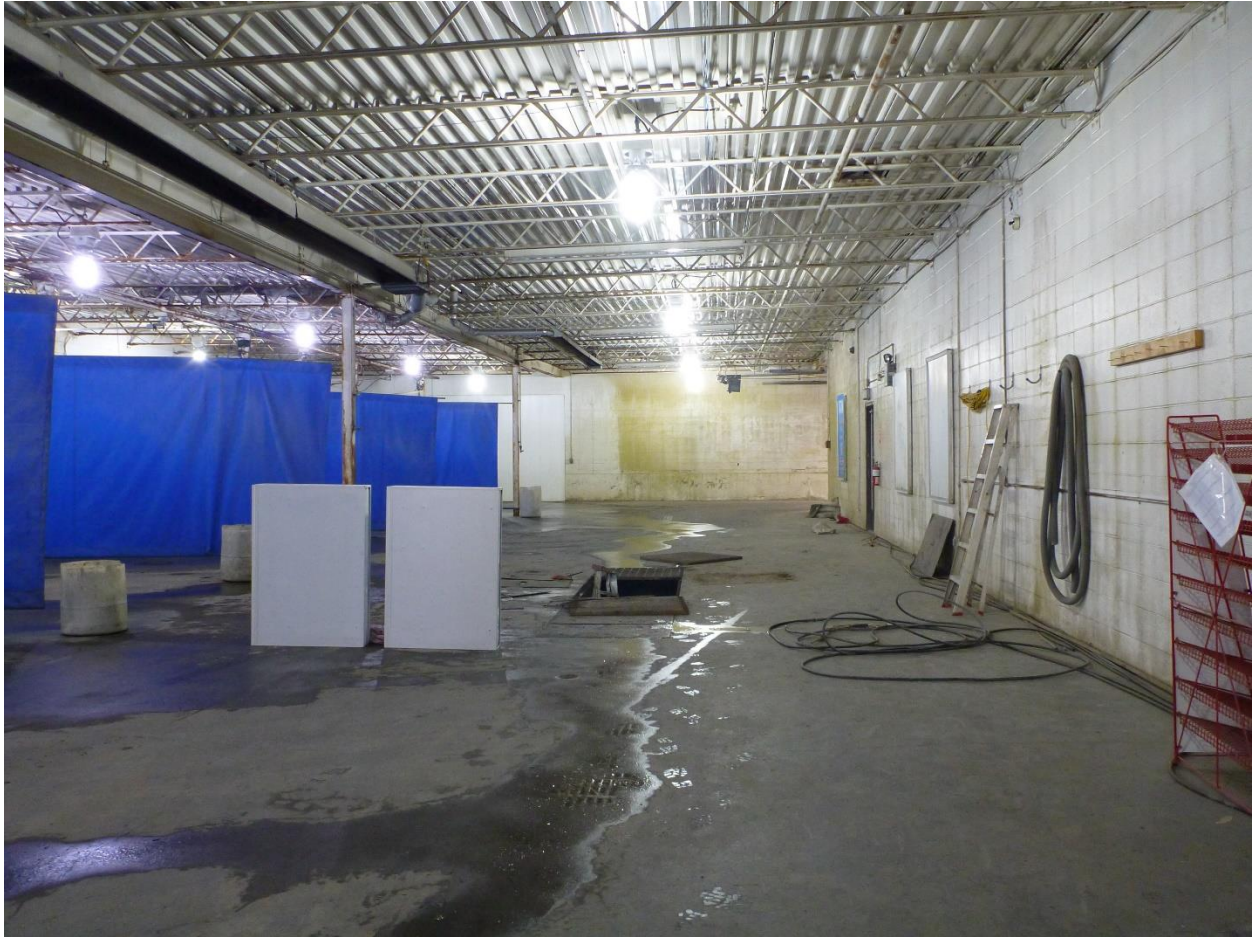
On July 3, 2019, Gangster Enterprises Ltd. and the co-owner/manager of 853272 Alberta Ltd. commenced clean out operations at the car wash at approximately 11:00 a.m. The bays closest to the entrance of the wash were vacuum emptied first, with cleaning progressing to the exit. At some point, the co-owner/manager of the car wash opened the sump pit by removing the cover and placed a stepladder inside, leaned against the side. The sump pit measured 1.08 metres (m) wide, 2.90 m long and 2.12 m deep. The co-owner/manager entered the pit and was using a water hose with a spray attachment to force dirt and debris from the drain lines connecting the pit back to the bay drains where vacuuming was occurring.

Figure 2. Car wash bays and sump pit.
