Investigation Report

Worker fatally injured after being buried in phosphate rock

June 2, 2016

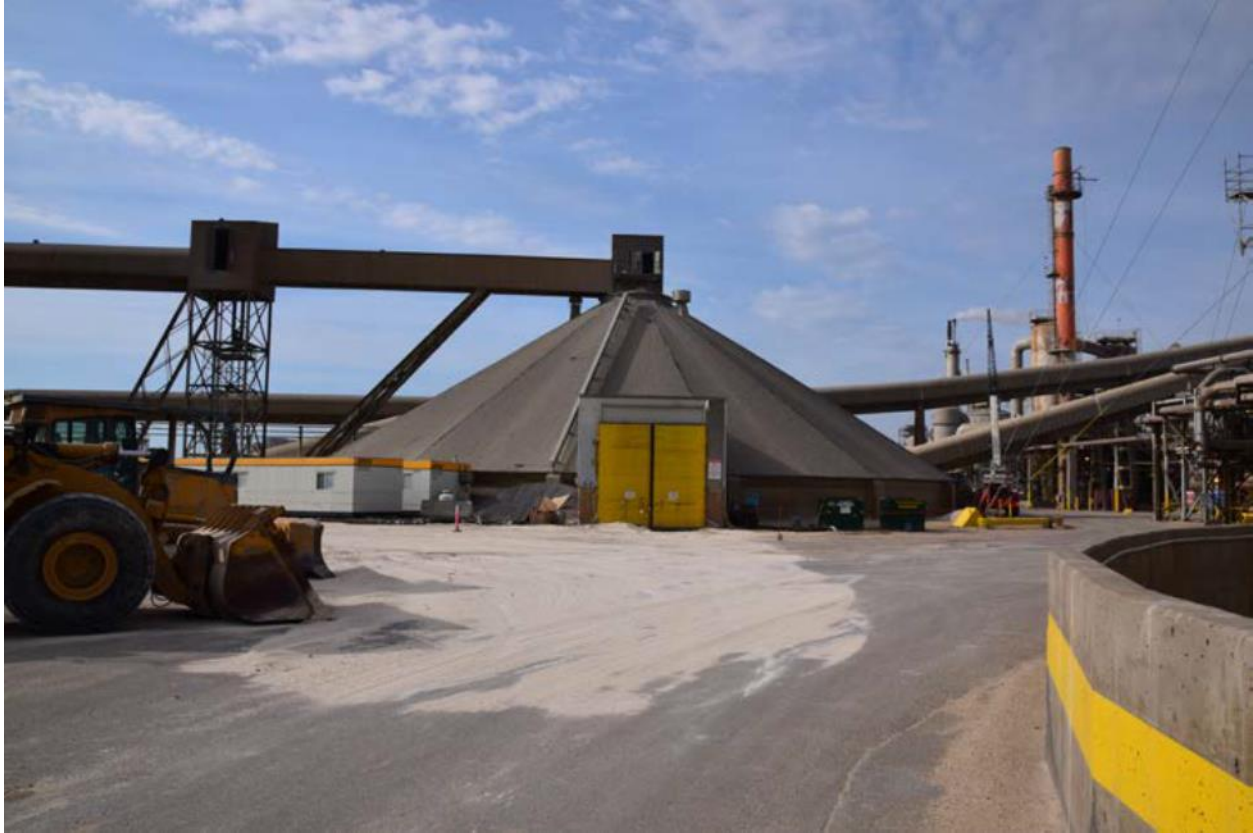
*Figure 1. Incident location was inside the teepee structure.*

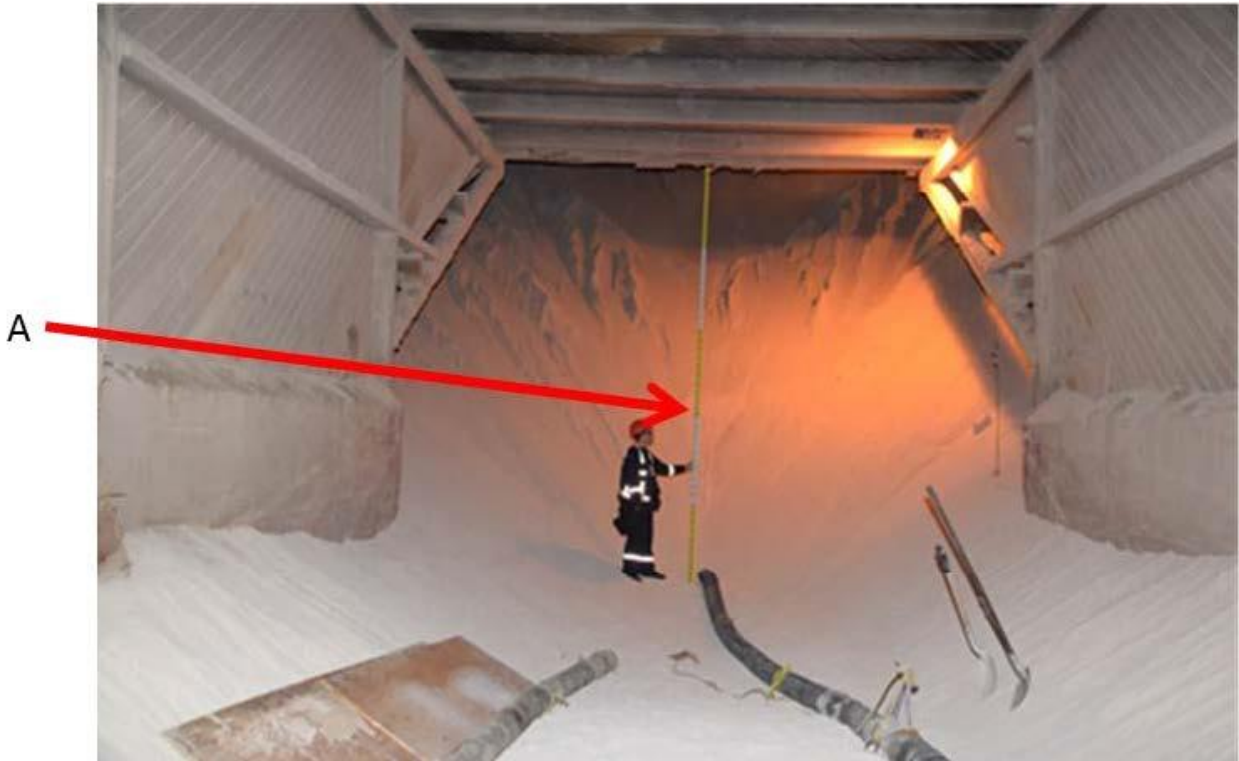
Figure 2.

A. Location where worker 1 was found. The height of the overhead beam in the photo is 5 metres (m). Each section of colour on the survey stick represents 1 m.

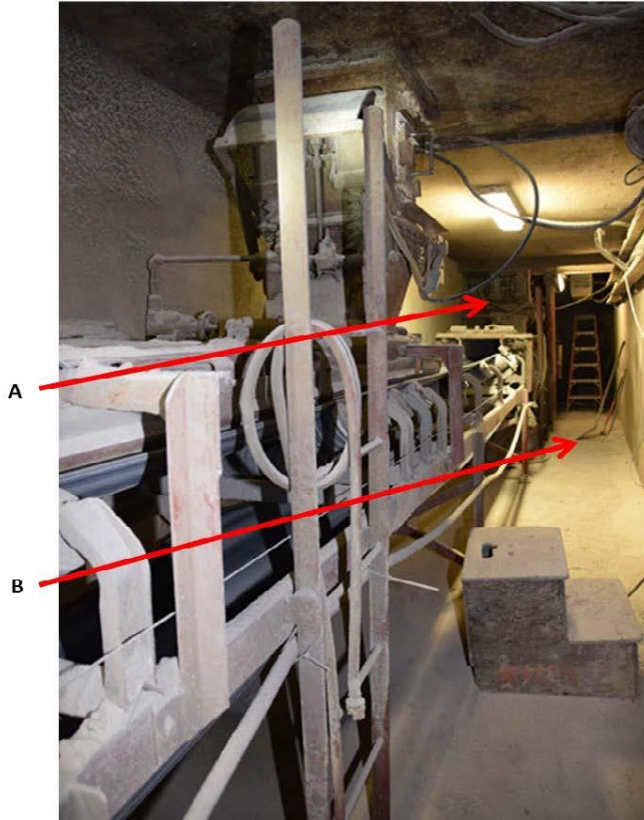
*Figure 3. Conveyor system located below the teepee structure.*

- A. Gate 24 feeder for the conveyor system located below the teepee.*
- B. Tools that workers were using underground to dislodge lumps in the feeder. This process was also called “rodding the gates”. Rodding the gates was a process where a worker used a metal bar and inserted it into the gate opening to clear the feeder gate of lumps.*

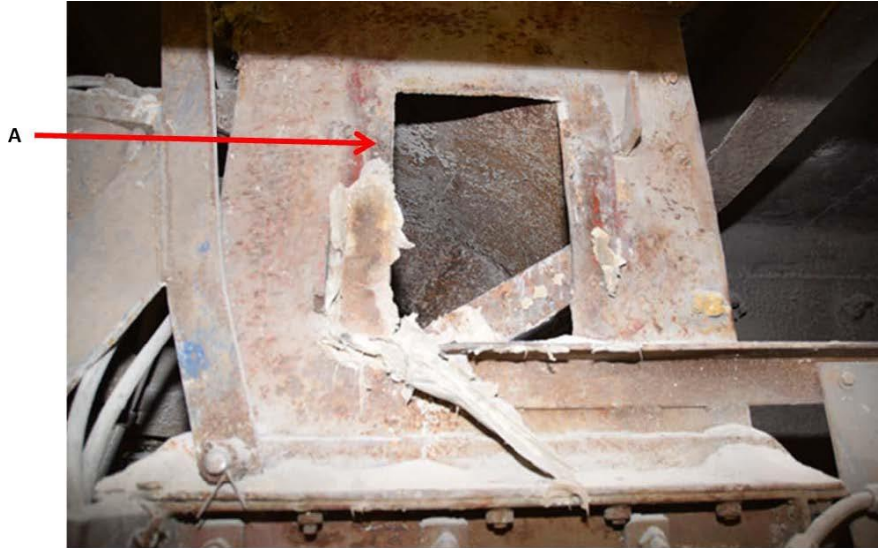
*Figure 4.*

- A. Opening on the side of gate 24 feeder access hatch from below the teepee in the conveyor area. The opening was approximately the size of a letter sized piece of paper.*

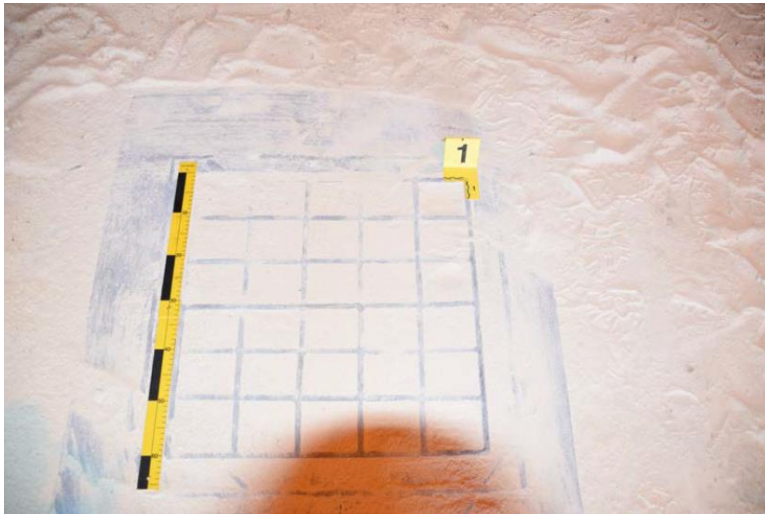
When one worker and one supervisor entered the teepee, they began picking up the lumps of the phosphate rock above the 24 gate in an attempt to prevent the lumps from clogging the feeder. As they were conducting this process, the phosphate rock continued to pour through the gate as sand does through an hour glass (Figure 6).

*Figure 6. Gate 24, ground level inside the teepee. Worker 1 was located above gate 24 within the phosphate pile. This gate fed into the feeder and conveyor. The gate measured 58 centimetres (cm) x 58 cm.*
