RECAPP Facility Evaluation Report

Drayton Valley Hospital & Care Centre

B1019A

Evaluation Company: PBK Architects
Evaluation Date: October 19 2011
Evaluator Name: Len O'Connor

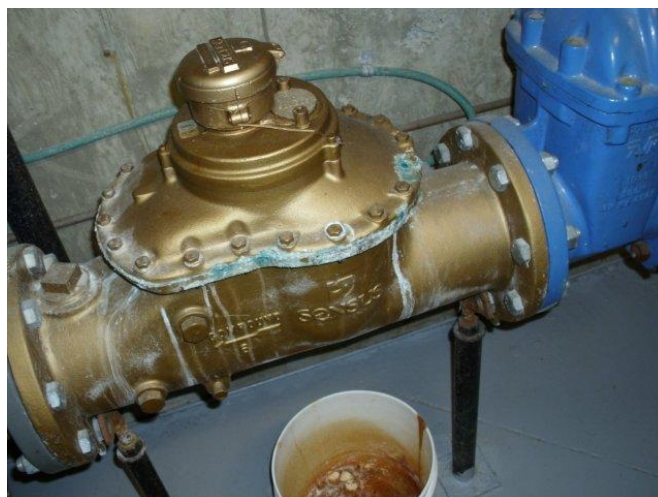
Evidence of high mineral content of incoming domestic water as shown by leaking seal at main water meter and small leaks/mineral build-up in other locations.

Leaking seal at main water meter.

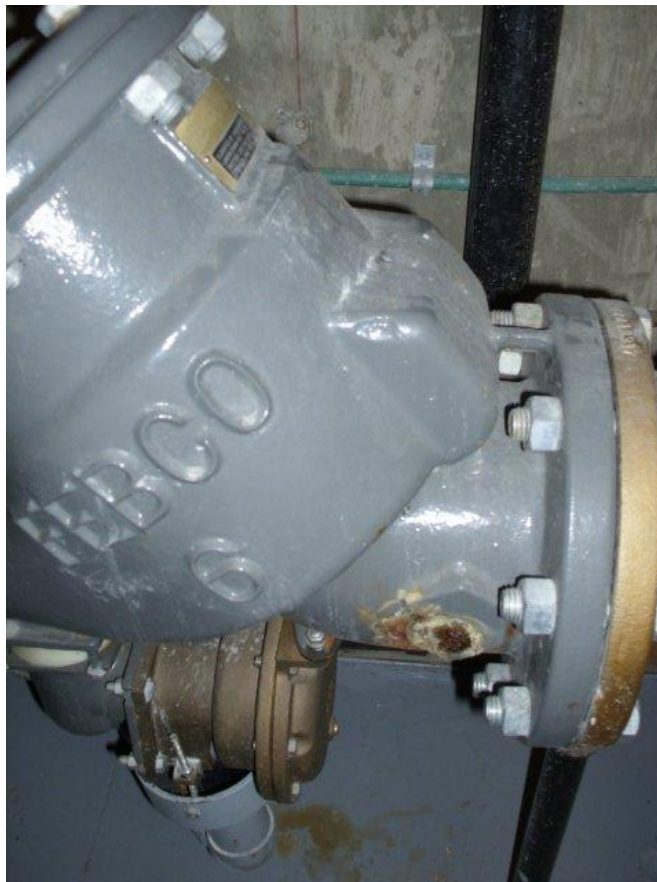
Backflow preventer on incoming water service. There is a hole at one end that requires repeated patching.

Backflow preventer with location requiring regular repairs (rusty spot near flange).

Backflow preventer requires regular maintenance to repair a hole that continually re-opens.

Continued requirement for patching, possibility of serious leak in main water supply to building.

Replace the backflow preventer to remove this requirement for regular maintenance.

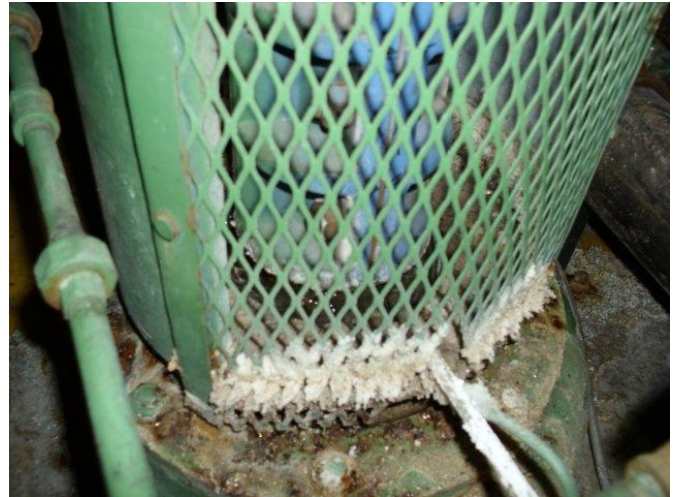
Etatech pumps (2) are original. Seal is leaking on P22.

P22 leaky seal

Seal on P22 (condenser pump) is leaking.

Continued leaking, water damage, and possible failure of condenser water system.

Replace mechanical seal.
