Investigation Report  
Worker Fatally Injured when Struck by Tree  
December 15, 2014

## Incident summary

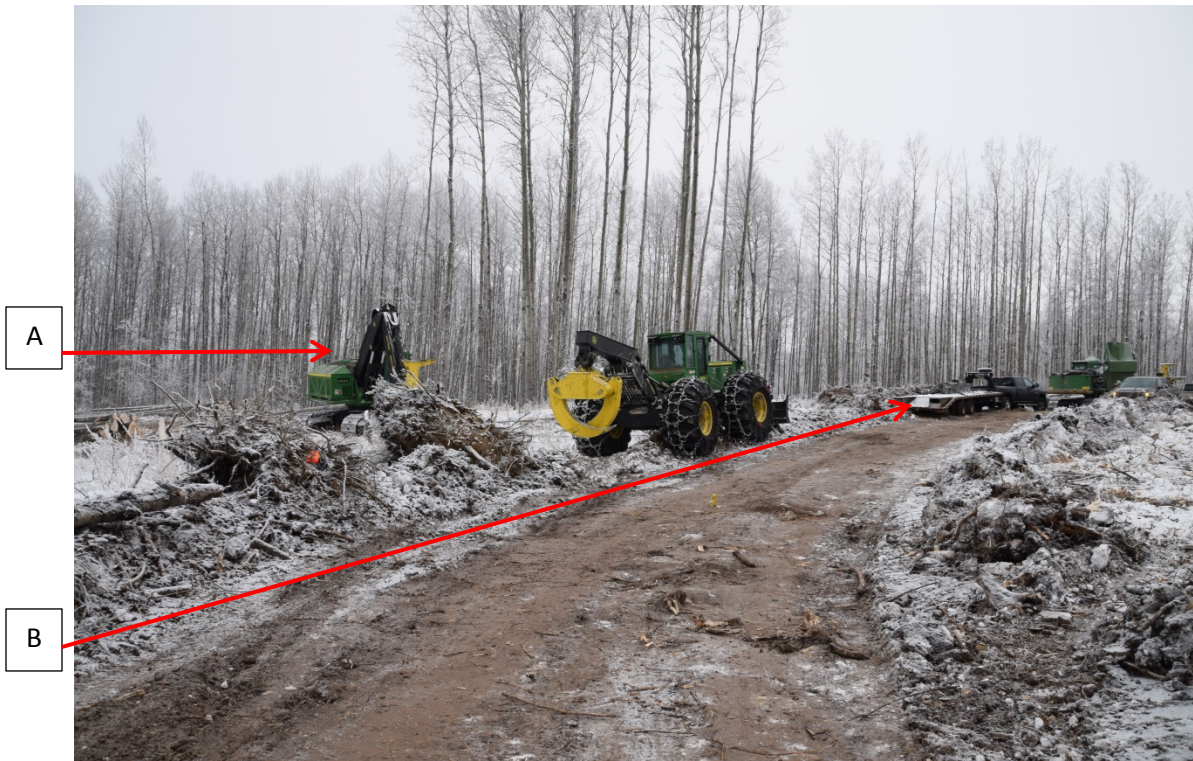
Figure 1. Accident location from road toward feller/buncher and truck and trailer

A: Feller/buncher

B: Truck and trailer

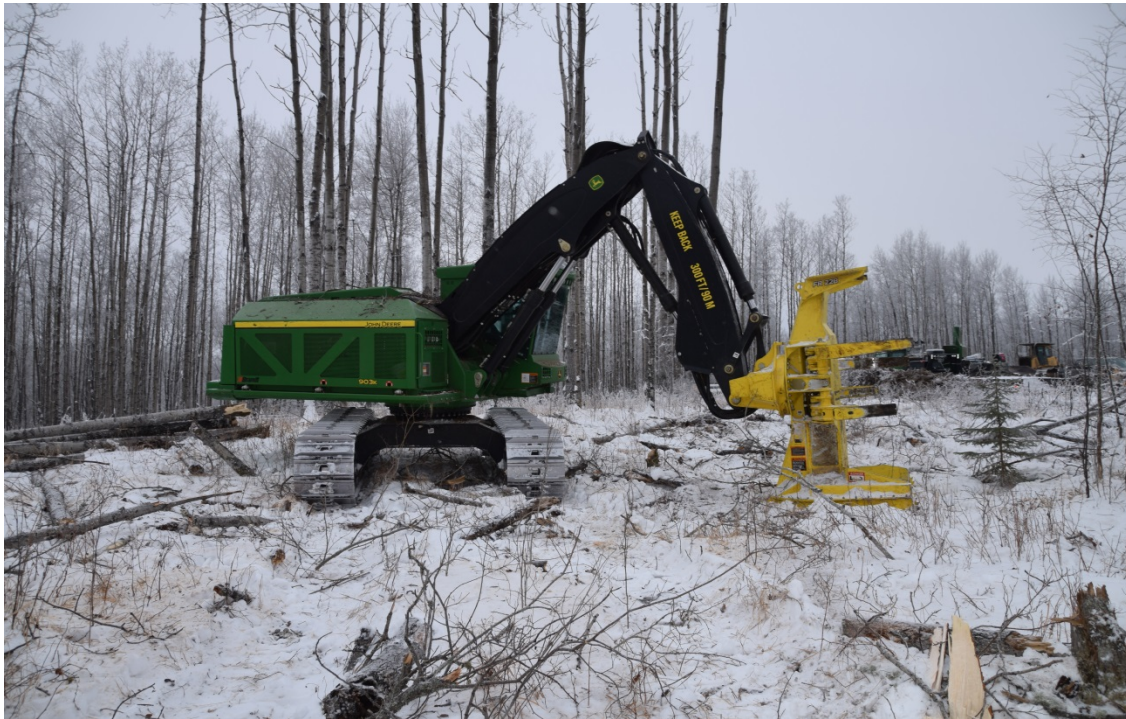
Figure 2. Feller/buncher in use at the time of the incident.

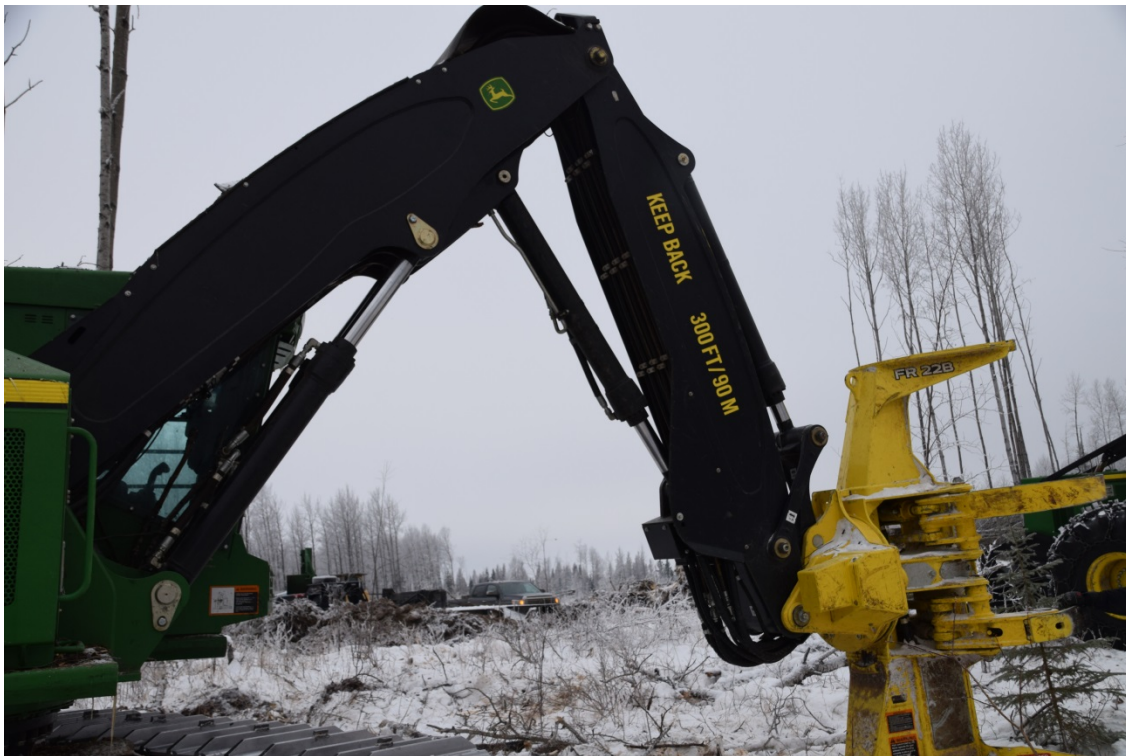
Figure 3. Feller/buncher. Proximity warning can be seen on the boom.

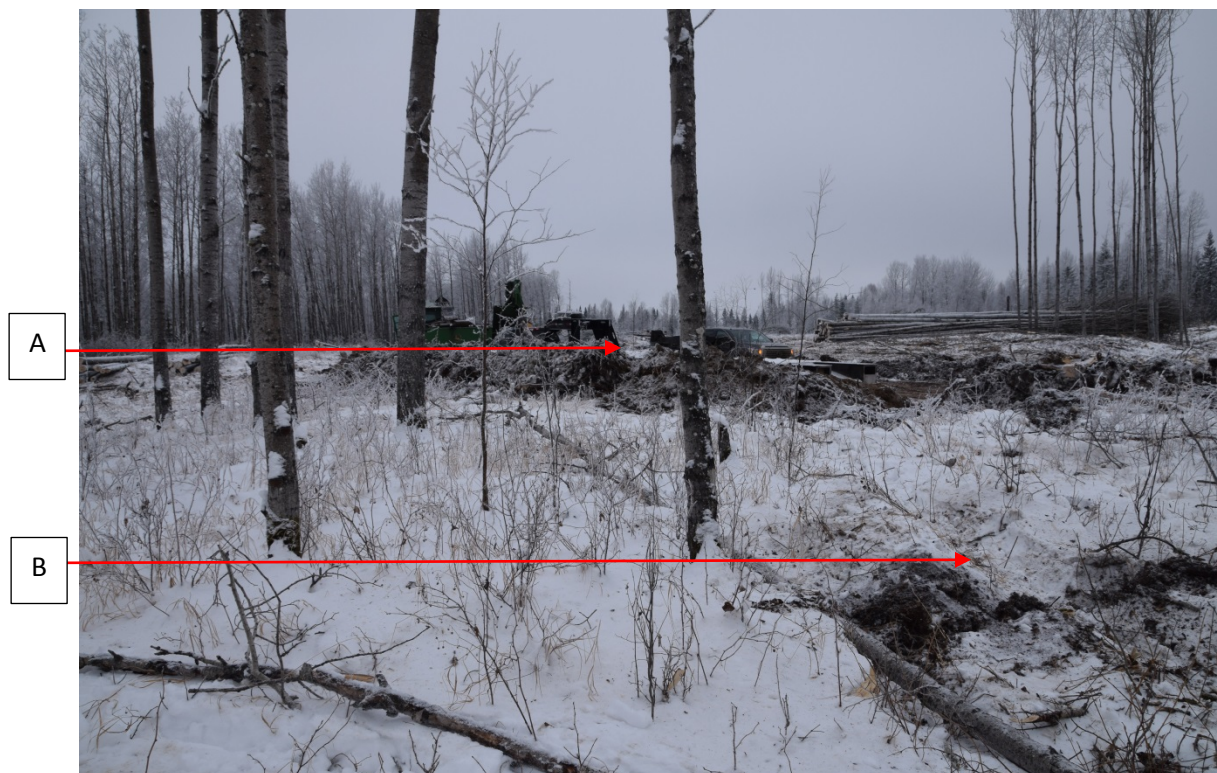
The equipment operator then re-engaged the feller/buncher and returned to felling trees. As the equipment operator was working along the cutline road, he observed someone (later identified as supervisor 1) working at the truck and trailer. The operating feller/buncher was approximately 16 m from the road and 23 m from the truck and trailer (figure 1). The equipment operator was felling several trees at a time, when one of the trees fell away from the feller/buncher and toward the truck and trailer. The tree was approximately 29 m in length and was observed to be broken at approximately 20 m from the tree base (figure 4). The equipment operator picked up the tree and placed it in the established tree pile.

*Figure 4. View from feller/buncher to truck-trailer. Indentation is consistent with a fallen tree from the feller/buncher.*

*A: Berm indentation indicating the presence of a fallen tree. Supervisor 1 was observed to be directly east of the indentation at the berm.*

*B: Field indentation indicating the presence of a fallen tree*
