Investigation Report
Worker fatally injured after well site explosion
October 23, 2018

Incident summary

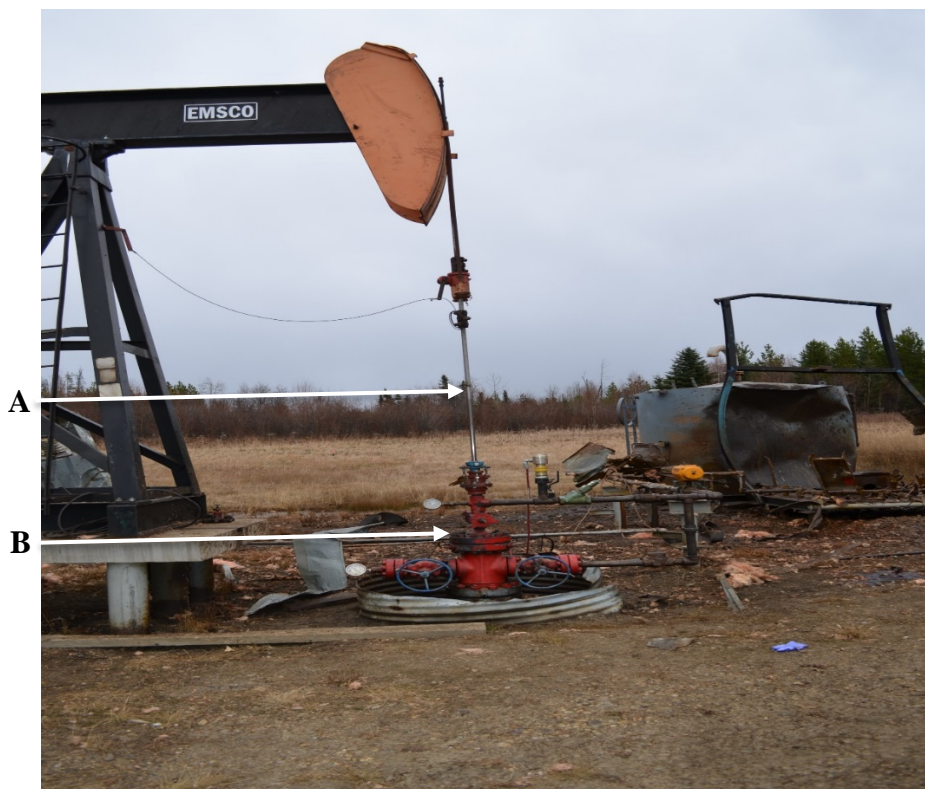
Figure 1. The wellhead and pumpjack sucker rod system still intact post explosion.

A. The pumpjack sucker rod system.

B. The wellhead.

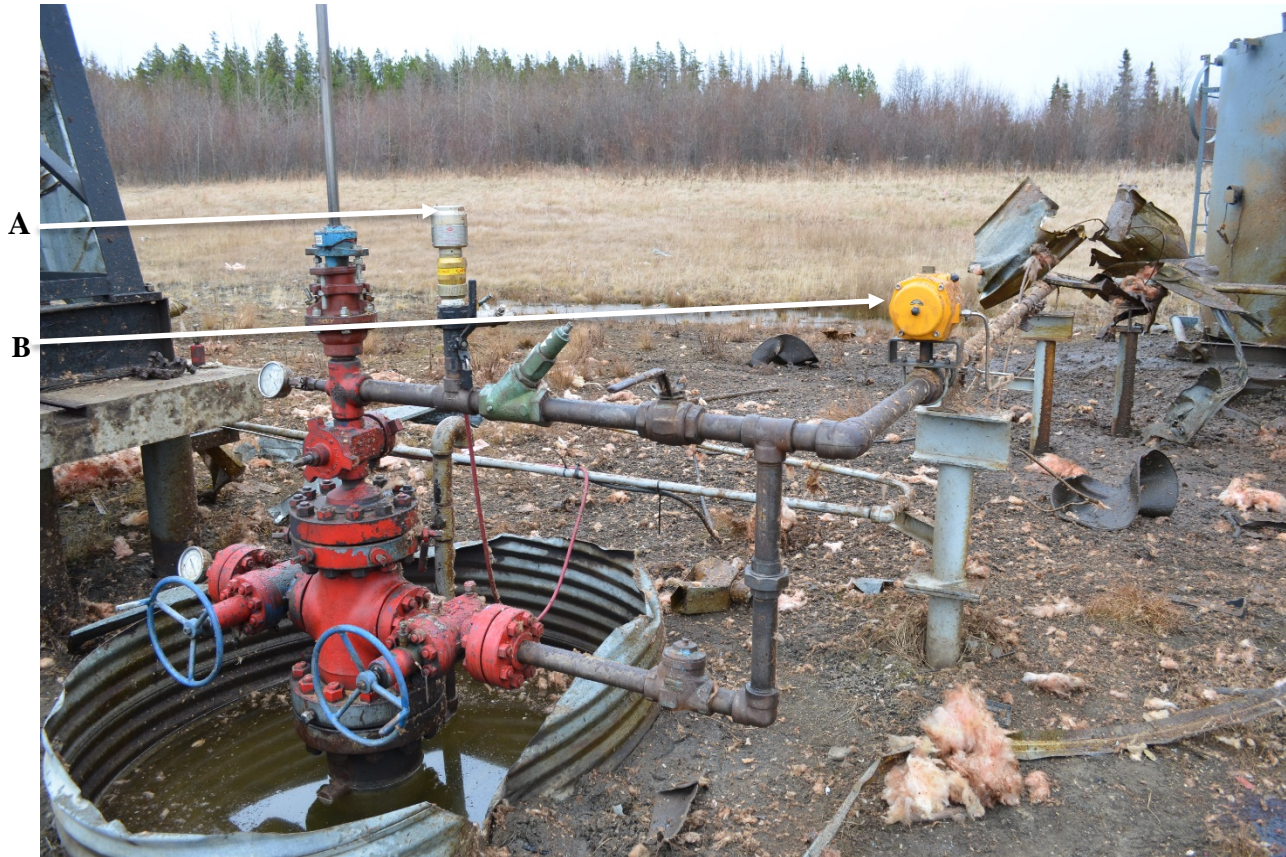
Figure 2. The pressure switch and ESD. Post incident showed that the pressure switch and the ESD were both engaged prior to incident occurring.

- A. The pressure indicator switch (Presco switch) safety button, located at the top of the device, was engaged. This button would pop up to indicate that the wellhead had experienced a high or low pressure.*
- B. The ESD in the shut in position.*

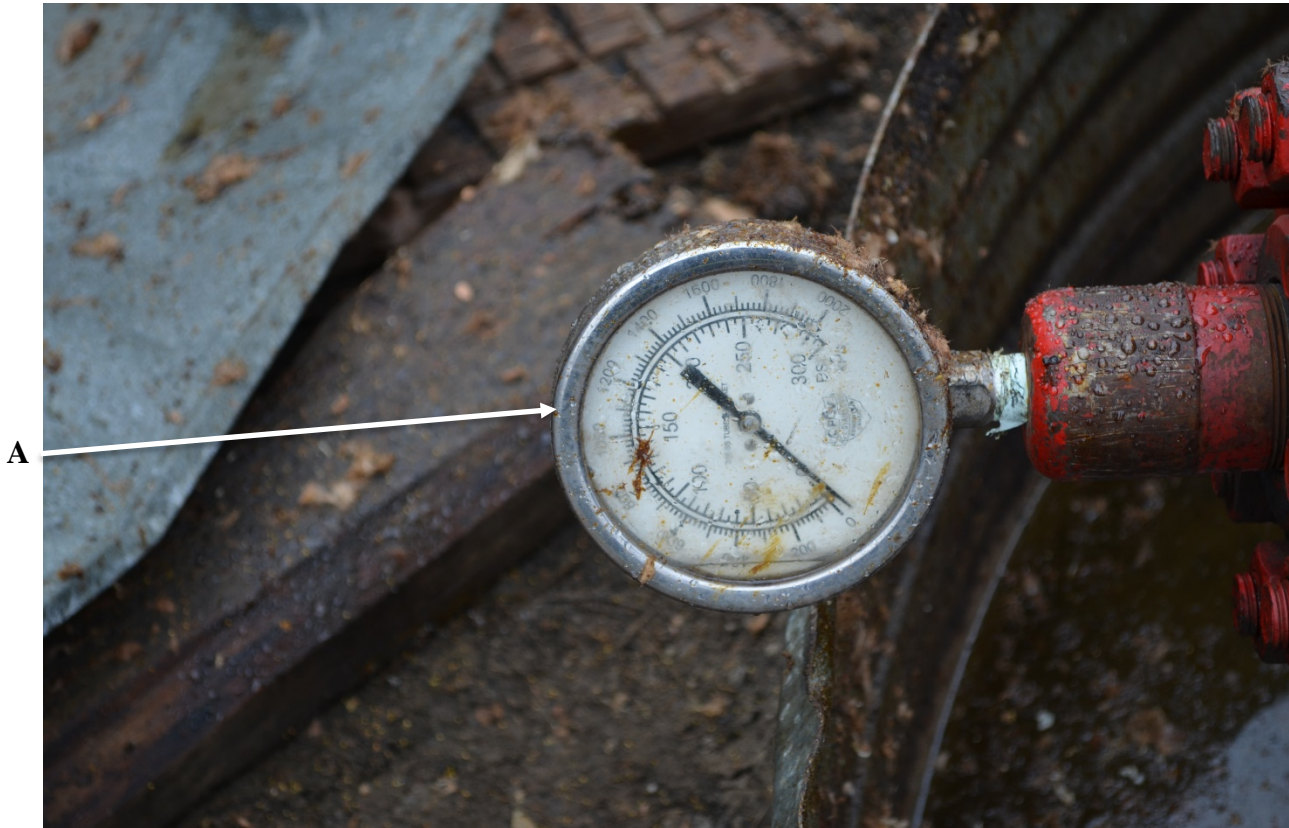
Figure 3. The pressure gauge needle was wrapped around the gauge and was sitting below the “0”. This was caused by a pressure, beyond the pressure gauge’s capacity of 300 pounds per square inch (psi), coming from down hole and through the piping that the pressure gauge was attached to.

A. The pressure gauge with the needle wrapped around.

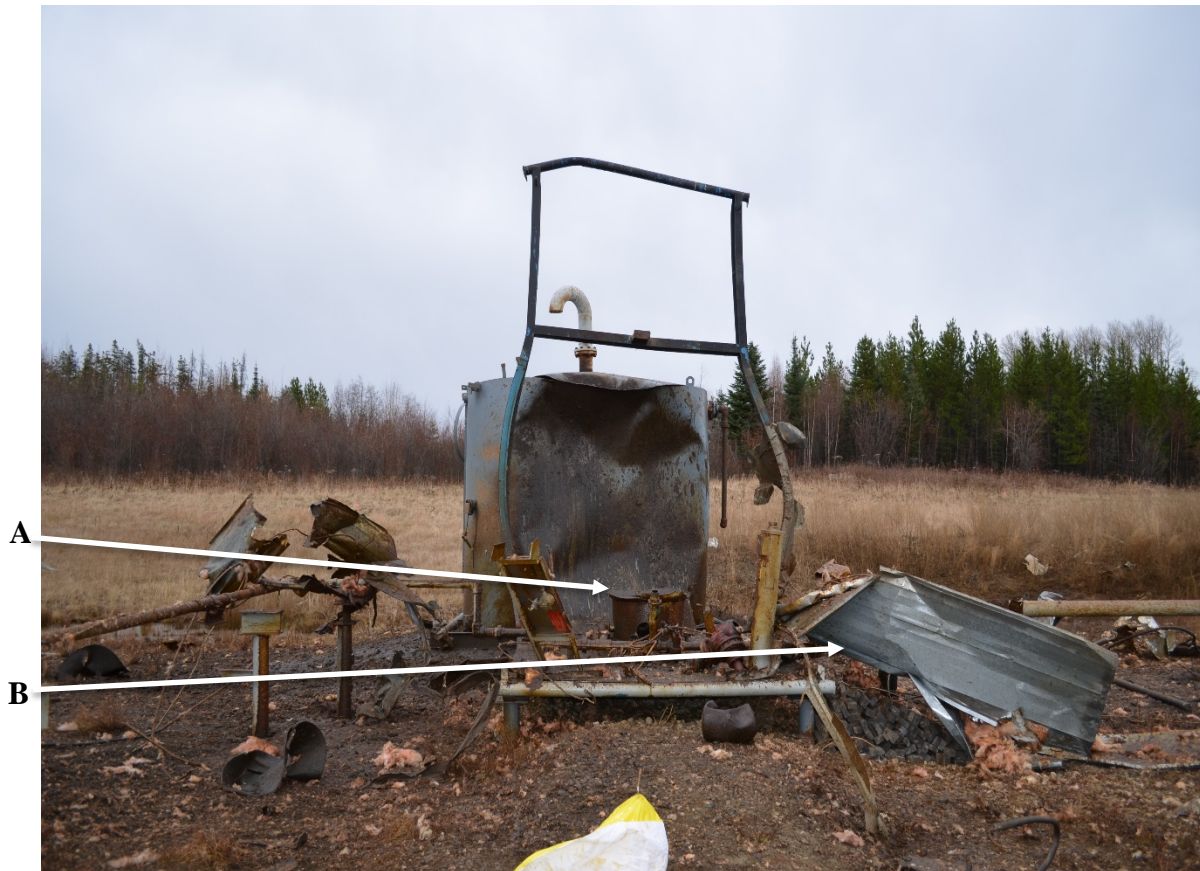
The Separator tank (vessel) was used to separate gas and liquid components from the fluids extracted from an oil well. The separator building was the structure built around the vessel. The explosion occurred within the separator building when the vessel ruptured (Figure 4).

Figure 4. The location of the separator building and remnants of its frame and the vessel were located in various pieces approximately 1000 metres (m) from the base. A manufacturer's identification placard from the vessel stated that Canadian Equipment Sales & Services Co. Ltd. manufactured the vessel on March 20, 1956 (Vessel No. 807) and was rated for a working pressure of 125 psi.

- A) The base of the vessel.
- B) Remnants of the separator building. Parts of the separator building were located in various locations from the separator building base up to 91 m away.
