# RECAPP Facility Evaluation Report

## Aspen Regional Health Authority

### Swan Hills Healthcare Centre

<b>Evaluation Details</b>	
<b>Evaluation Company:</b>	Francis Ng Architect Ltd.
<b>Evaluation Date:</b>	June 5 2009
<b>Evaluator Name:</b>	Francis Ng

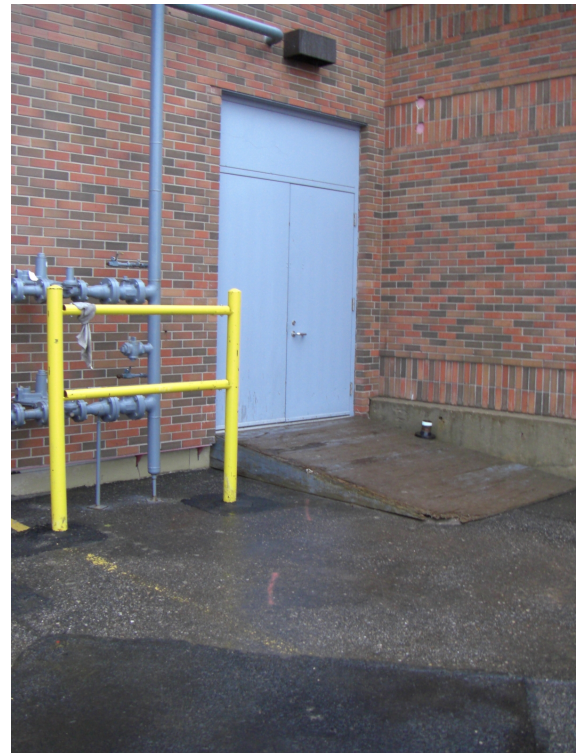
(1985) Basement (Maintenance - Mechanical Room 0160) - wood ramp is worn out.

Replace with concrete ramp. (3 ramps)

<u>Type</u>	<u>Year</u>	<u>Cost</u>	<u>Priority</u>
Failure Replacement	2011	\$9,000	Low
