Worker Fall from Ladder

Type of Incident: Fatality

Date of Incident: September 27, 2012

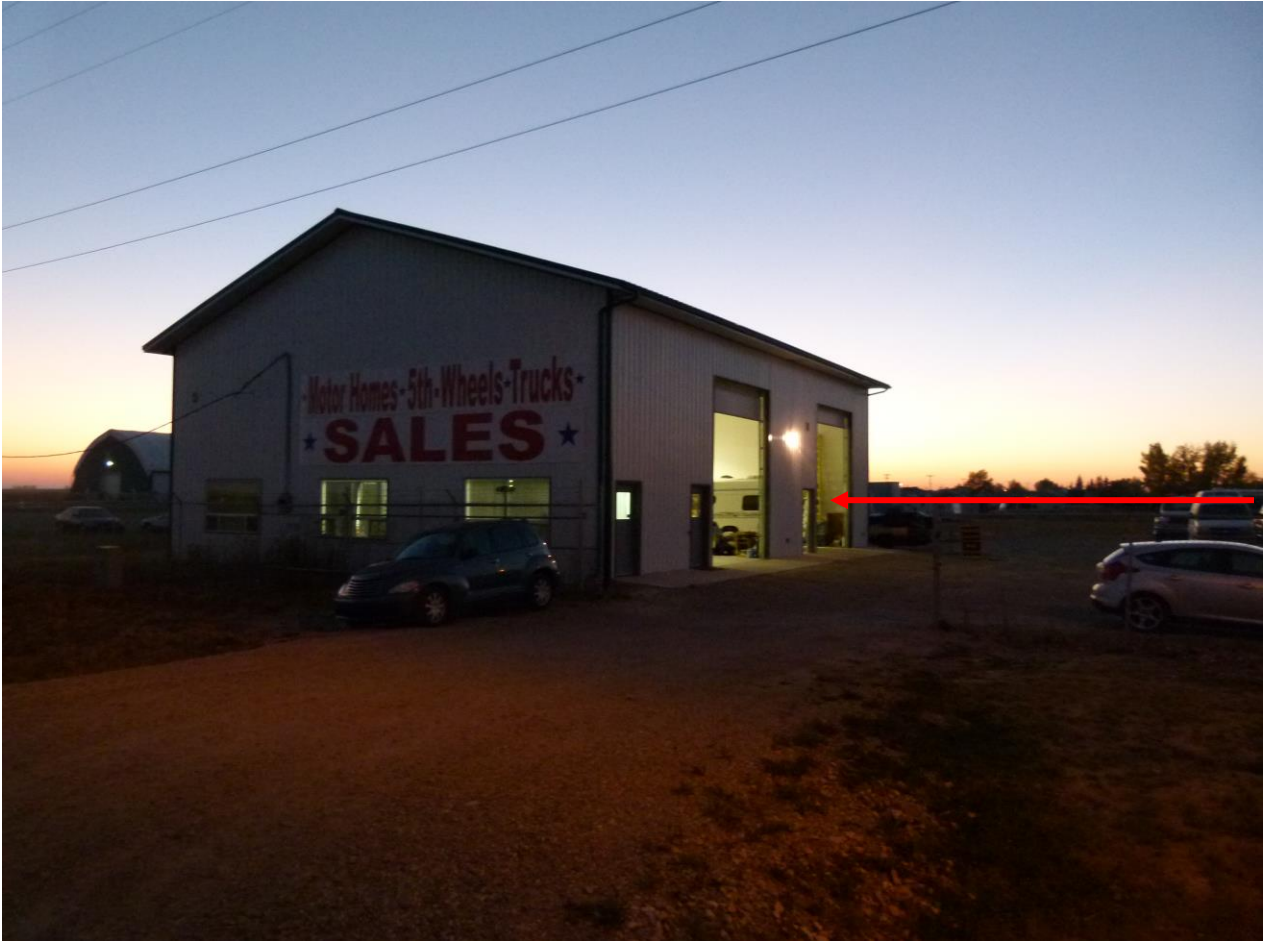
The incident occurred in the north service bay of the Commuter shop located at #1 Skyland Road, Beiseker, Alberta, see Attachment A – Map, Attachment B – Photographs 1 and 3.

Photograph 1 – Shows shop looking west/southwest.

- 1. Shows bay the incident occurred in.

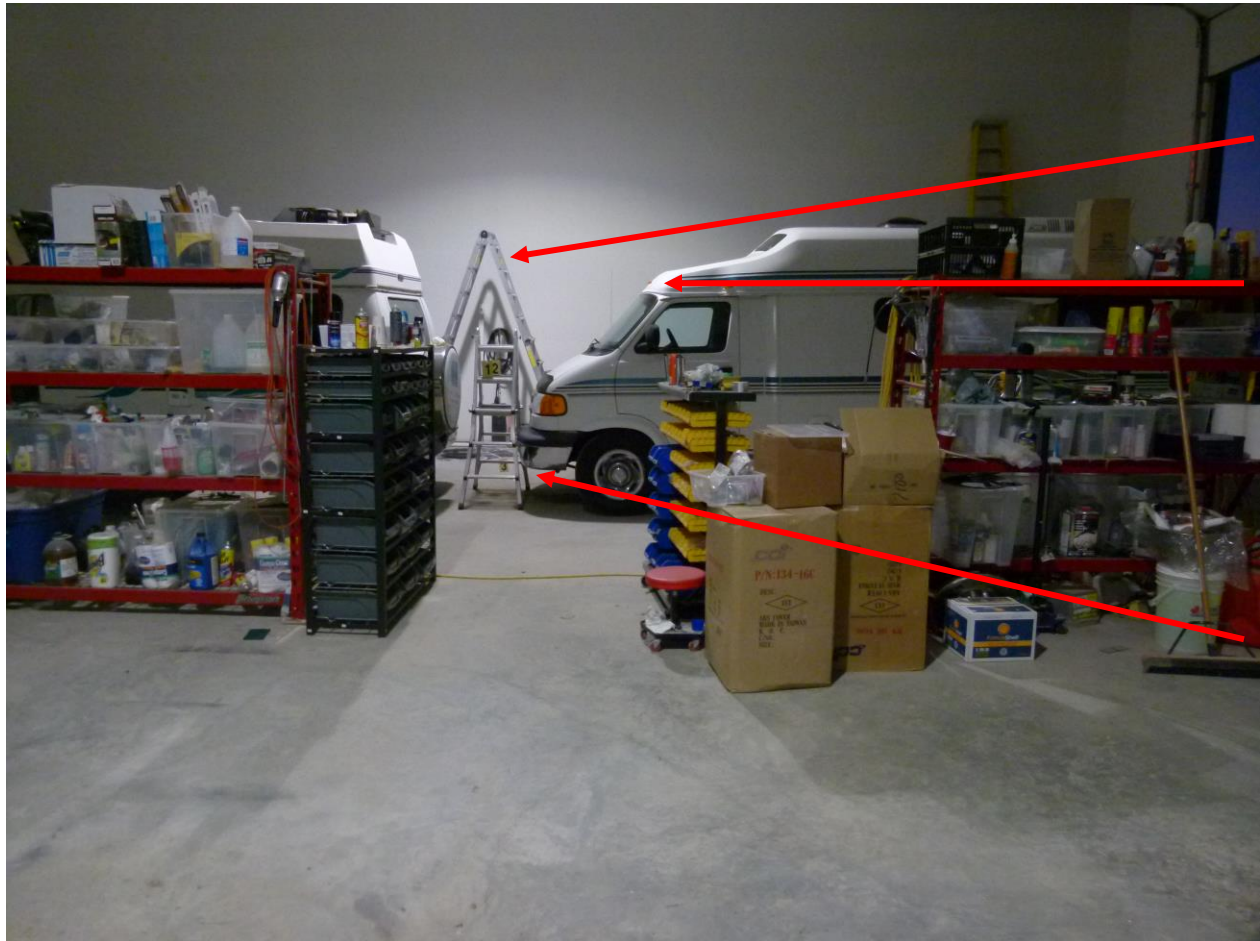
Photograph 2 – Shows the incident scene looking west.

1. Shows the taller ladder that was available.
2. Shows the clearance lights of the van Worker 1 (***** ***) was working on.
3. Shows the ladder Worker 1 (***** ***) was working from.

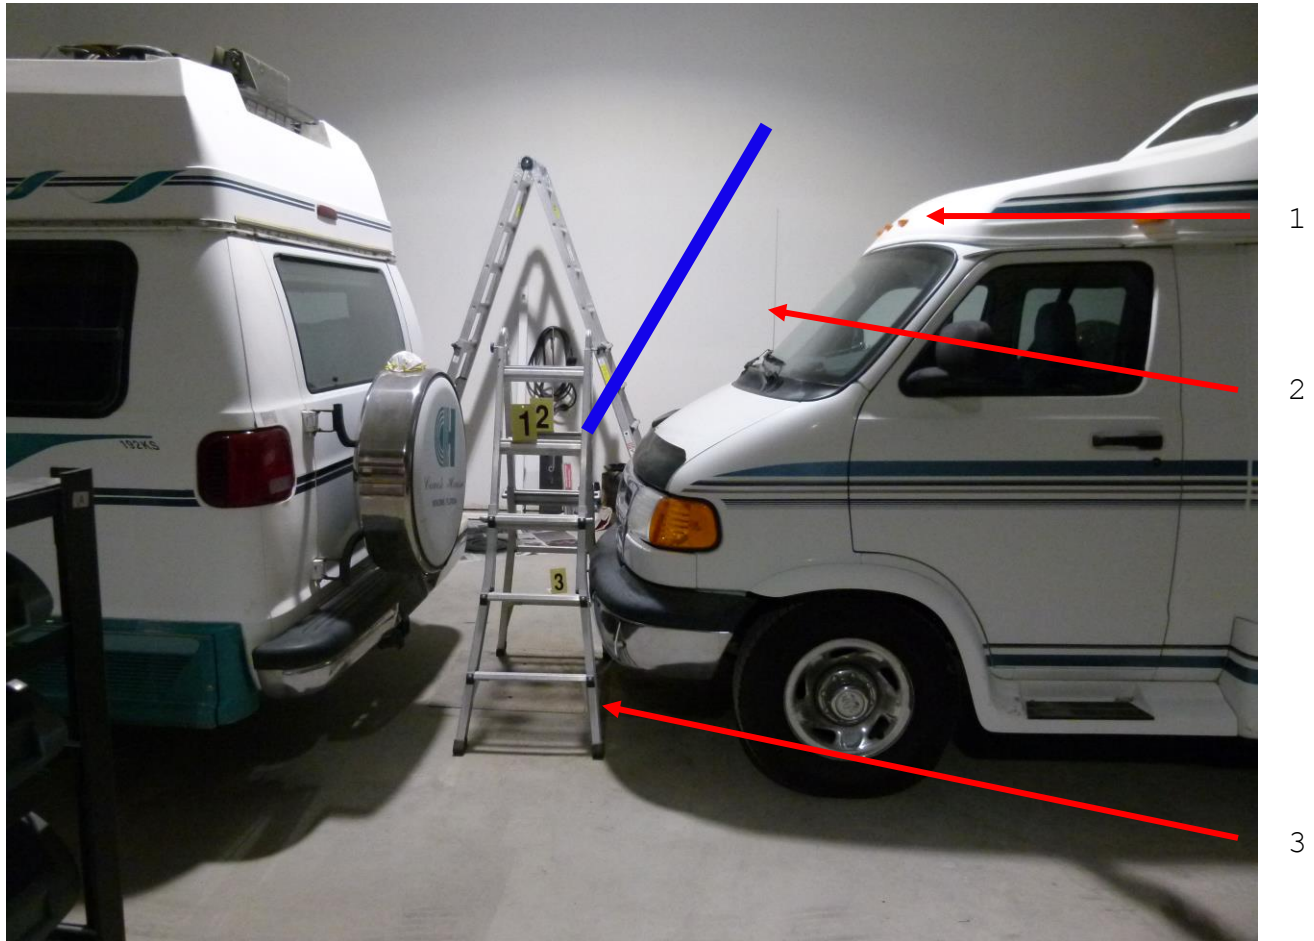
Photograph 3 – Shows the incident scene looking west. Markers 1 and 2 show the reported location of Worker 1's (***** ***) feet.

1. Shows the clearance lights of the van Worker 1 (***** ***) was working on.
2. Shows the approximate angle Worker 1 (***** ***) would have been at.
3. Shows the ladder Worker 1 (***** ***) was working from.

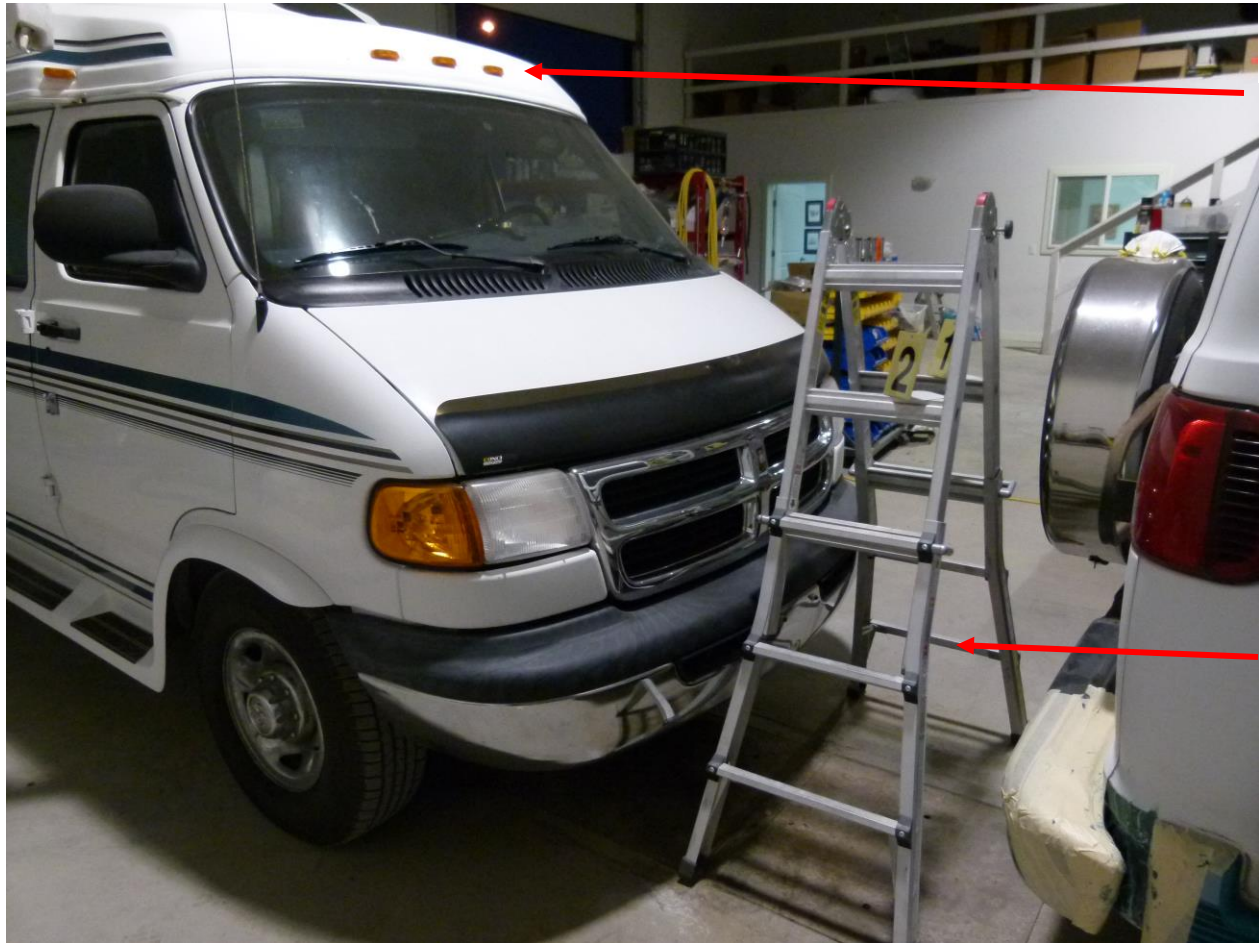
Photograph 4 – Shows the incident scene looking east/northeast. Markers 1 and 2 show the reported location of Worker 1’s (***** ***) feet.

1. Shows the clearance lights of the van Worker 1 (***** ***) was working on.
2. Shows the ladder Worker 1 (***** ***) was working from.

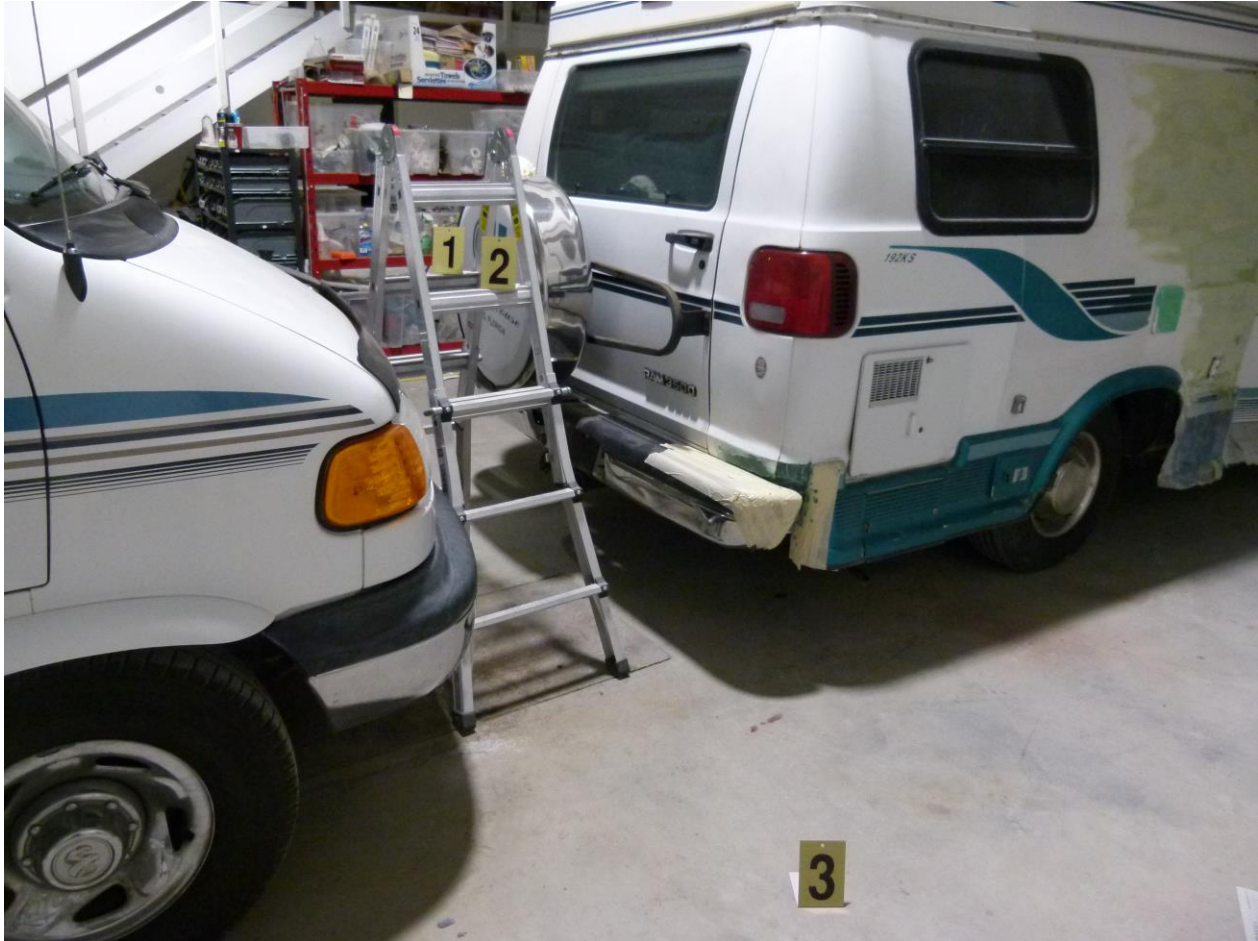
Photograph 5 – Shows the incident scene looking east/southeast. Markers 1 and 2 show the reported location of Worker 1’s (***** ***) feet. Marker 3 shows the approximate location where Worker 1 (***** ***) landed.
