Occupational Health and Safety

Fatality Report

Worker Crushed by Ice

Type of Incident: Fatality

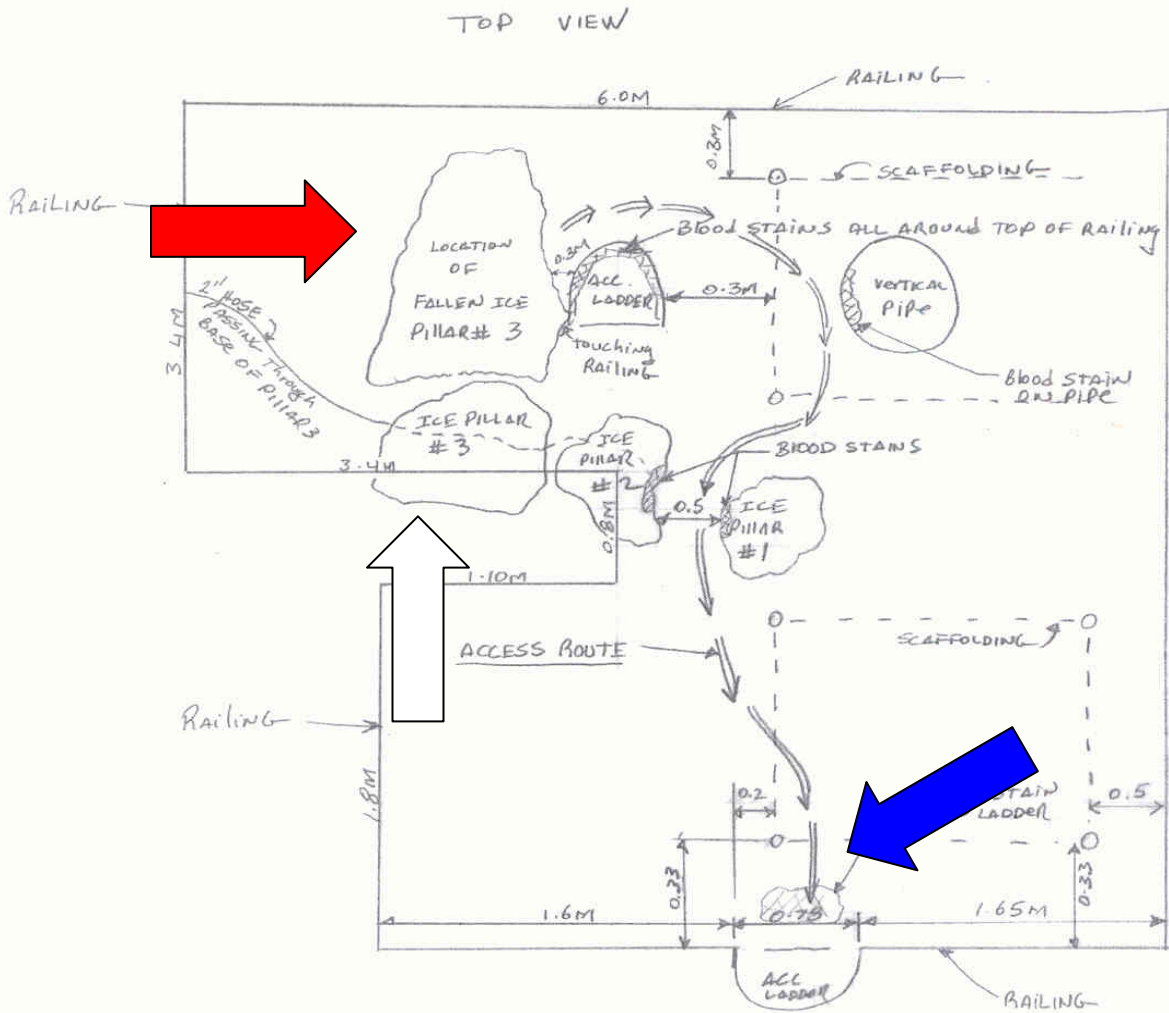
- 5.2.1 Initial examination of the site revealed a blood trail leading from the location where the Process Operator [REDACTED] received his injuries to the location where he was found. (Attachment B – Diagram)
- 5.2.2 An Environment Canada weather report was obtained for Fort McMurray. On the morning of the incident the temperature varied from minus 31.7 degrees Celsius at 6:00 a.m. to minus 28.9 degrees Celsius at 11:00 a.m.

White arrow shows the ice mass location before it fell. Red arrow shows the ice mass location after it fell. Blue arrow shows the location of the Process Operator when he was found.

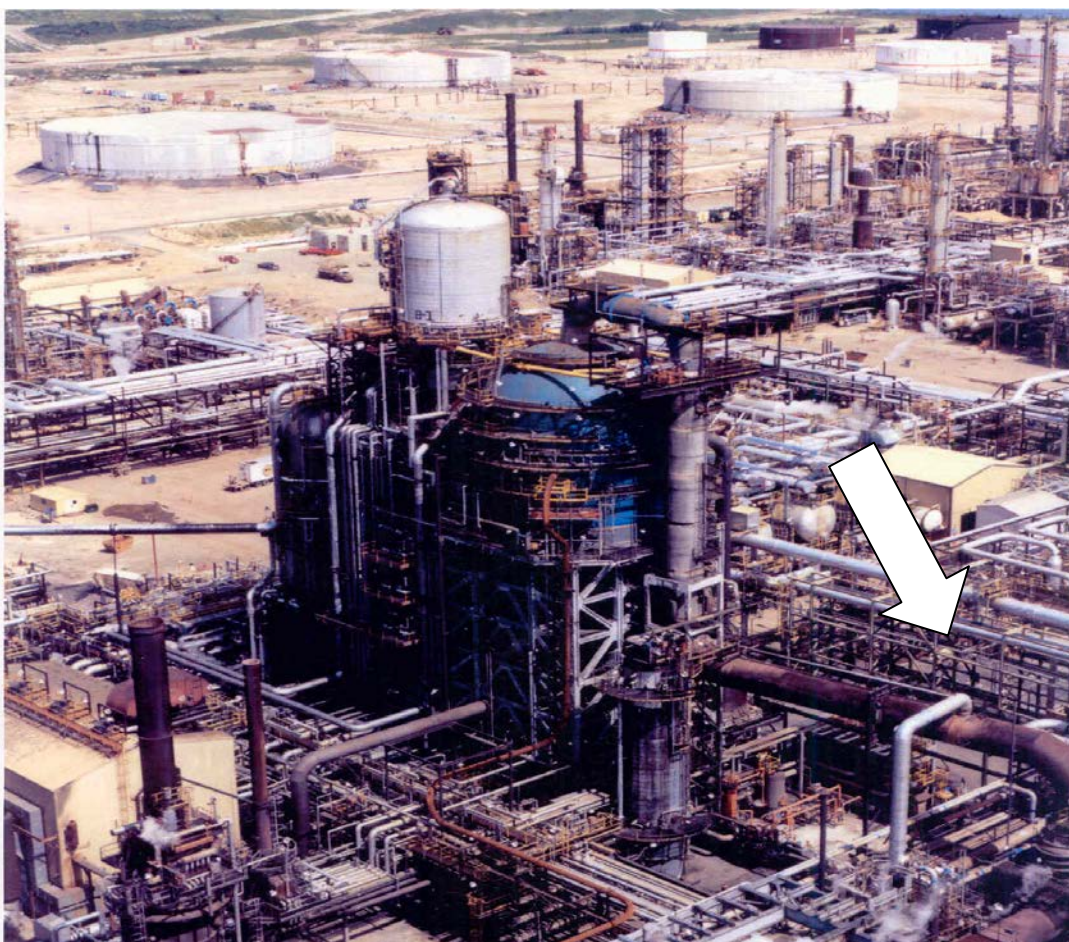
- 5.1.2.1 The 8.0 pipe rack is a steel framework containing pipes carrying tail-gases into the coker. (Attachment C – Photographs #1, #2).

Photograph #1 Shows an aerial view of the 8.1 Coker at the Syncrude Canada Ltd. Midred Lake facility. Arrow indicates the location of the 8.0 pipe rack.

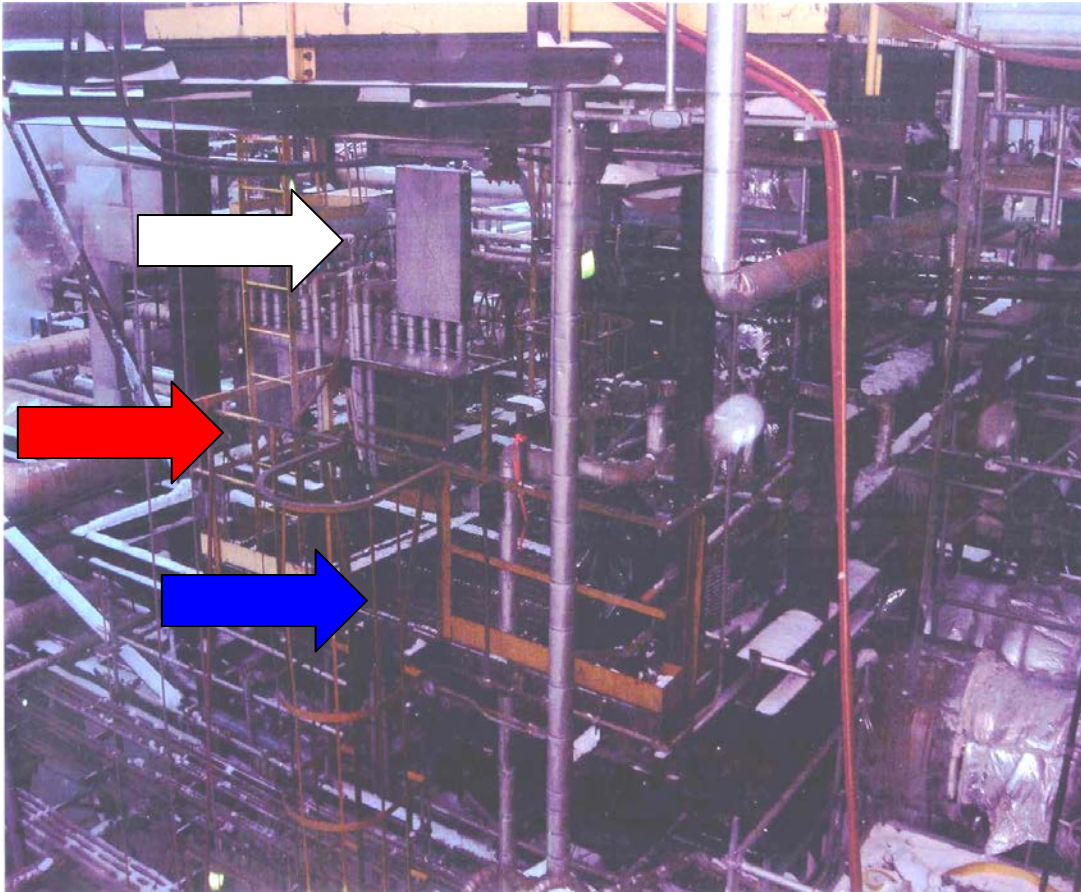
Photograph #2

7.2.1 Steam had been leaking from a tracer line on a tail gas pipe, causing a large pillar of ice to grow from the platform level underneath the leak. The ice had originally extended from the platform level, encasing the railing and over the manifold box, a total height of approximately 2.7 m. The evidence indicated that the Process Operator [REDACTED] had been melting the ice from the bottom. The ice mass had eventually become unstable, rotating around the railing and striking the Process Operator [REDACTED] as it fell.

Shows a view of the incident location. The white arrow indicates the manifold box, and the red arrow indicates the railing that the ice mass had been covering before it fell. The blue arrow indicates the platform level that the Process Operator was standing on when the incident occurred.

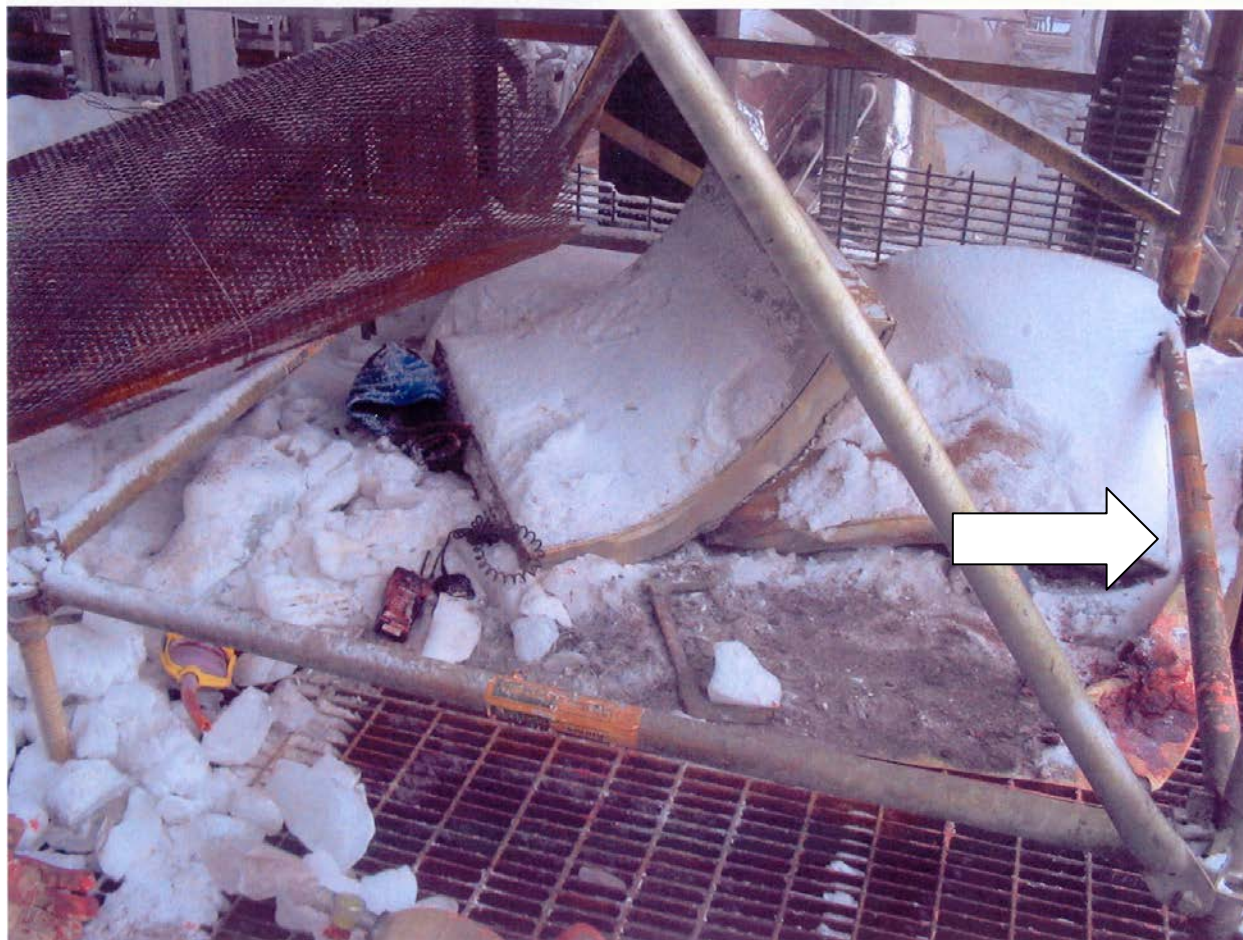
Photograph #3 Shows the staging where the Process Operator was found, The Process Operator's legs were under the scaffold member shown by the arrow, with his feet protruding over an access ladder.

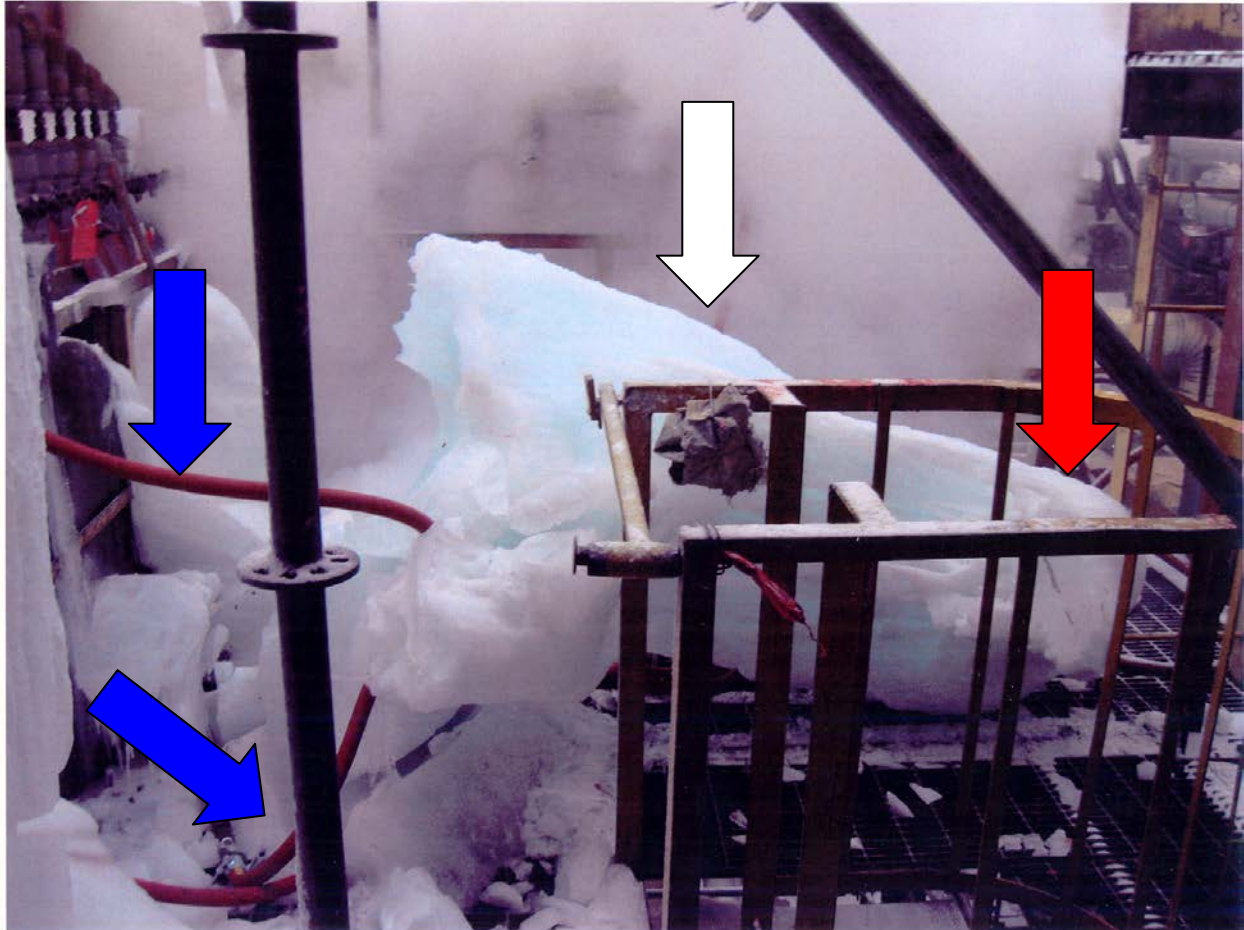
7.1.1 The Process Operator [REDACTED] had been melting a large mass of ice from a work platform. The Process Operator [REDACTED] had melted the ice from the bottom, causing the remaining ice to become unstable. The ice fell and rotated as it fell, striking the Process Operator [REDACTED], or crushing him against adjacent metal railings and pipework, and caused injuries that proved to be fatal. The weight of the ice mass, based on volume, was estimated to be between 1200 lbs (545 kg) and 1600 lbs (727 kg). The Process Operator [REDACTED] had moved towards an access ladder after the incident, where he collapsed and was found.

7.2.2 The Process Operator [REDACTED] had started to melt the ice mass on the previous day. Steam lances had been left on in the ice mass overnight. Ice would have been melting from the base of the ice mass and still accumulating at the top of the ice mass. It is likely that the ice mass had become less stable overnight.

Photograph #4 Shows the platform where the incident occurred. The mass of ice that fell is laying on the platform. White arrow indicates the ice mass. Red arrow indicates the fixed access ladder.. Blue arrows indicate steam pipes attached to lances placed to melt the ice.

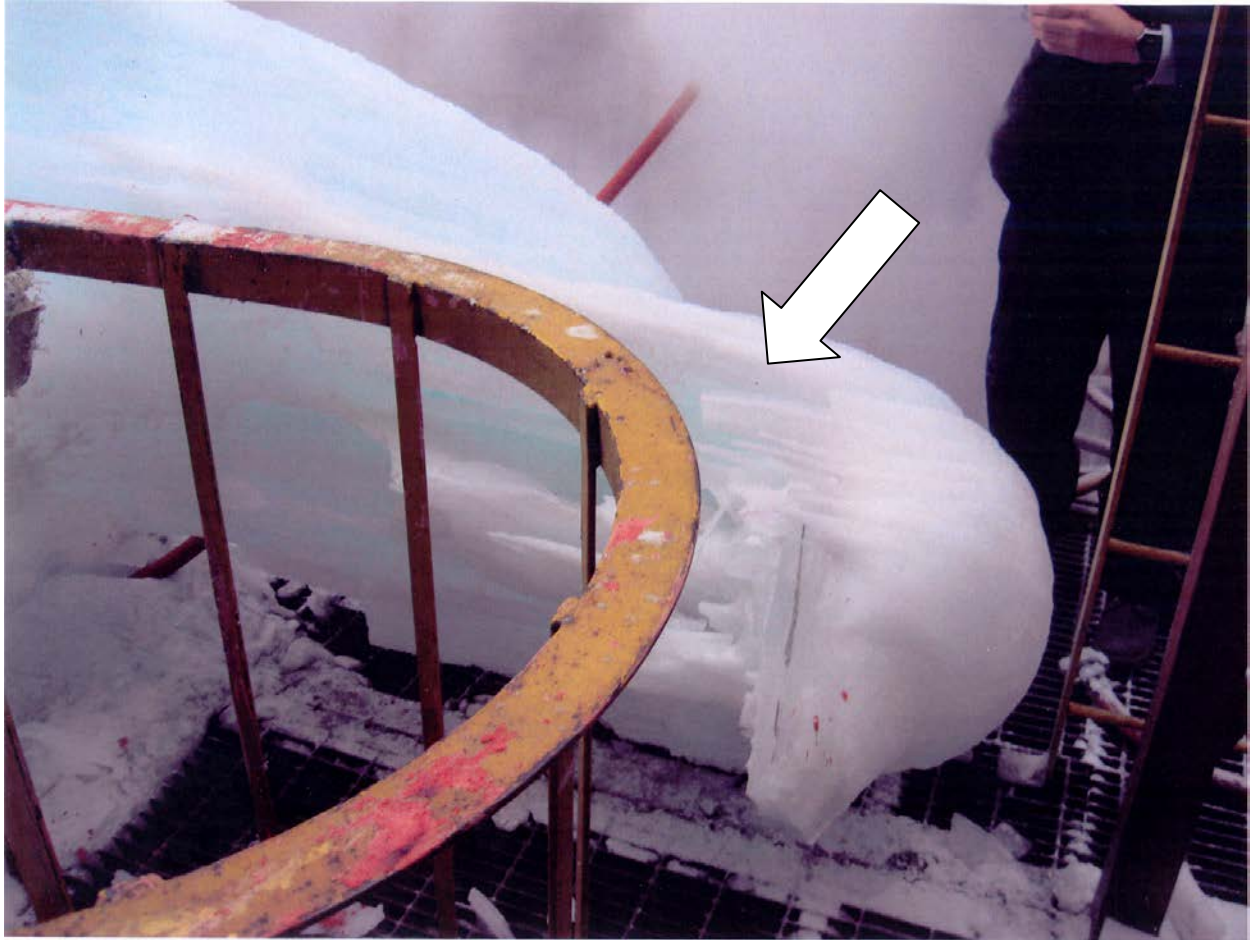
Photograph #5 Shows the top end of the ice mass. Arrow indicates the shape of the manifold box that the ice had formed around before it fell.

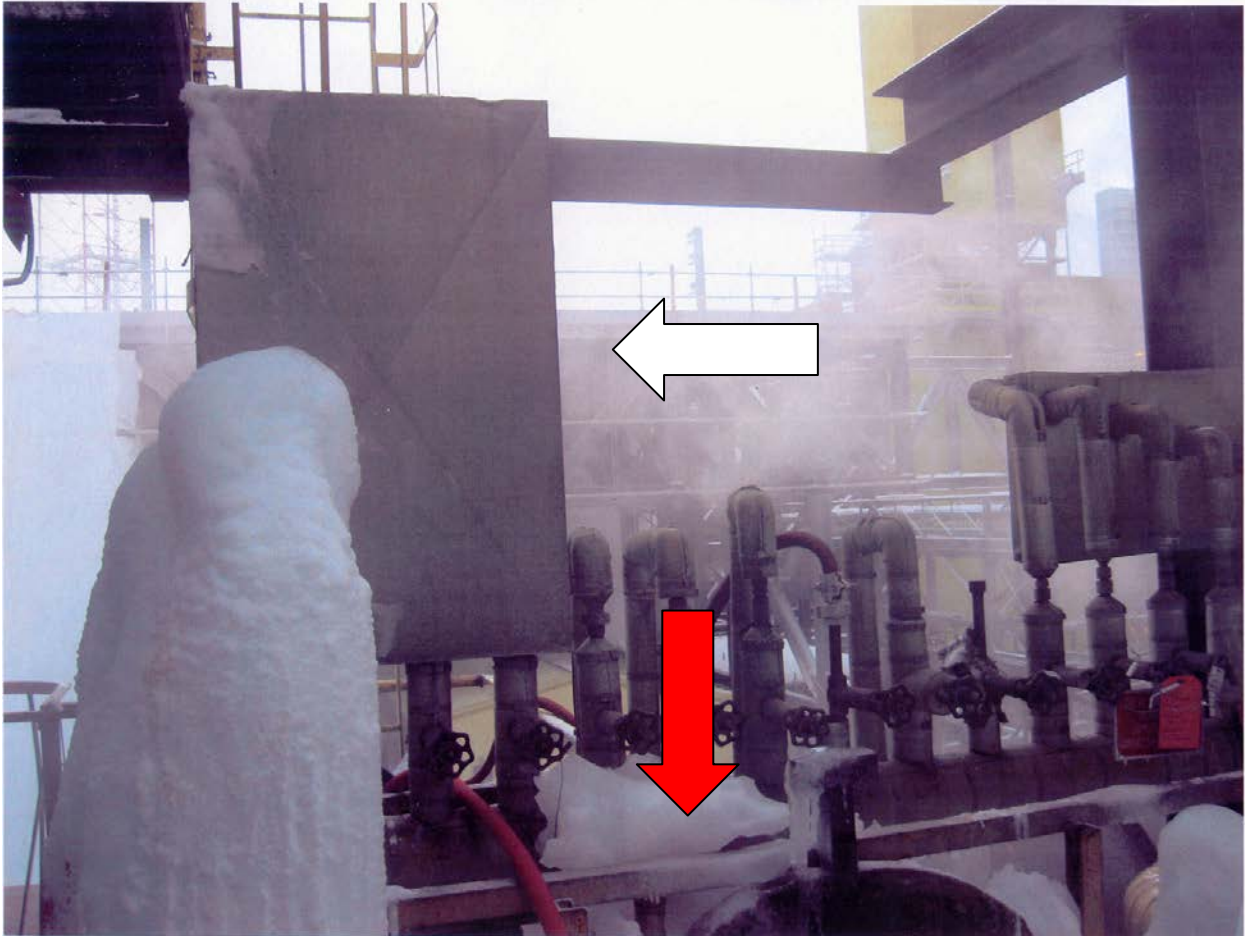
Photograph #6 Shows the location of the ice mass before it fell. White arrow indicates the manifold box. Red arrow indicates the railing.

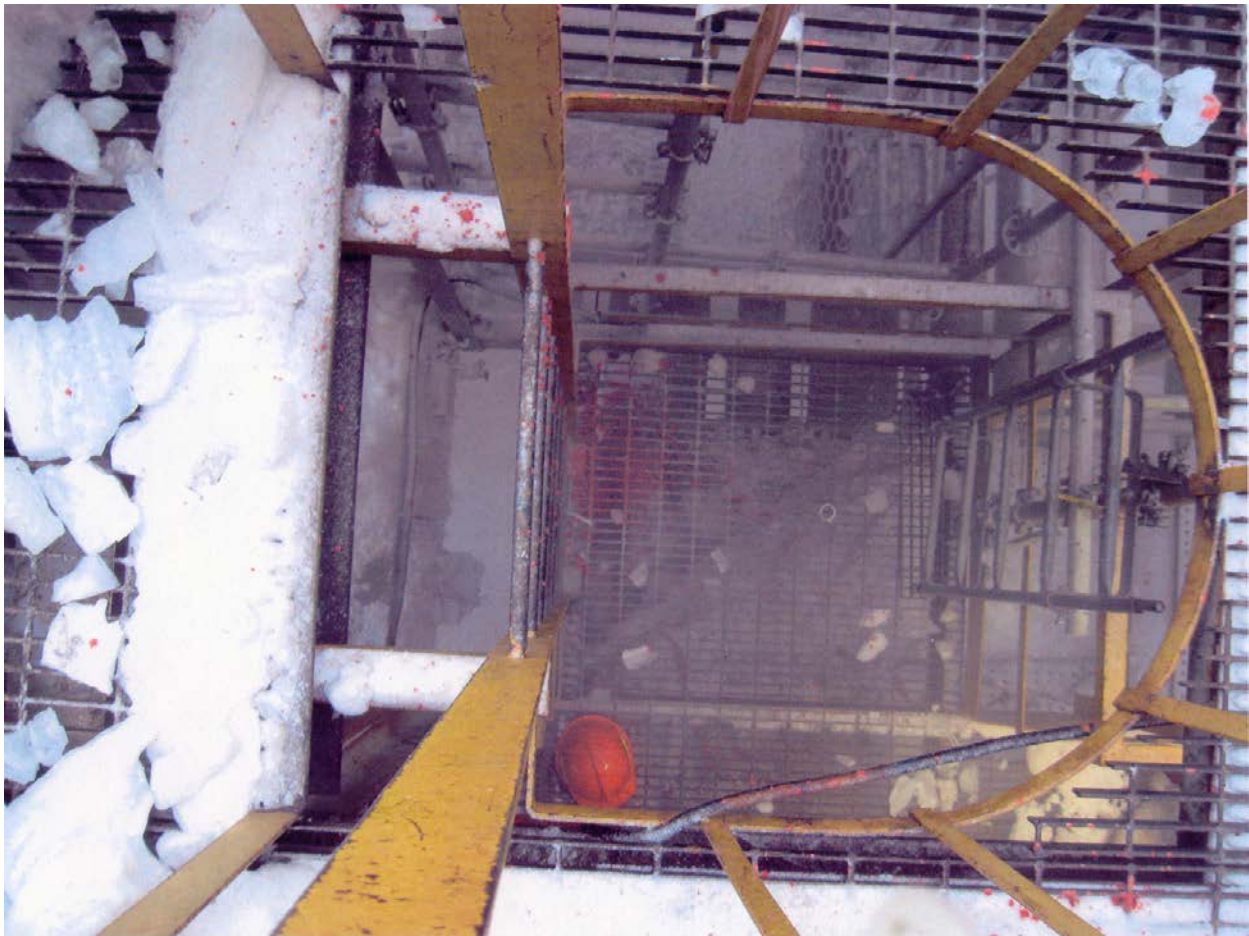
Photograph # 7 Shows the Process Operator's hard hat on a lower work platform approximately 3 m below the platform where the incident occurred.
