# **Worker fatally injured when run over by rail car**

January 10, 2020

This document reports the Alberta Occupational Health and Safety (OHS) investigation of a fatal incident that occurred in January 2020. It begins with a short summary of what happened. The rest of the report covers this same information in greater detail.

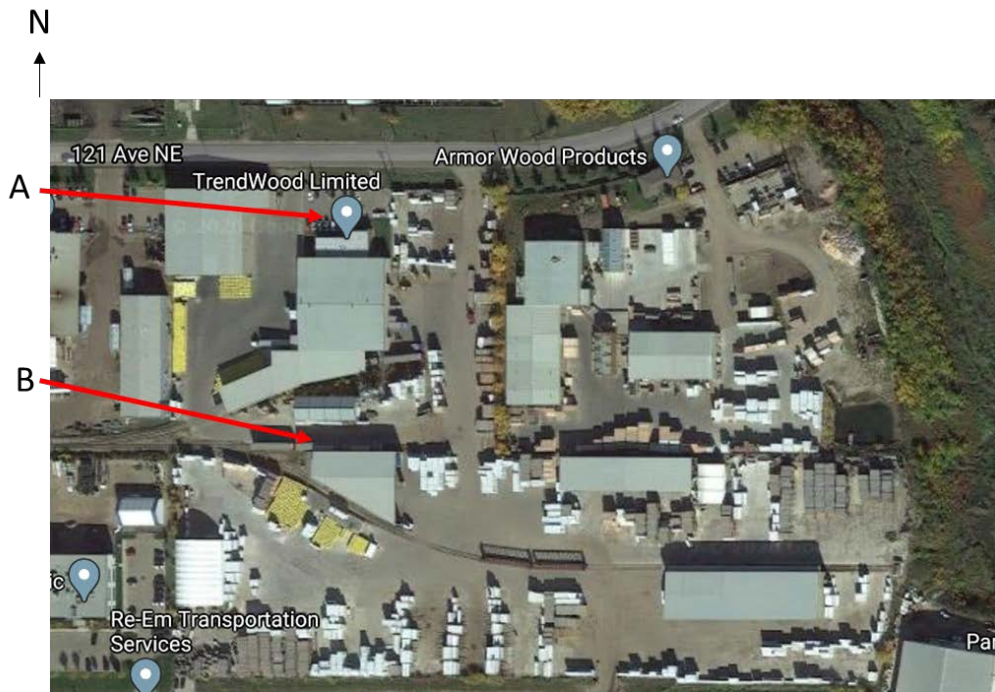
Figure 1. Overview of Trendwood work site:

- A. Front office
- B. Incident location

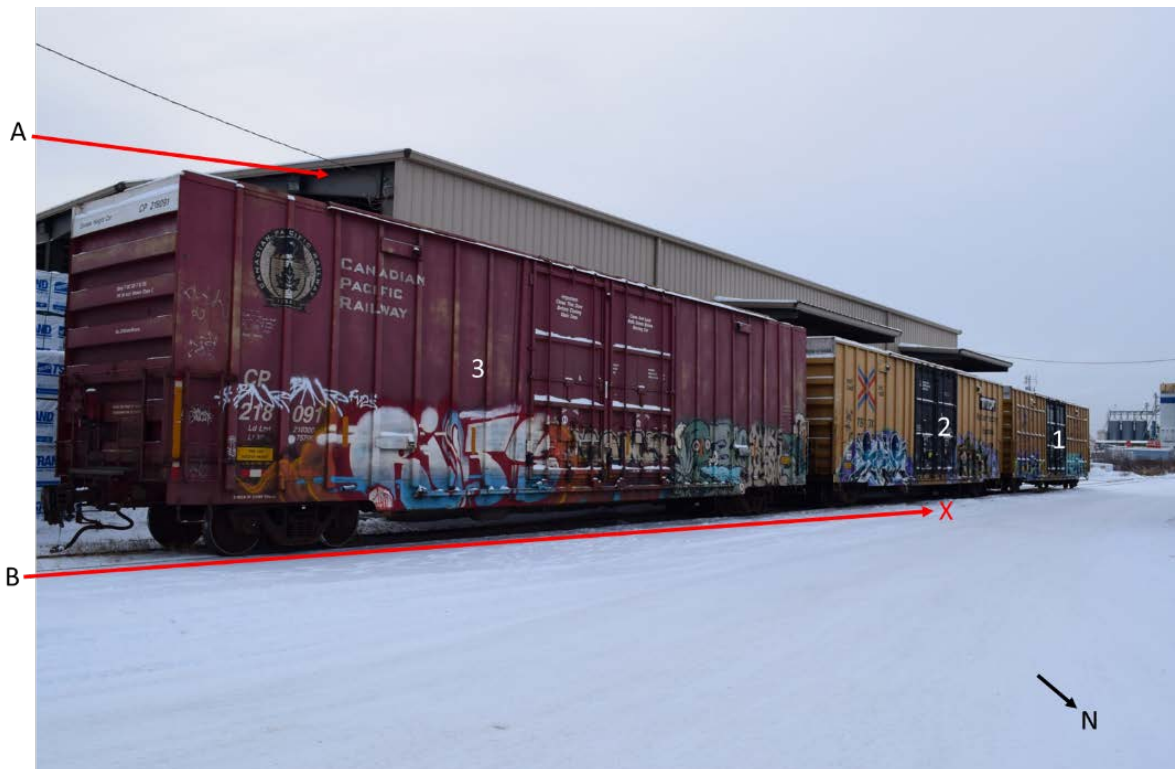
Figure 2. Long shot facing southwest.

A. Warehouse

B. Area where the Operator 1 was found and pulled out from beneath the rail car by co-workers

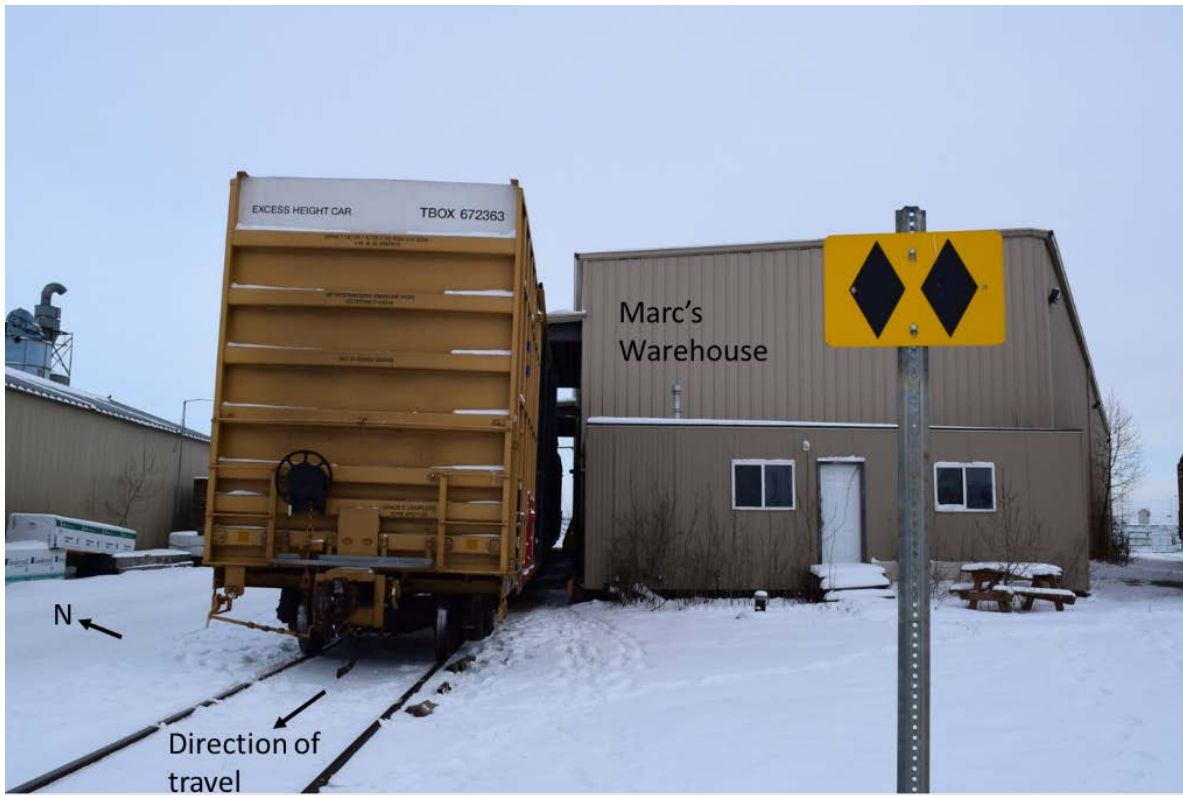
Figure 3. Long shot facing east of rail car 1 and warehouse.

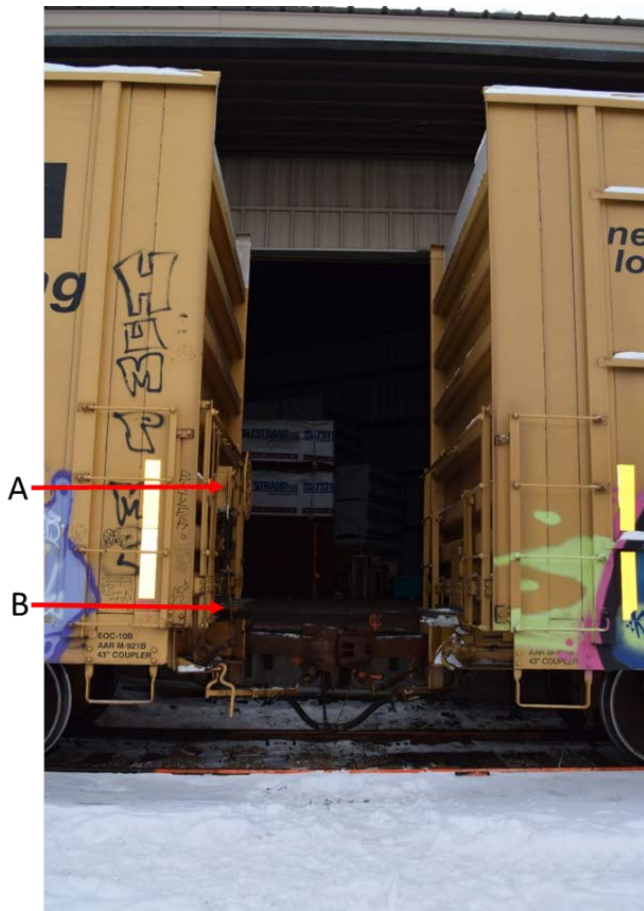
Figure 4. Work area – rail cars 1 and 2.

A) The brake wheel

B) The work platform Operator 1 would have been standing on prior to the incident

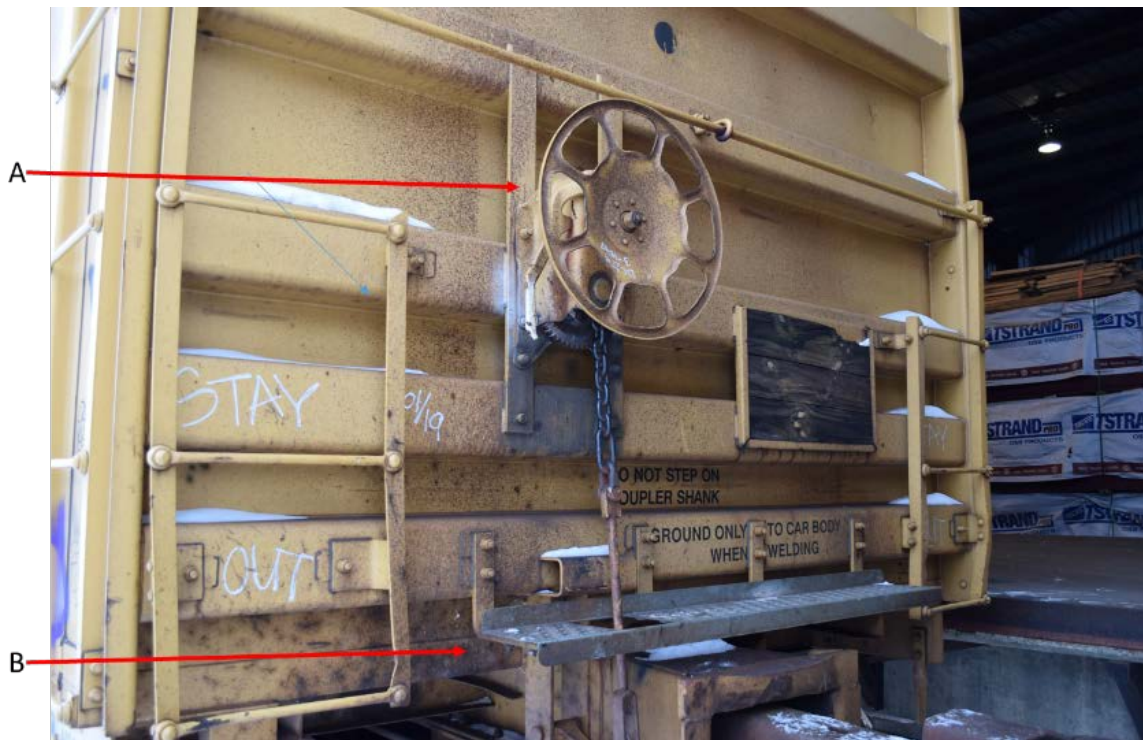
Figure 5. Rail car 2 work area.

- A) Brake wheel
- B) Platform

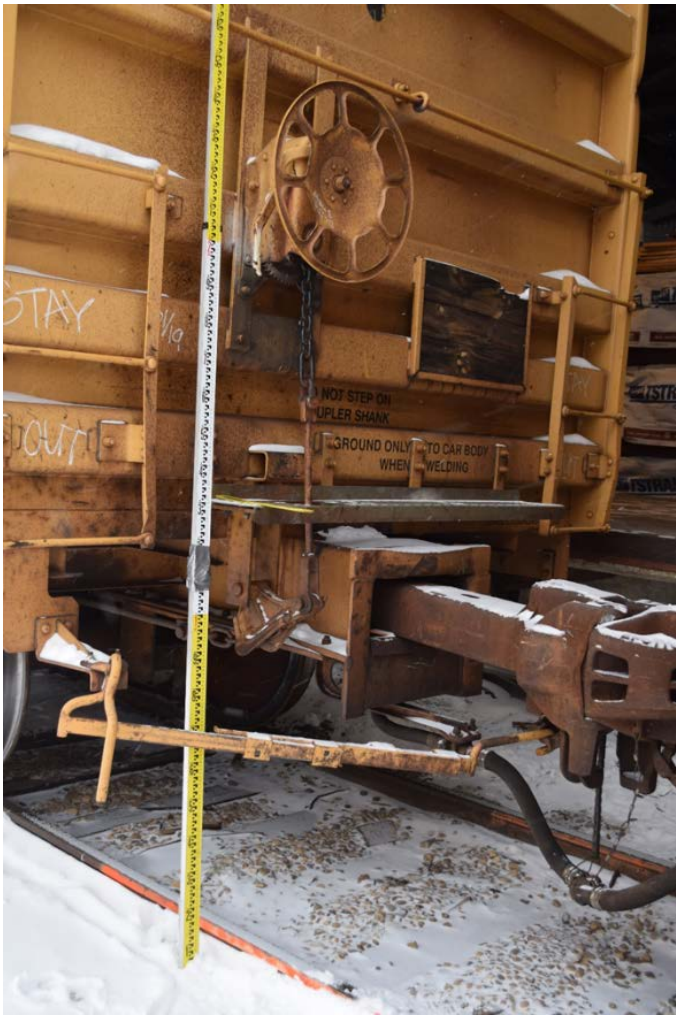
*Figure 6. Work area of rail car 2 with scale. Each section of the survey measurement stick indicates 1 metre. The platform measured 1.3 metres from the ground.*

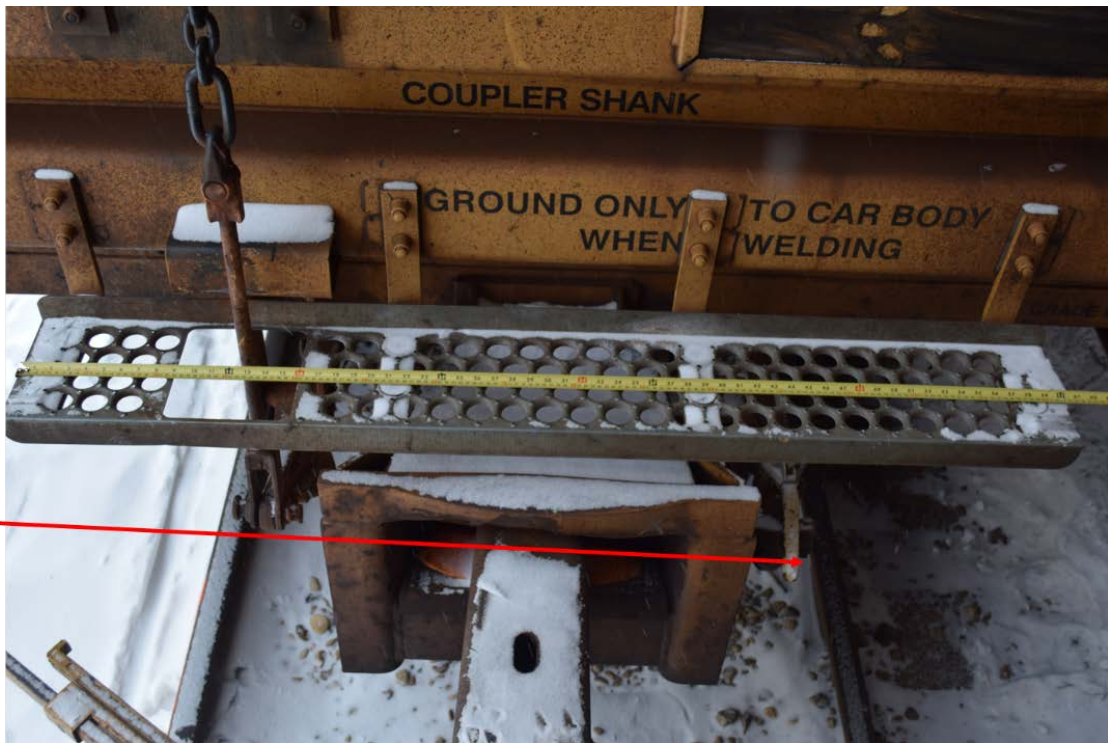
Figure 7. Mid-shot of the 1.63 metre worker platform on rail car 2.  
A. Rail the Operator fell on.

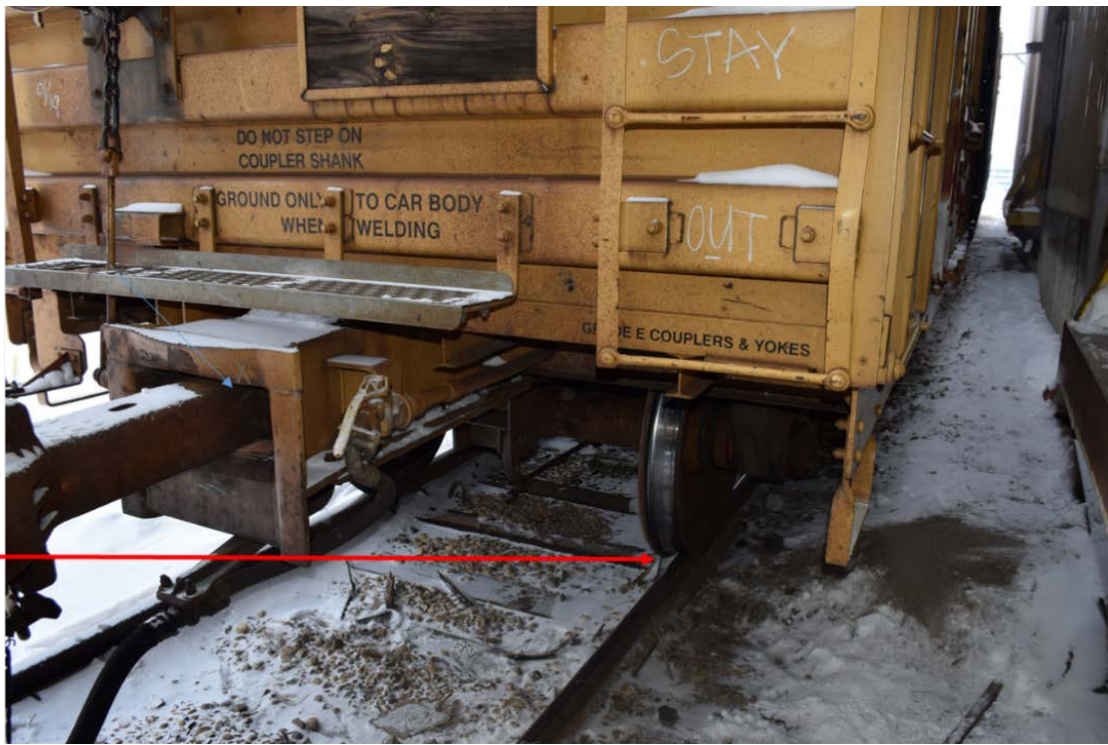
Figure 8. Rail car 2

A. Rail and wheels that ran over Operator 1.

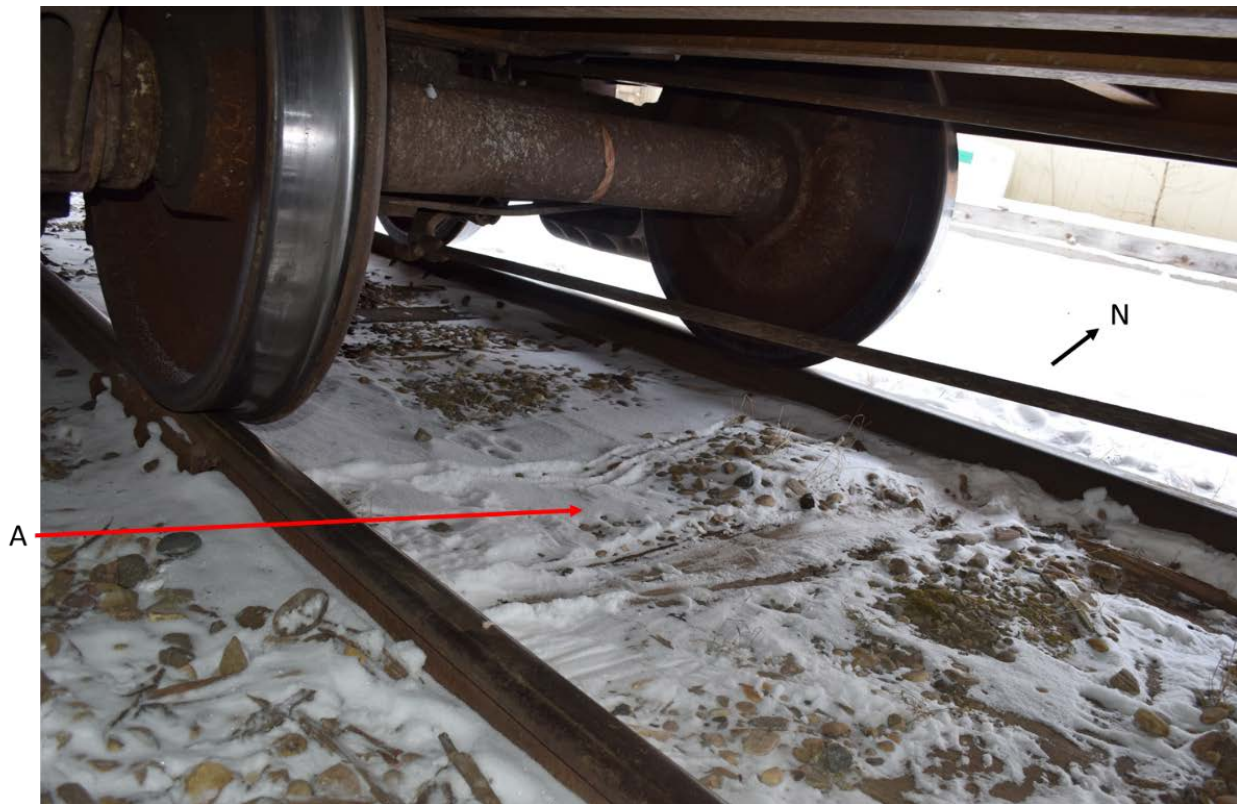
Figure 9. Area where Operator 1 was found by co-workers below rail car 2.

A. Markings in the snow indicated the worker was dragged out from beneath the rail car in a northward direction.

Operator 3 returned to the rail cars 1- 3 approaching from the north and looked under the cars. Operator 3 found Operator 1 unconscious underneath rail car 2. Operator 1 was found in a supine position with their head pointing north and their torso laying over the south rail.
