WORKER CRUSHED IN CONVEYOR

Type of Incident: Fatality

Date of Incident: December 6, 2012

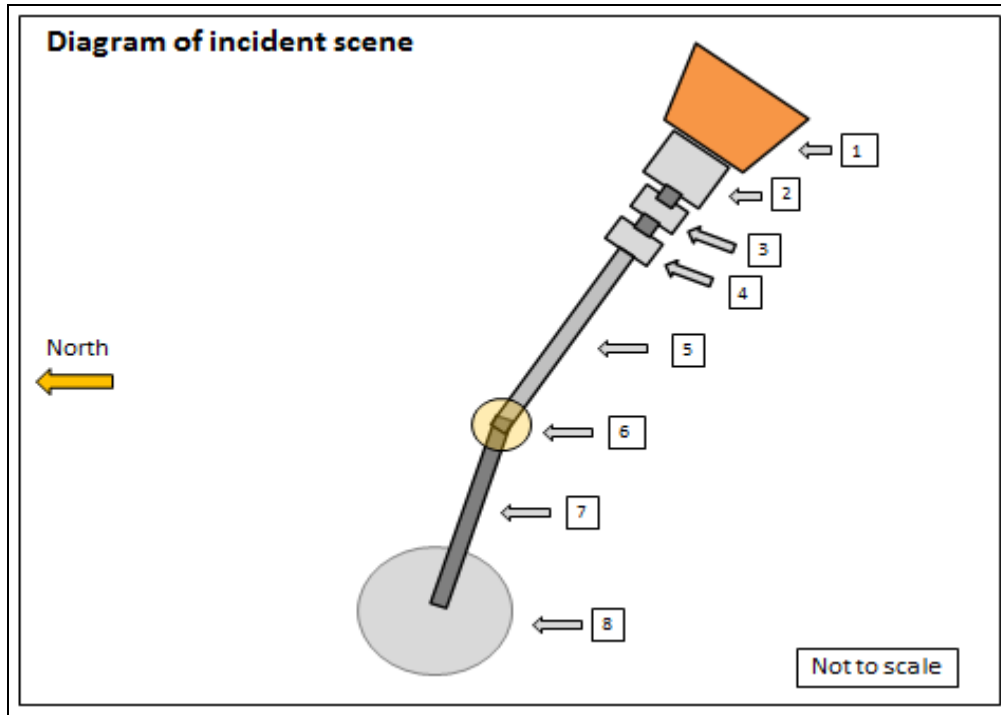
Attachment B – Scene Diagram

1. Dump area
2. Dump hopper
3. Vibrating grizzly feeder
4. Impactor
5. Conveyor 88
6. Incident scene
7. Conveyor 25/26
8. Surge pile

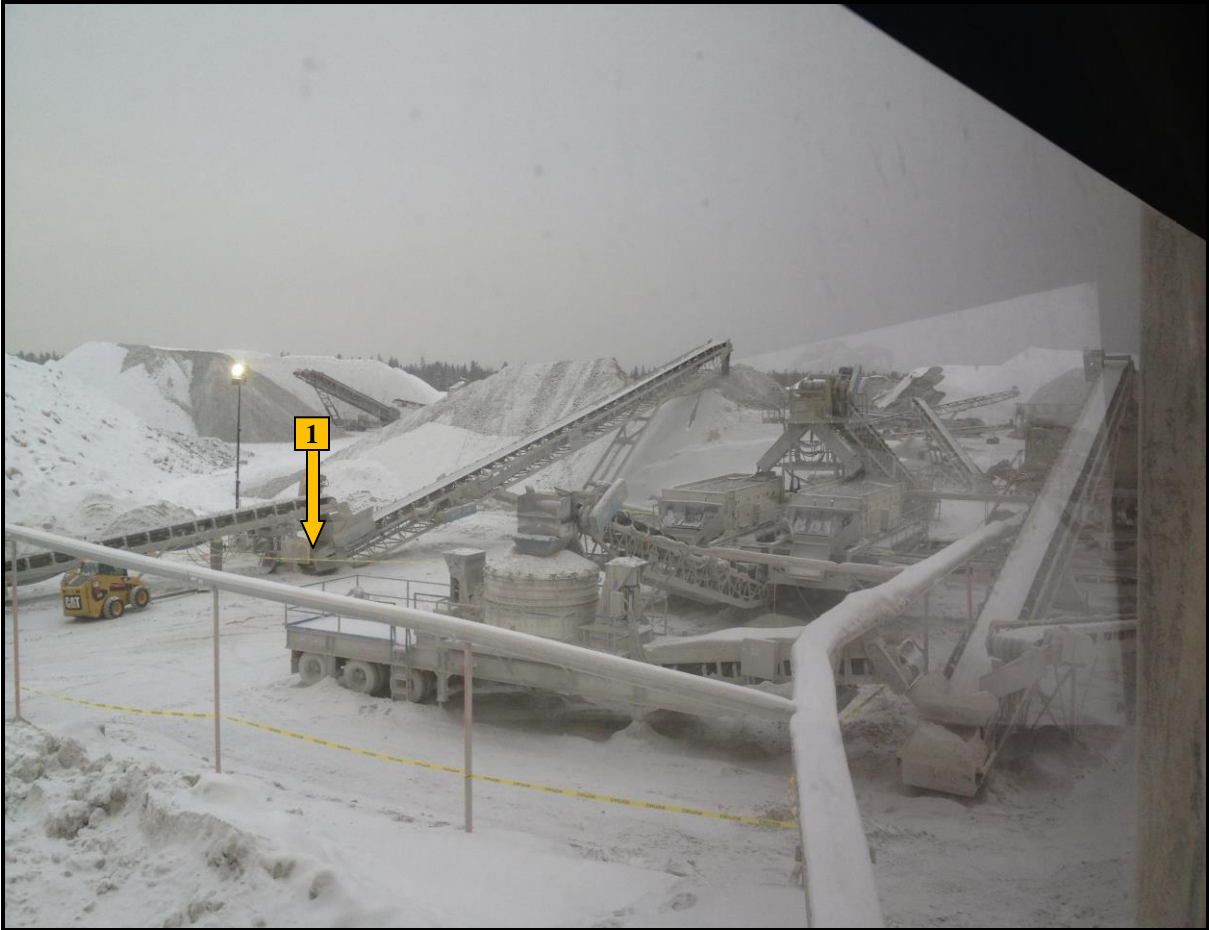
Photograph #4 (picture provided by Hammerstone Corporation)

- 6.1 On December 6, 2012 at 6:00 a.m. the Lead Crusher Hand (***** *) commenced his regular dayshift at the Muskeg Valley Quarry. The Lead Crusher Hand (***** *) was working as part of the Andreas ground crew for the balance of the shift. The ground crew is responsible for monitoring the operation of the crushing system, including the conveyors, secondary and tertiary crushers, screeners and stackers and to communicate with the tower operator who is also monitoring the Andreas crushing system.
- 6.2 In the afternoon of December 6, 2012 shortly before 3:25 p.m., the Lead Crusher hand (***** *) was observed by the Tower Operator (**** *) to be performing cleaning activities underneath conveyor 88 adjacent to, and immediately east of, the belt gravity take-up mechanism. The conveyor was

operational at the time (Attachment C, Photograph #4).

This is a photograph facing southwest of the Andreas Crushing Spread from the control tower. This is the view the tower operator had at the time of the incident.

1. Incident scene

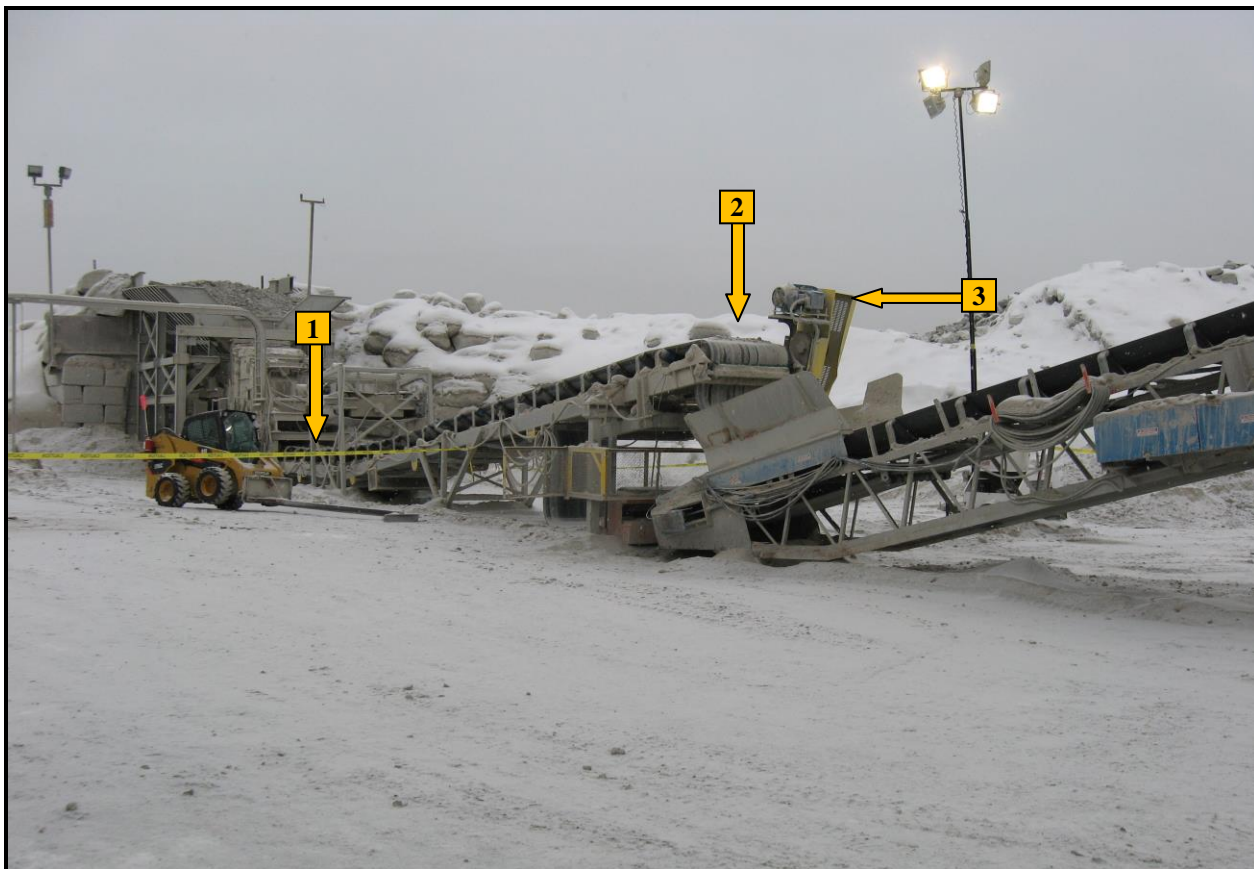
Photograph #5

1. Incident scene
2. Head pulley
3. 60 Horsepower electric motor

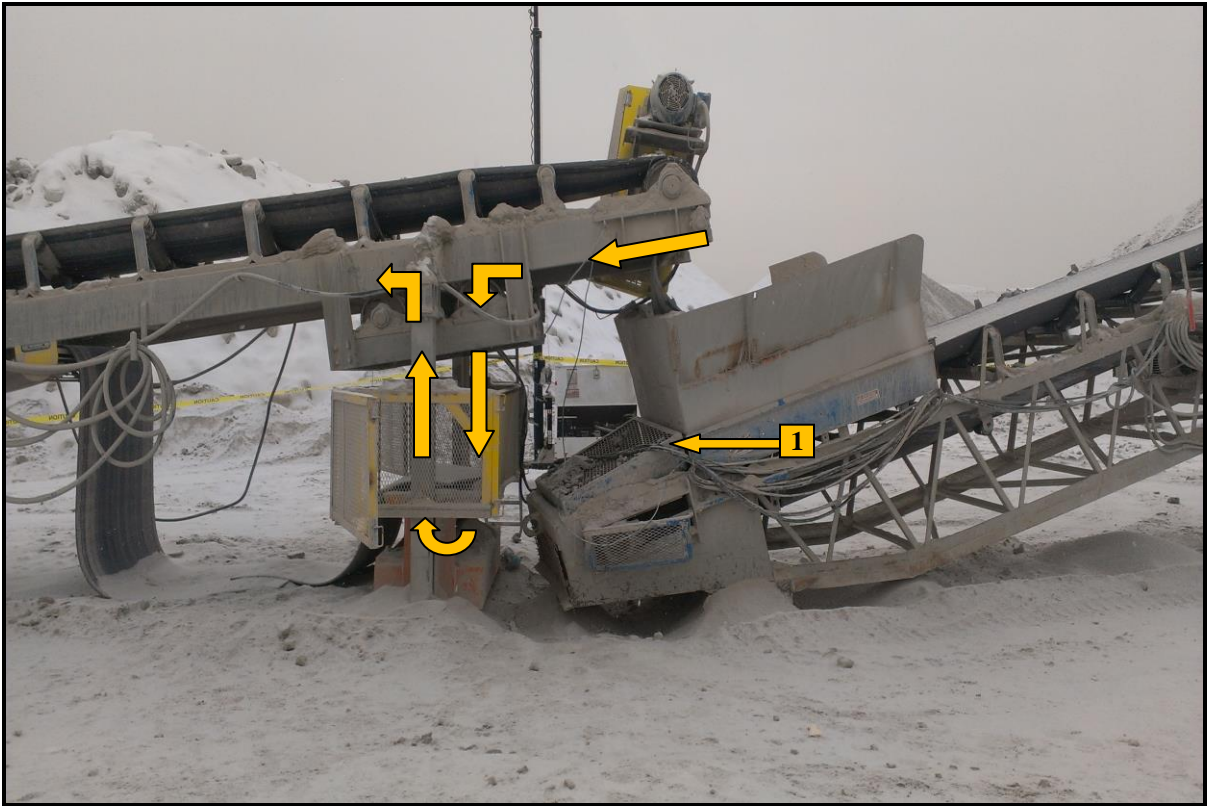
Photograph #6

5.1.3.2 Approximately 2 m from the head pulley on the return belt, there is a belt gravity tower take-up mechanism comprised of two bend pulleys which bend the bottom belt down towards a single, lower gravity tower pulley (these are commonly referred to as S-rollers by crushing personnel). The lower gravity tower pulley floats on a frame and is weighted with concrete and steel which enables it to keep tension on the belt itself. Proper tension on the conveyor belt is critical for conveyor drive purposes (Attachment C, Photograph #6).

- 5.2.2 The Occupational Health and Safety investigators observed two conveyors (conveyor 88 and conveyor 25/26) which were not operational and confirmed to be locked out. Conveyor 88 ran from a hopper towards the tail end of conveyor 25/26 which then fed an adjacent stockpile. Near the head pulley of conveyor 88, there were two rollers (pulleys) separated by a horizontal structural steel beam. Directly below these two rollers, there was a third pulley with a partially removed steel mesh guard. The conveyor belt had been cut adjacent to these pulleys and the resulting two sections of belt were lying on the ground underneath conveyor 88 (Attachment C, Photograph # 6).

- 5.2.4 The tail pulley guard of conveyor 25/26 was located underneath the head pulley of conveyor 88. Standing on the tail pulley of conveyor 25/26 provided easy access to the roller where the hard hat and steel bar were trapped (Attachment C, Photograph #6).

1. Tail pulley guard of conveyor 25/26

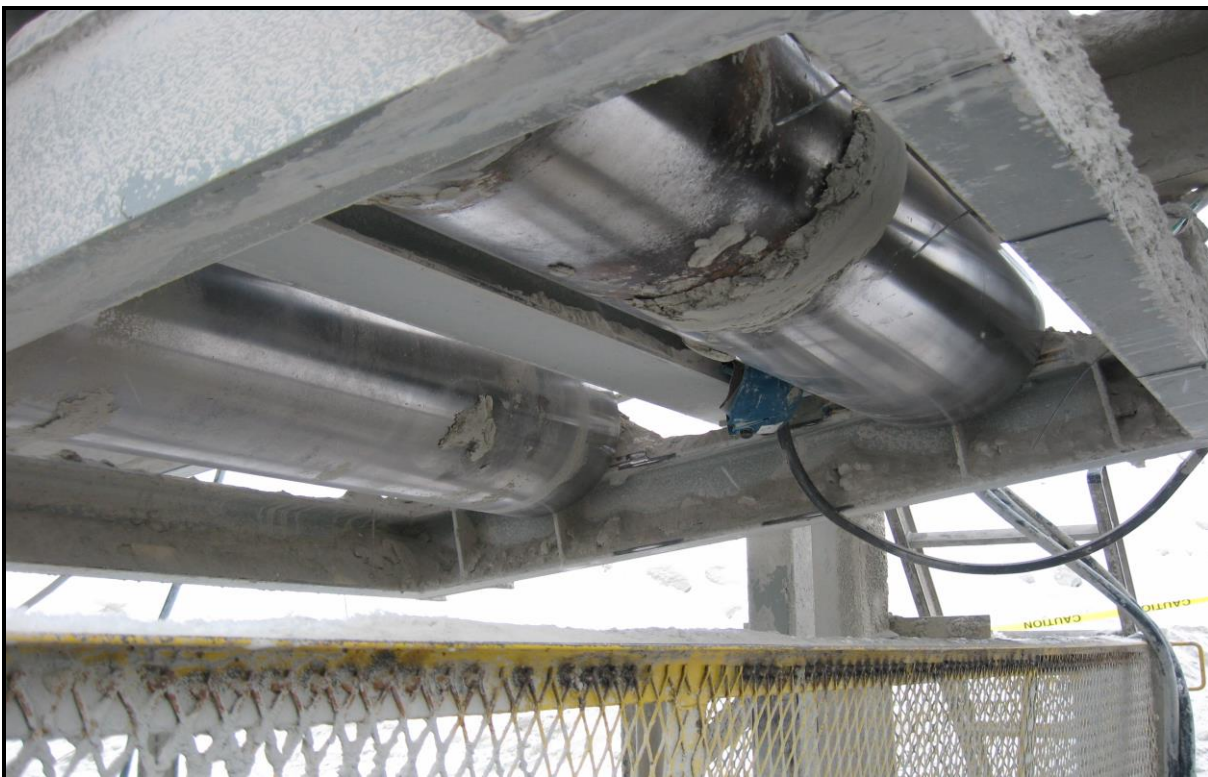
Photograph # 7

5.1.3.4 Occasionally, pulleys on the conveyor belt can become coated with limestone mud which, if left to build up, causes shaking and disruption of proper conveyor belt operation. Hammerstone crusher hands routinely use a shovel or steel metal bar known as keystick to clean the debris off pulleys (Attachment C, Photograph #7). The conveyor is de-energized and locked out prior to performing any maintenance activity.

- 5.2.3 A blue hard hat was observed to be trapped between the western pulley and the structural steel beam. The hard hat was broken in several places. Adjacent to the hard hat, a bend steel rod was observed protruding from the bottom of the pulley resulting in a semi-circular shape. A build-up of limestone mud was observed on the rollers (Attachment C, Photograph #7).

- 6.3 The Tower Operator (***) observed the Lead Crusher Hand (*****) cleaning built-up limestone mud off the roller on the east end of the belt gravity take-up with a metal bar (Attachment C, Photograph #7). The Lead Crusher Hand (*****) continued to clean the roller in this manner for a short period of time, then proceeded behind the belt gravity take-up mechanism on the south side of conveyor 88. At this point, the Lead Crusher Hand (*****) was not within the line of sight of the Tower Operator (***) .

This is a photograph underneath the bend pulleys. Note the broken, blue hard hat lodged between the bend pulley and the frame as well as the bent piece of steel bar known as keystone. Also note the accumulation of limestone on the bend pulleys.
