WORKER FALLS FROM SCAFFOLD

Date of Incident: September 11, 2007

Type of Incident: Fatality

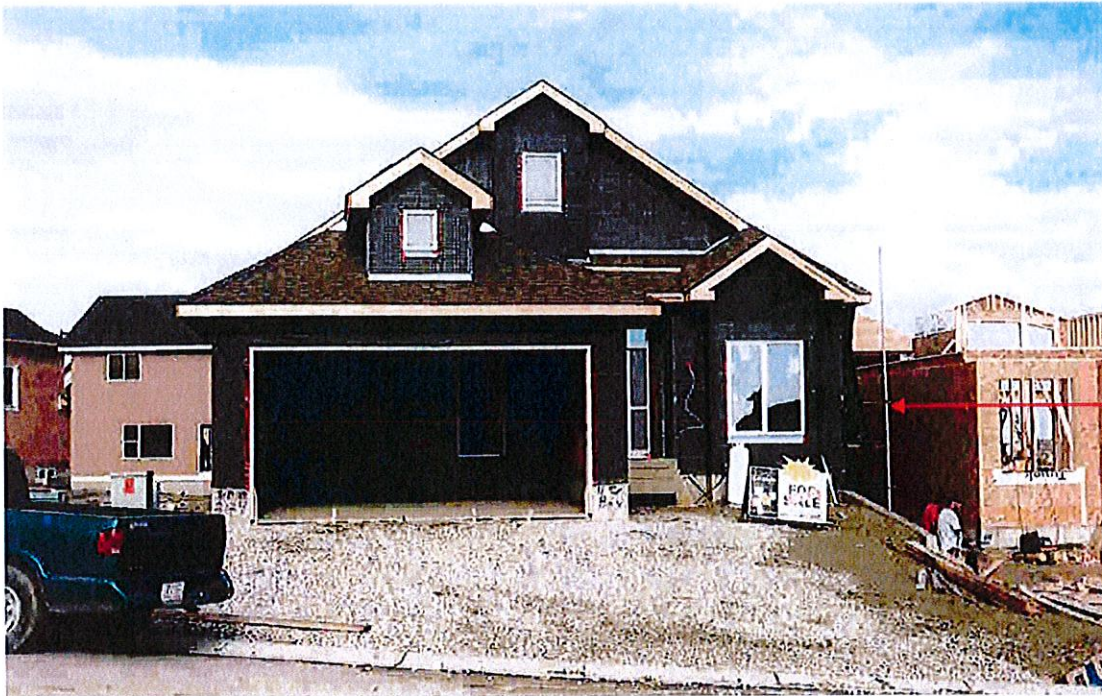
Photograph 1 – Shows the house located at 11 Cranridge Bay S.E., Calgary, Alberta where the incident occurred.

1. Shows the partially erected scaffold

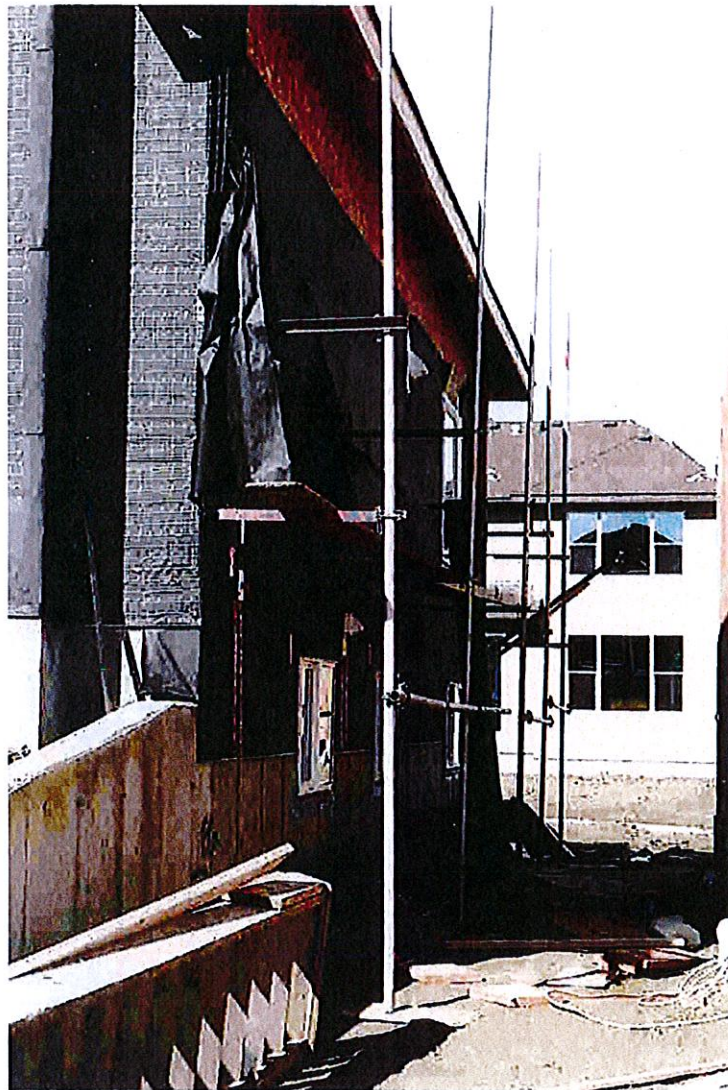
- 5.1.1 Equipment involved in the incident was a single pole metal scaffold erected by Worker 1 () and Worker 2 () of Westcan Stucco Wire Ltd. The main components of the scaffold were steel poles, base plates, clamps, iron wall tie-ins and scaffold planks (Refer to Attachment B – Photograph 2 and Attachment C – Diagram).
- 5.1.2 The scaffold poles were erected vertically between 3.1 and 4.5 meters apart with similar horizontal steel members fastened at approximately 1.5 meters above ground level. Iron wall tie-ins were fastened at heights of approximately 2.1 meters and 3.15 meters. A

laminated scaffold plank 3.6 meters long and 0.24 meters wide was placed across the second level iron wall tie-ins at a height of 3.15 meters. No method of securement was in place for the scaffold planks, which were installed individually on the iron wall tie-ins.

Photograph 2 – Shows a southeast view of the partially erected single pole scaffold.

- An order for Westcan Stucco Wire Ltd. to ensure scaffold is erected in accordance with CSA Standard CAN/CSA-S69.2-M87 (R1998), *Access Scaffolding for Construction Purposes*.

- An order for Westcan Stucco Wire Ltd. to ensure appropriate fall protection is in place when erecting scaffold.
- A stop use order on the single pole scaffold until workers have been adequately trained on the safe erection of scaffold.

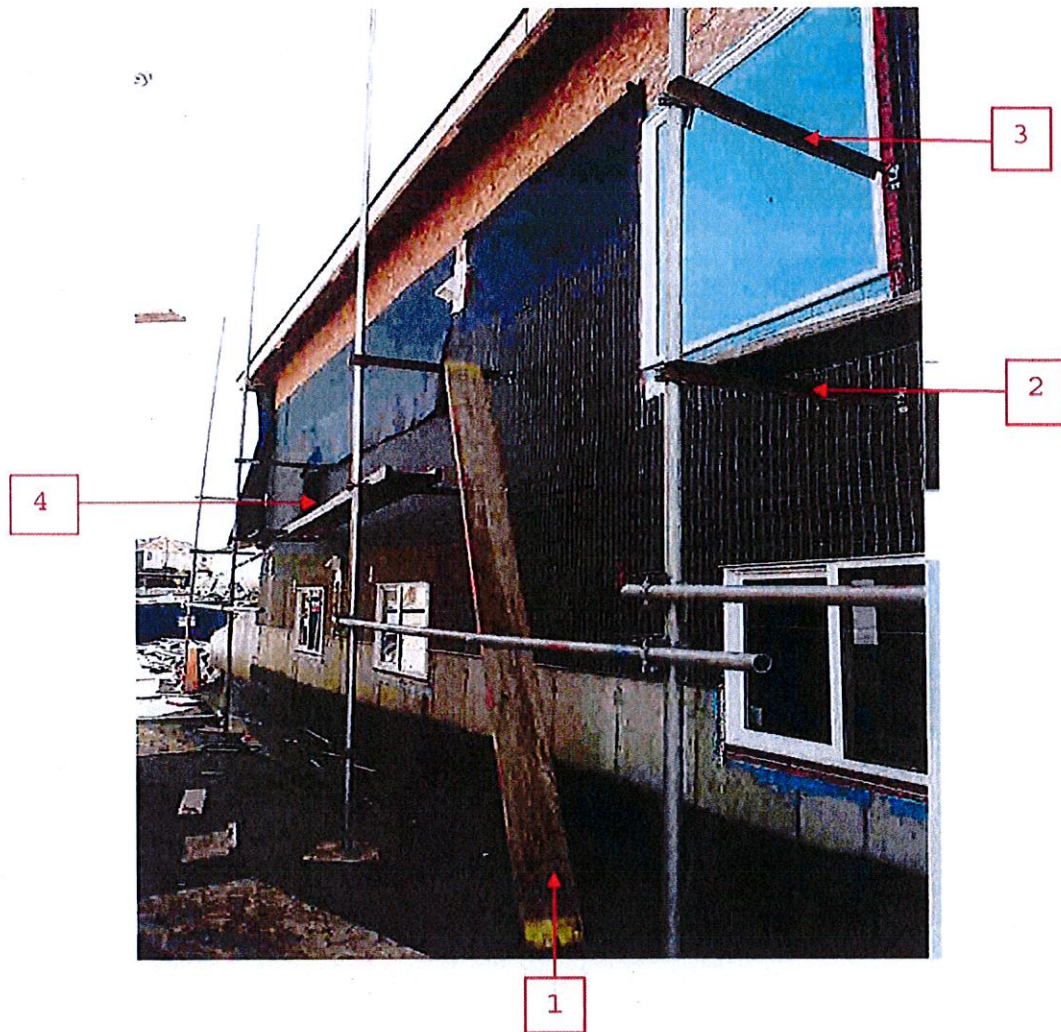
- 5.1.3 Access to the first working level at a height of approximately 2.1 meters was provided through a scaffold plank that was placed on a two-step aluminum ladder called a “horse”. Access to the second working level of 3.15 meters was gained by climbing up the vertical scaffold pole (Refer to Attachment B – Photographs 3 and 4 and Attachment C - Diagram).
- 5.1.4 The scaffold equipment was owned jointly by the employer (Westcan Stucco Wire Ltd.) and Worker 2 (). There were no manufacturer’s specifications or specifications certified by a professional engineer available at the work site.

- 7.2.1 There was no access or egress ladder in place for workers to safely move from one level to another level of the scaffold.
- 7.2.2 Scaffold planks were not secured to prevent movement as required by Occupational Health and Safety legislation.
- 7.2.3 There was no record found to indicate that Worker 1 () was formally trained on the safe erection of single pole scaffold.
- 7.2.4 There were no manufacturer's specifications or specifications certified by a professional engineer available at the work site describing the safe erection of single pole scaffold.

Photograph 3 – Shows northeast view of the incident scene.

1. Shows the scaffold plank that fell when Worker 1 () attempted to access the second level.
2. Shows the level where Worker 1 () was standing prior to climbing.
3. Shows the second level that Worker 1 () attempted to access.
4. I-beam floor joist where Worker 2 () was standing at the time of the incident.

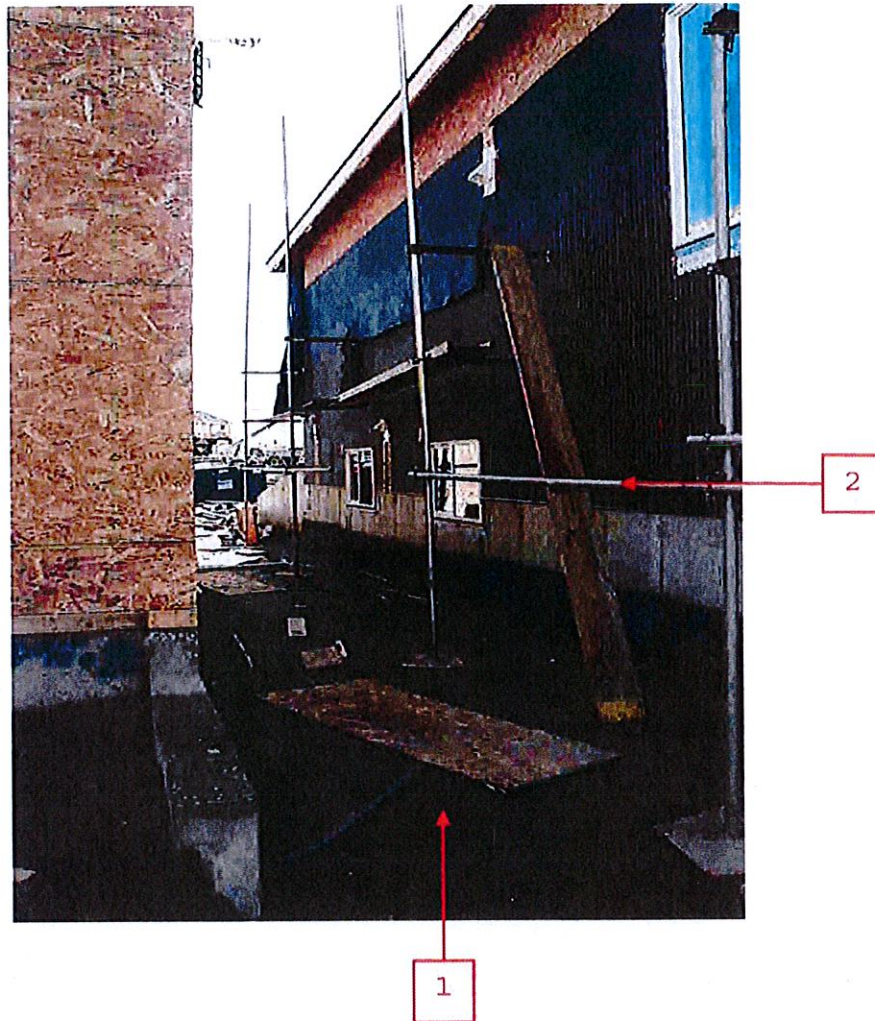
- 7.1.1 Worker 1 () was fatally injured when he fell while climbing a scaffold pole from the first level to the second level.

Photograph 4 – Shows northeast view of the incident scene.

1. Shows the approximately location where Worker 1 () landed after he fell.
2. Shows the crossbar that Worker 1 () struck prior to landing on the ground.

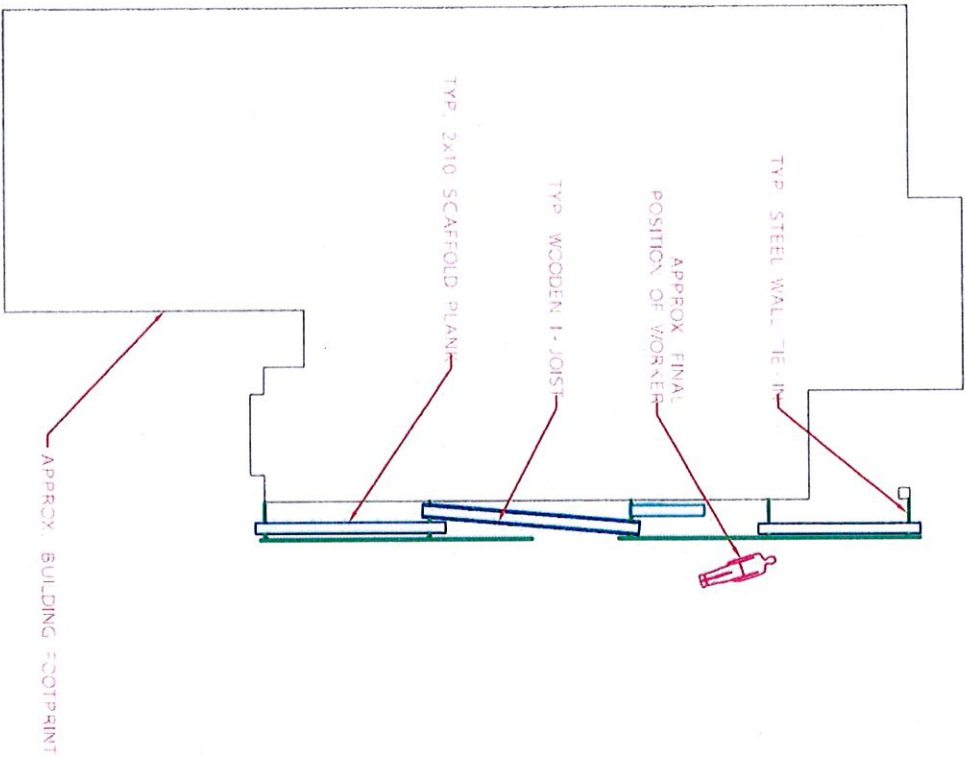
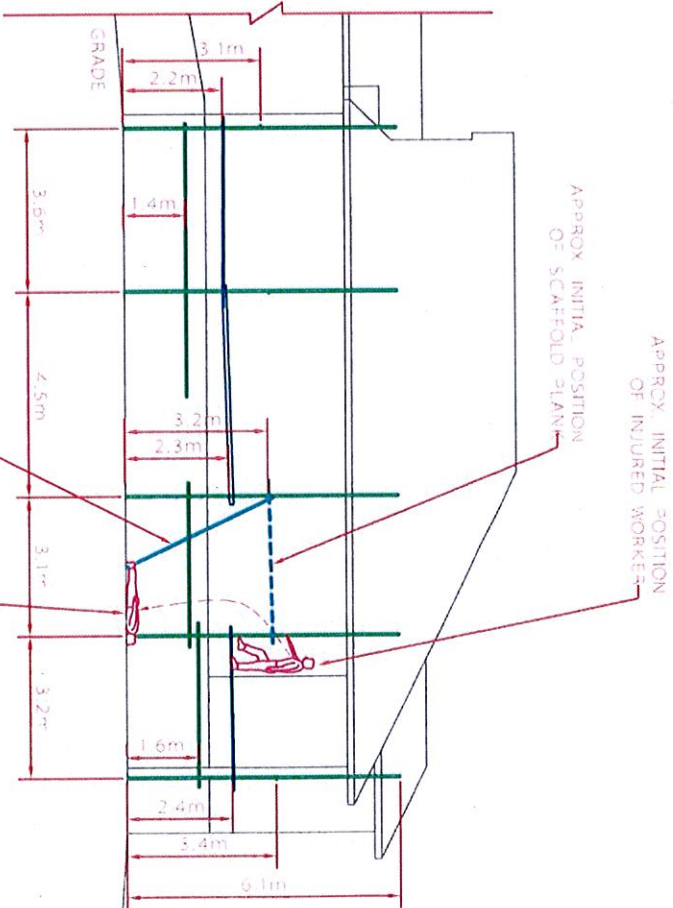
MULTIPLE VIEWS OF
CONSTRUCTION SITE
DIAGRAM 1 OF 1

PLAN VIEW OF BUILDING

EAST ELEVATION OF BUILDING
