**WORKER CRUSHED WHILE OPERATING  
KNUCKLE BOOM PICKER**

Type of Incident:      Fatality

Date of Incident:      October 16, 2010

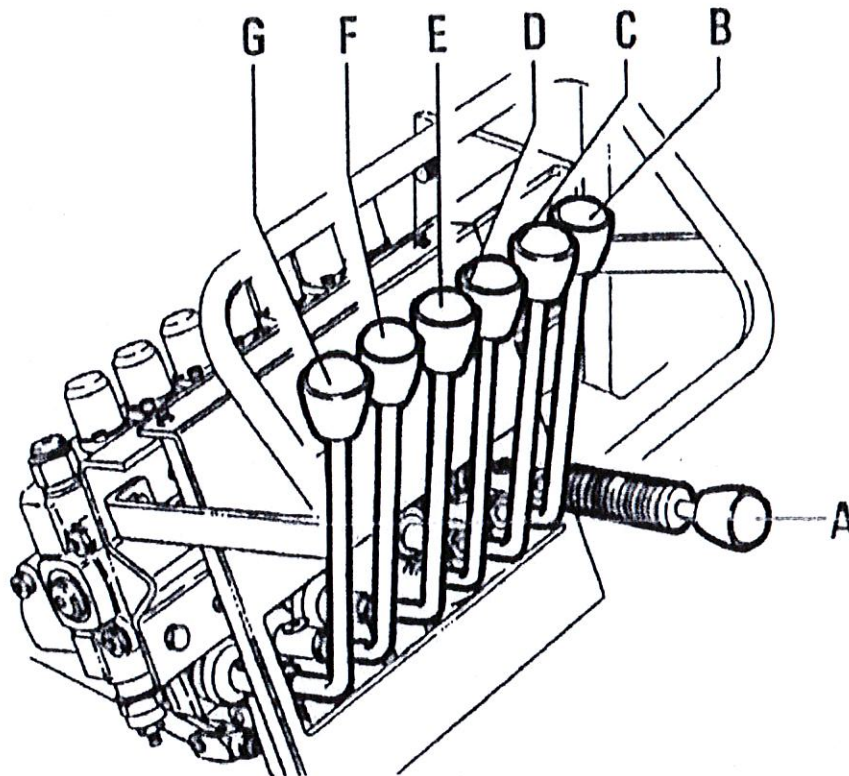
Diagram #1

- 5.2.6 A hazard assessment was completed by the Apprentice Boom Truck Operator ( ) and Swamper ( ) identifying existing and potential hazards.
- 5.2.7 The manufacturer's design of the operating controls for the PM S.p.A. knuckle boom picker Unit T-09, Model Series 10 are reversed from left to right between the driver's side and the passenger's side. (Attachment B – Diagram 1 and 2)

- 7.2.4 The manufacturer's design of the AutoGRU PM S.p.A. passenger side controls are in opposite order from the driver's side controls. (Attachment B – Diagram 1)
- 7.2.5 Apprentice Boom Truck Operator ( ) had followed directions given to offload material at the Bearing Oilfield yard prior to commencement of offloading the tubing and sucker rod at the Tuboscope Canada yard.

Placement of controls on driver's side of AutoGRU PM S.p.A. knuckle boom picker, Model Series 10. Controls from left to right are;

- G – 2<sup>nd</sup> Activation control lever
- F – 1<sup>st</sup> Activation control lever
- E – Boom extension cylinder control lever
- D – Main boom cylinder control lever
- C – Column cylinder control lever
- B – Rotation control lever
- A – Crane outrigger control lever

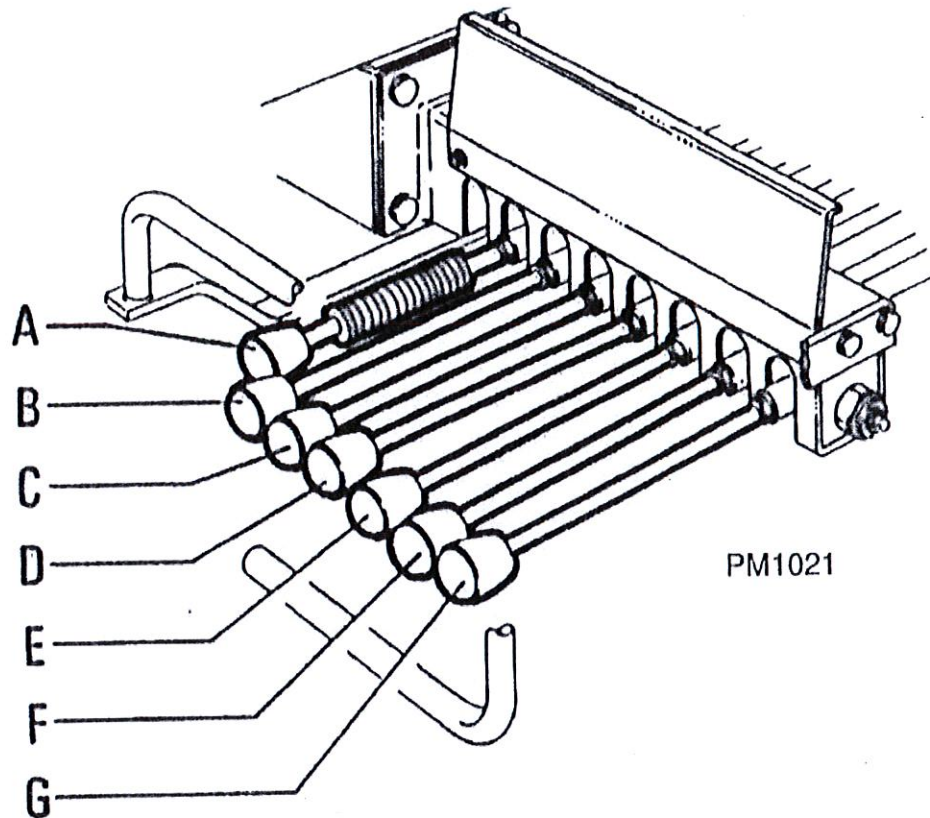
Diagram #2

Placement of controls on passenger side of AutoGRU  
PM S.p.A. knuckle boom picker, Model Series 10.

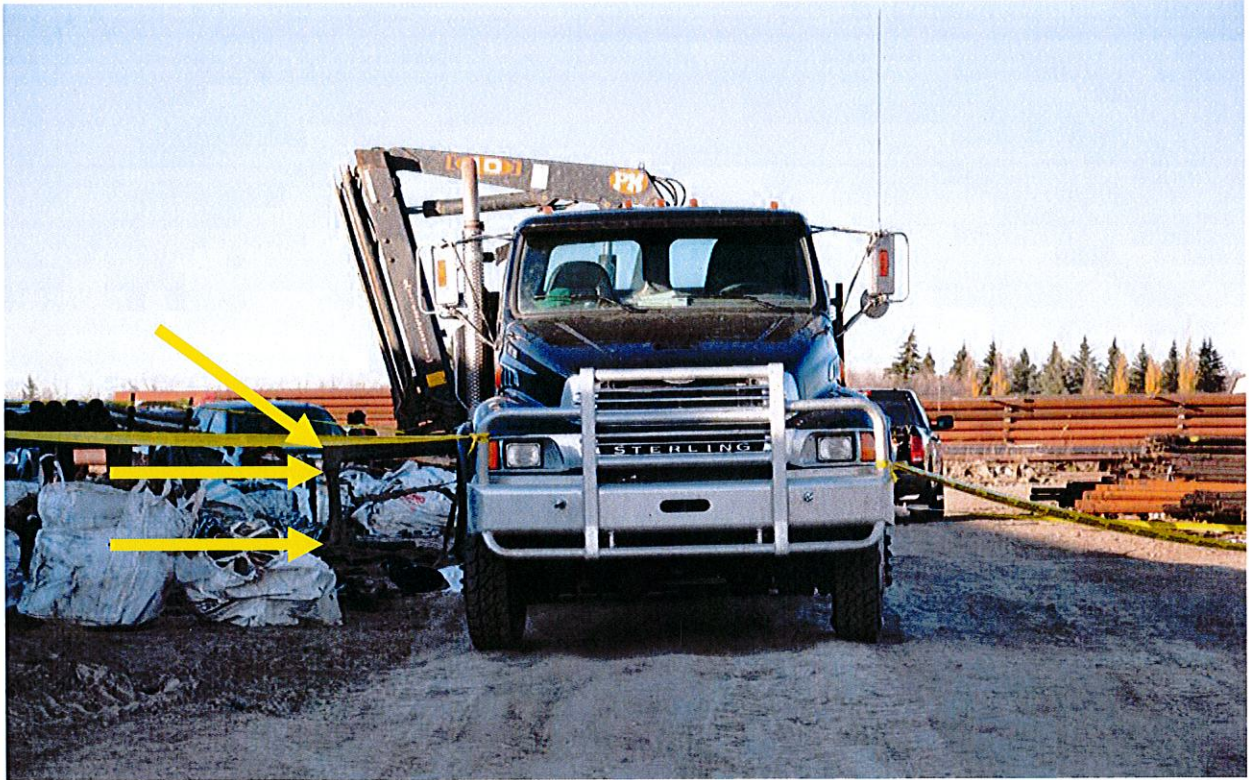
- 5.2.2 Upon the arrival of Occupational Health and Safety it was observed the driver's side outrigger was not engaged and the passenger side outrigger arm was only partially extended. (Attachment C – Photograph 1). The knuckle boom picker was positioned on the passenger side with the boom partially extended placing the boom at the front of the trailer. (Refer to Attachment C – Photograph 2).

Photograph #1 Western Sterling conventional truck and AutoGRU PM S.p.A. knuckle boom picker showing that the driver side outrigger was not engaged. The arrow indicates the passenger side outrigger partially engaged. See Photograph #2.

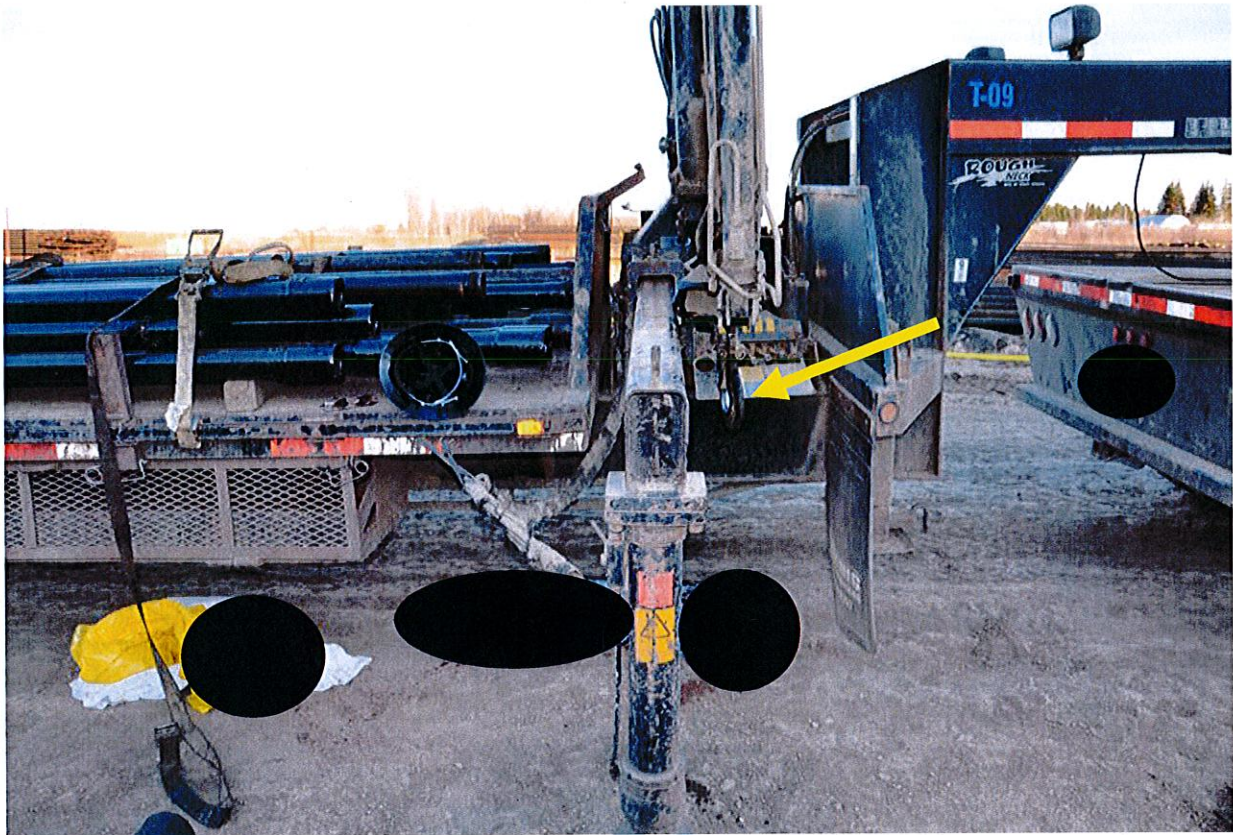
Photograph #2      The arrow shows the boom partially extended placing the boom at the front of the trailer and ahead of the outrigger by the controls. See Photograph #4.

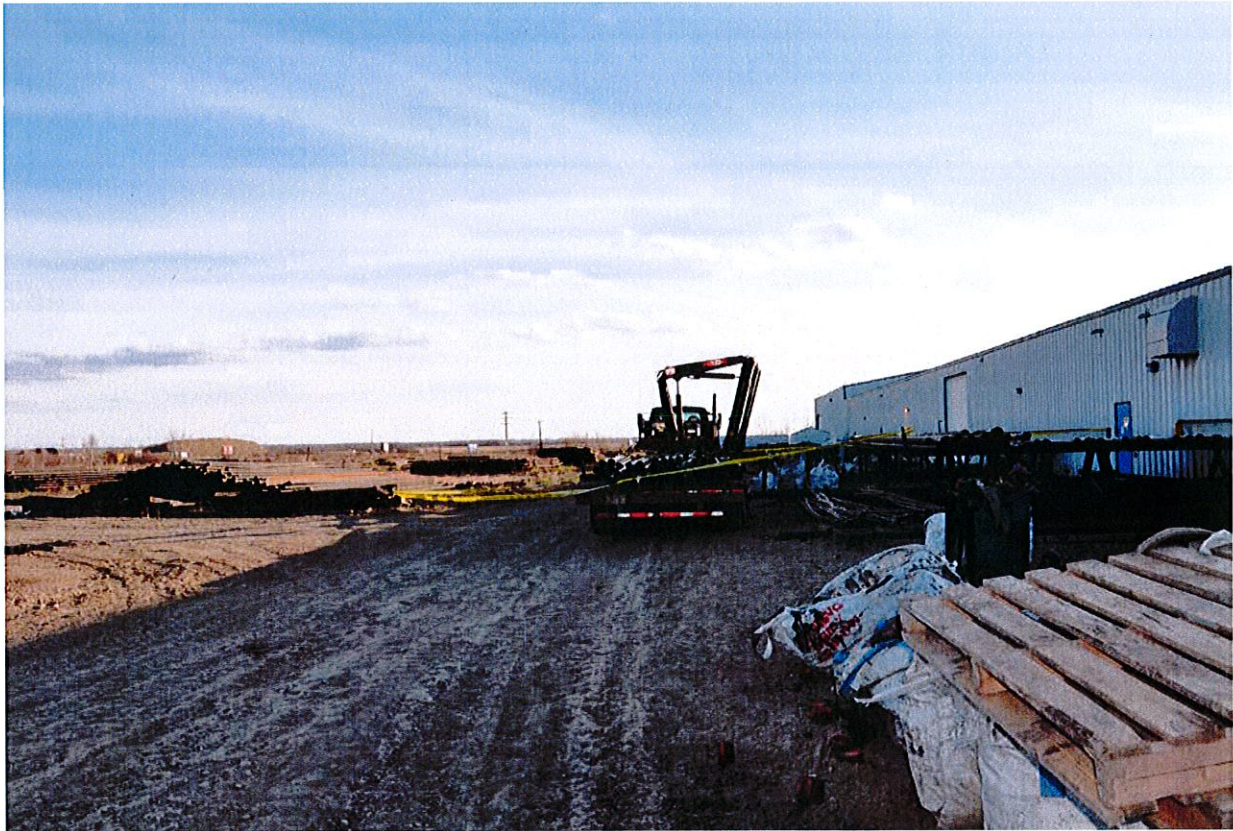
- 6.5 The Apprentice Boom Truck Operator ( ) drove to the east side of the building and proceeded to position the trailer facing south (Attachment C – Photograph 3).

Photograph #3 Shows the Western Sterling Conventional Truck and Roughneck Tri-axle trailer with AutoGRU PM S.p.A. knuckle boom picker positioned on the east side of the Tuboscope Canada building facing south.

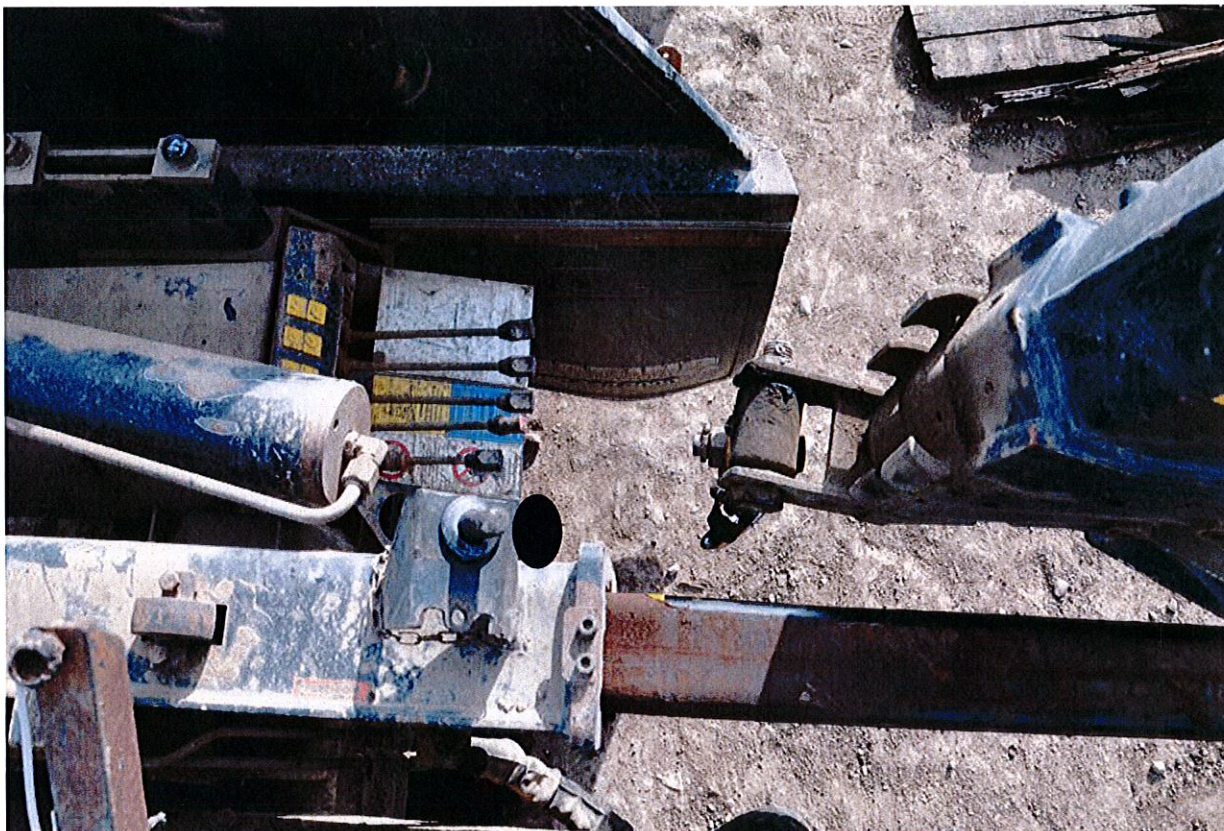
- 6.9 While the Swamper ( v) was rolling up the straps from the driver's side, he heard the Apprentice Boom Truck Operator ( ) let out a scream from the passenger side. When the Swamper ( ) attended to the scream he observed Apprentice Boom Truck Operator's ( ) head caught between the outrigger and the knuckle boom. The Swamper ( ) immediately operated the controls to release the Apprentice Boom Truck Operator's ( ) head from being pinched between the outrigger and the knuckle boom. (Attachment C – Photograph 4) Upon releasing the controls, Apprentice Boom Truck Operator ( ) fell to the ground under the trailer. (Attachment C – Photograph 4).

- 7.1.1 The direct cause of the Apprentice Boom Truck Operator's ( ) fatal injuries occurred as a result of being crushed between the AutoGRU PM S.p.A. knuckle picker boom and the outrigger on the passenger side while operating the controls to boom out the mast.

Photograph #4      Top view of knuckle boom picker controls, outrigger and boom positioned from the passenger side.
