# Worker fatally injured when struck with equipment

October 16, 2017

## **Incident summary**

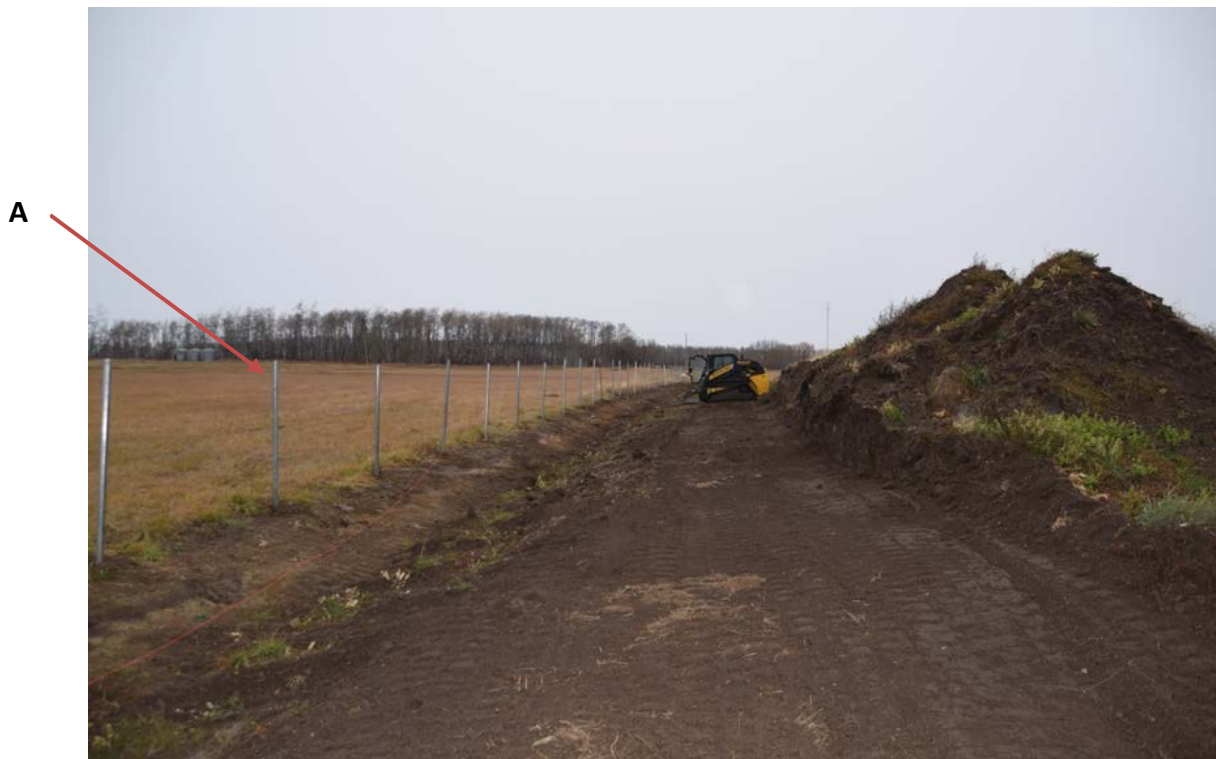
*Figure 1. The fence posts were aligned north to south in the area where the incident occurred.*

*A. The galvanized metal poles that were set in posts holes, to which chain link fence would be attached.*

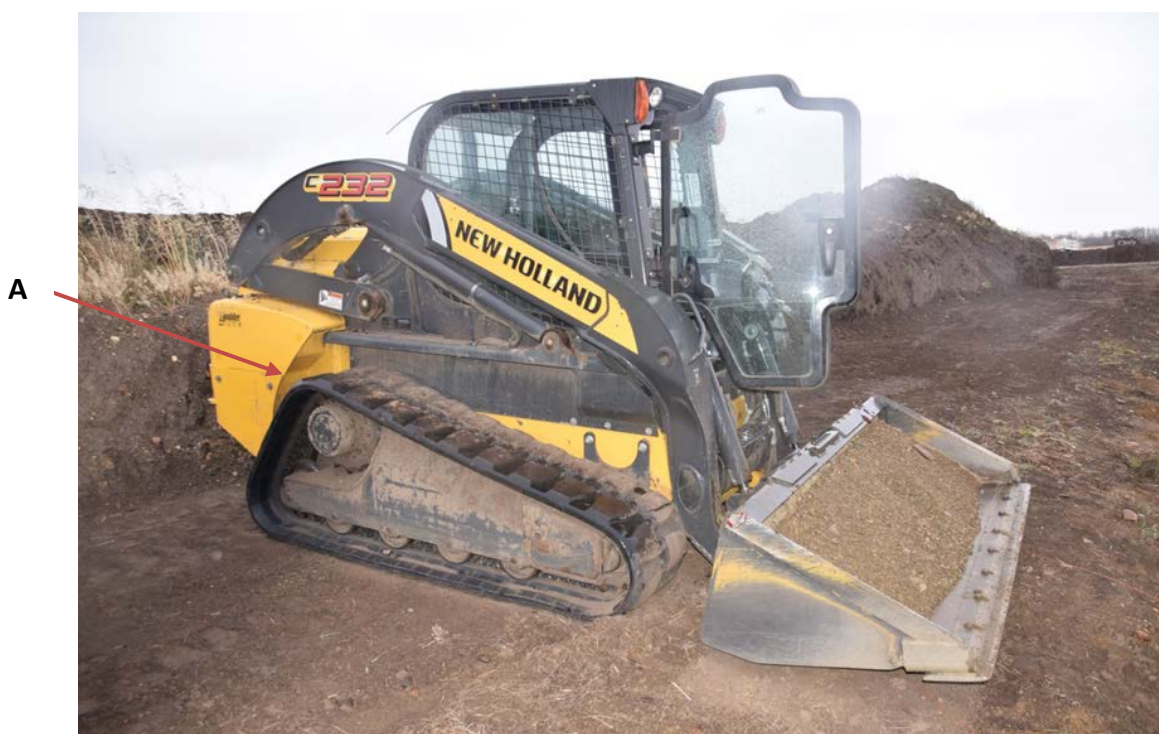
*Figure 2. Perspective of the compact track loader on the east side of the fence. (Not representative of position of the machine at time of incident, or immediately post incident).*

- A. *This model of compact track loader had been obtained by the employer PGA as the configuration of the loader with a tracked system provided more stability than 'wheeled' loaders.*

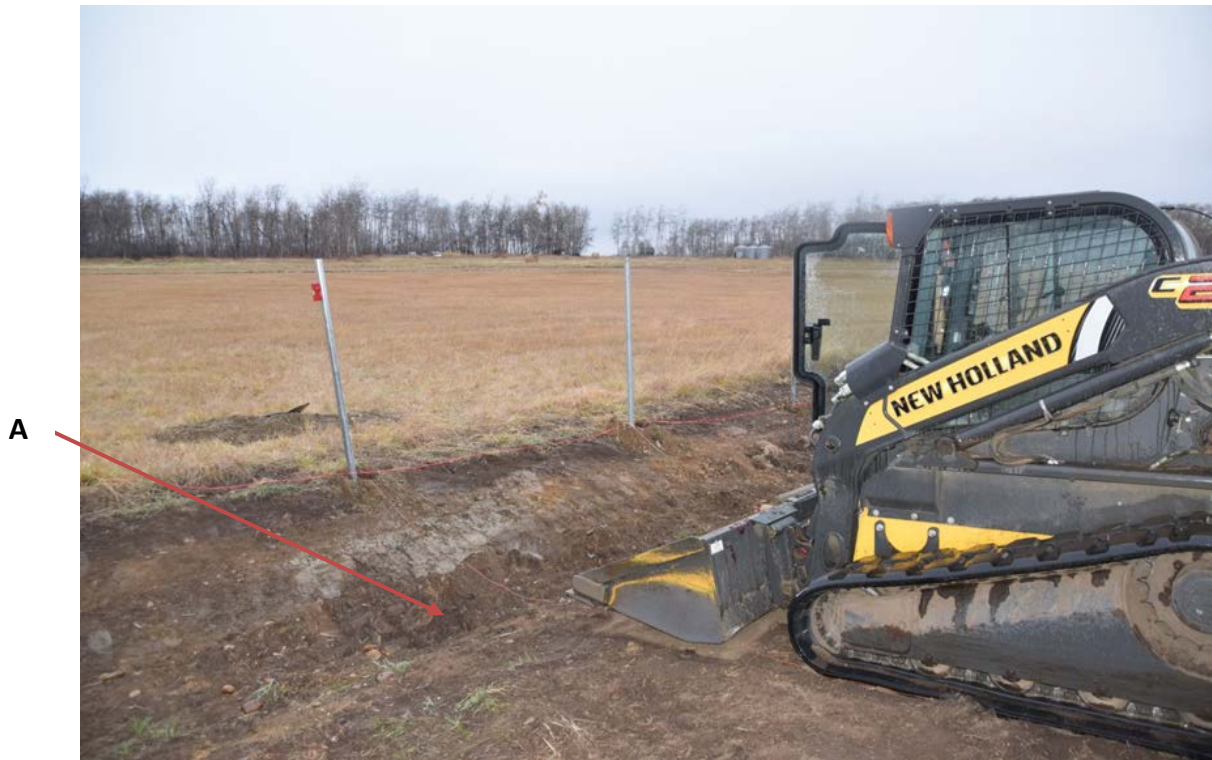
*Figure 3. Perspective facing northwest indicating the fence posts running north – south. The depression running parallel along the east side of the fence indicates non-level terrain.*

*A. Non-level terrain.*

The Admin/Sales worker was standing on the west side of the post when the Operator/Labourer drove the compact track loader in a forward direction towards the line of the fence post holes. There was a depression (non-level area) along the east side of the fence (Figures 3, 4 and 5).

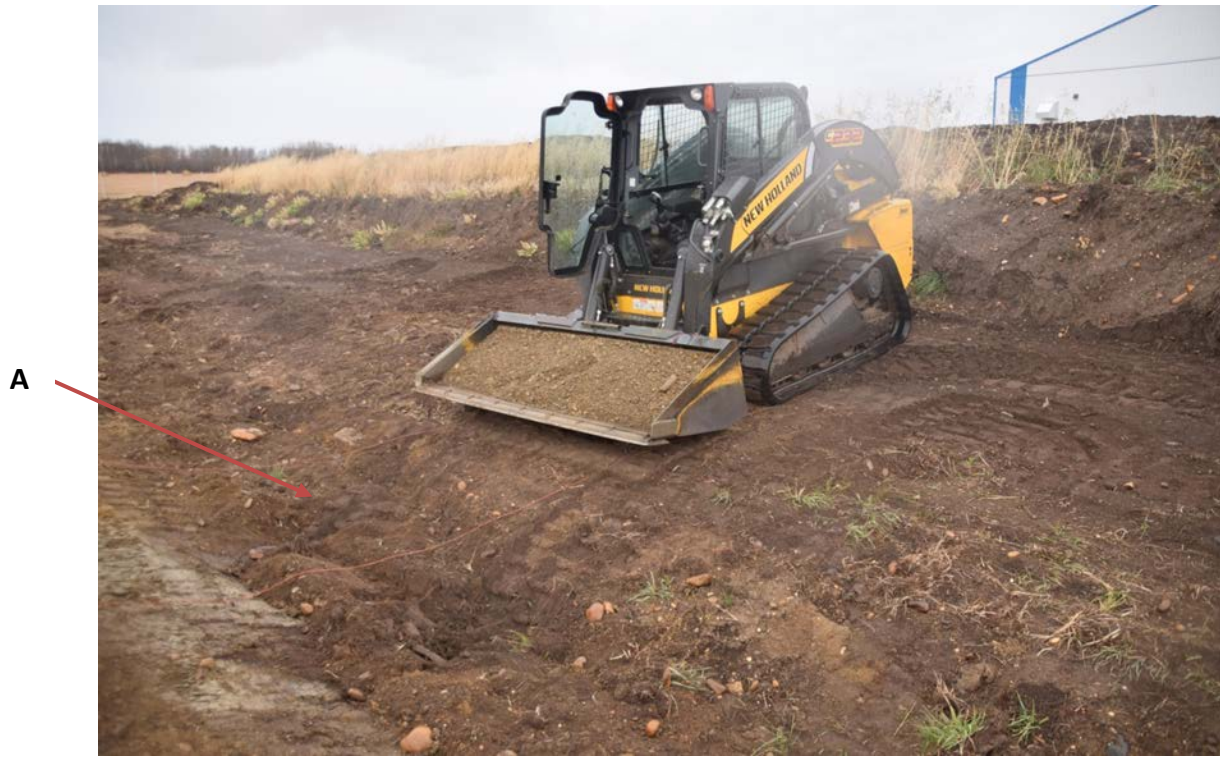
*Figure 4. Perspective facing northeast, indicating the slope and depression into which the compact track loader was proceeding (from east to west) towards the line of fence post holes, which ran north to south.*

- A. The depression at the bottom of the slope was a contributor to a decrease in the load stability of the compact track loader.*

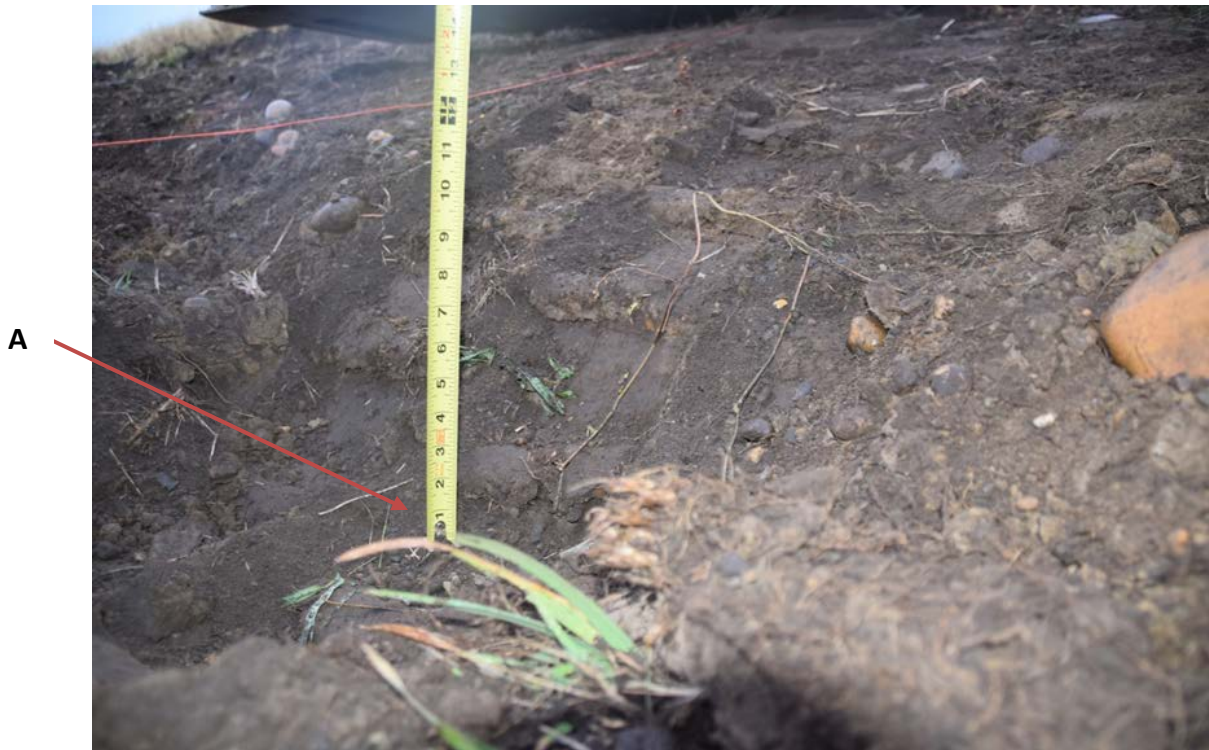
Figure 5. The depth of the depression, measured post-incident, was approximately 30.48 cm (12 inches).

- A. The depression in the terrain, in combination with the compact loader hydraulic arms being in an elevated position while carrying a bucket-load of gravel when the compact track loader was in a forward motion on a downward slope resulted in instability of the compact track loader thereby allowing it to tip forward.
