Investigation Report  
Worker fatally crushed in equipment  
November 18, 2014

## Incident summary

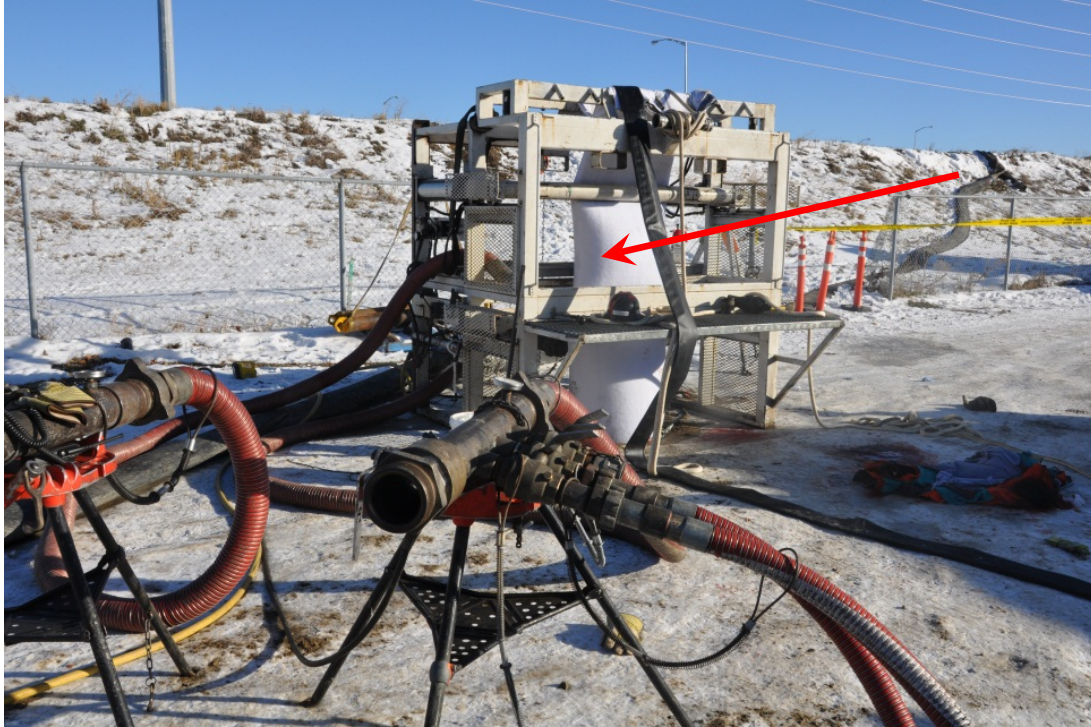
*Figure 1. Dual Gland Air Inversion (DGAI) Unit located in alley beside 129 Cranberry Square, Calgary, Alberta the day of the incident. The photo shows the liner (indicated by arrow) in place in the DGAI Unit.*

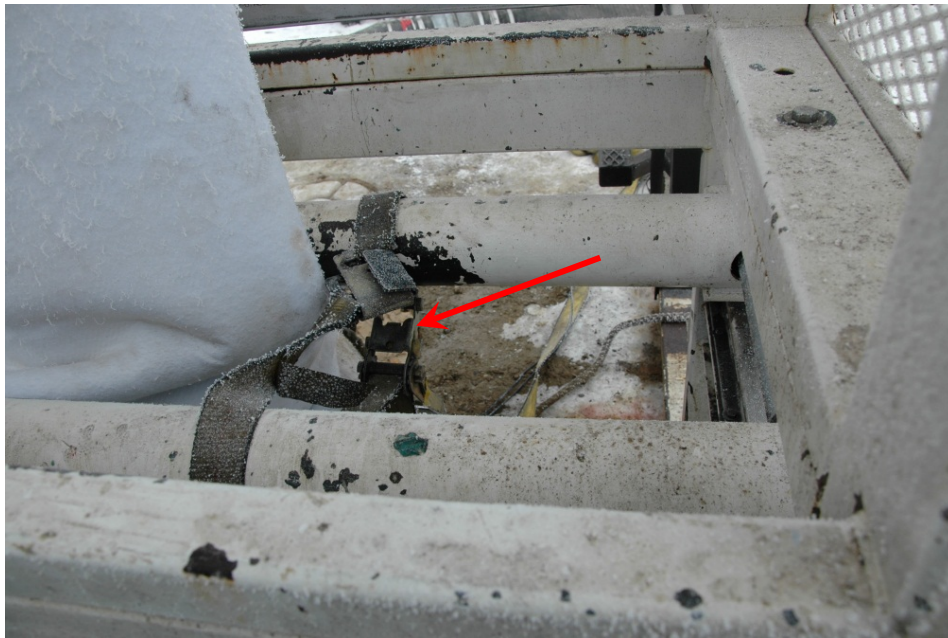
This was a cargo-restraint device composed of a webbing strap, flat hooks and a standard in-line ratchet handle. This style of strap was designed and is sold for securement of cargo on trailers. At the time of the incident, the flat hooks were connected in an orientation where one hook was positioned ninety degrees to the other hook as shown in Figure 2.

According to information provided by Insituform Technologies Ltd. personnel, these straps were used in the operation of the DGAI to increase the closure of the upper gland during steaming/curing of the lining and were included as part of the written work procedure. Workers applied a strap on the lower gland because the air pressure during the insertion process was causing the gland to be pushed open.

*Figure 2. Ratchet strap in place on lower gland of the DGAI.*

Prior to the incident, workers had applied a ratchet strap, normally used for securing cargo, to the lower gland to keep it closed in order to maintain air pressure in the liner during the inversion process.

Workers were proceeding to open the lower gland to allow the layflat and guide rope to pass the lower gland when they realized that the strap was still in place. The gland was being operated at approximately 100 psi. The ITL supervisor attempted to release the ratchet strap while the gland was still engaged but was unsuccessful. With the gland engaged, the strap and ratchet were under additional tension. The ITL supervisor called for the DGAI operator (ITL superintendent) to reverse the gland however the DGAI operator was adjusting a guide on a cylinder assembly located to the right of the Operator’s Station. The DGAI operator was not able to see the supervisor when the request was made to back the gland off because his line of sight with the ITL supervisor was blocked by the dry end of the liner which was inflated in the middle of the DGAI Unit. The ITL supervisor left front of the DGAI to find the DGAI operator because the system noise from the compressed air made communication difficult in addition to the line of sight issue. At the same time, the DGAI operator was attempting to determine where the ITL supervisor was before moving the gland so as not to injure the worker. Unknown to either worker, the ITL labourer accessed the DGAI from underneath a fixed work platform located on the back or “live” side of the DGAI. He was kneeling in front of the gland when the ratchet released on its own causing the gland to move forward, trapping the ITL labourer between the steel gland and the steel frame of the DGAI Unit.

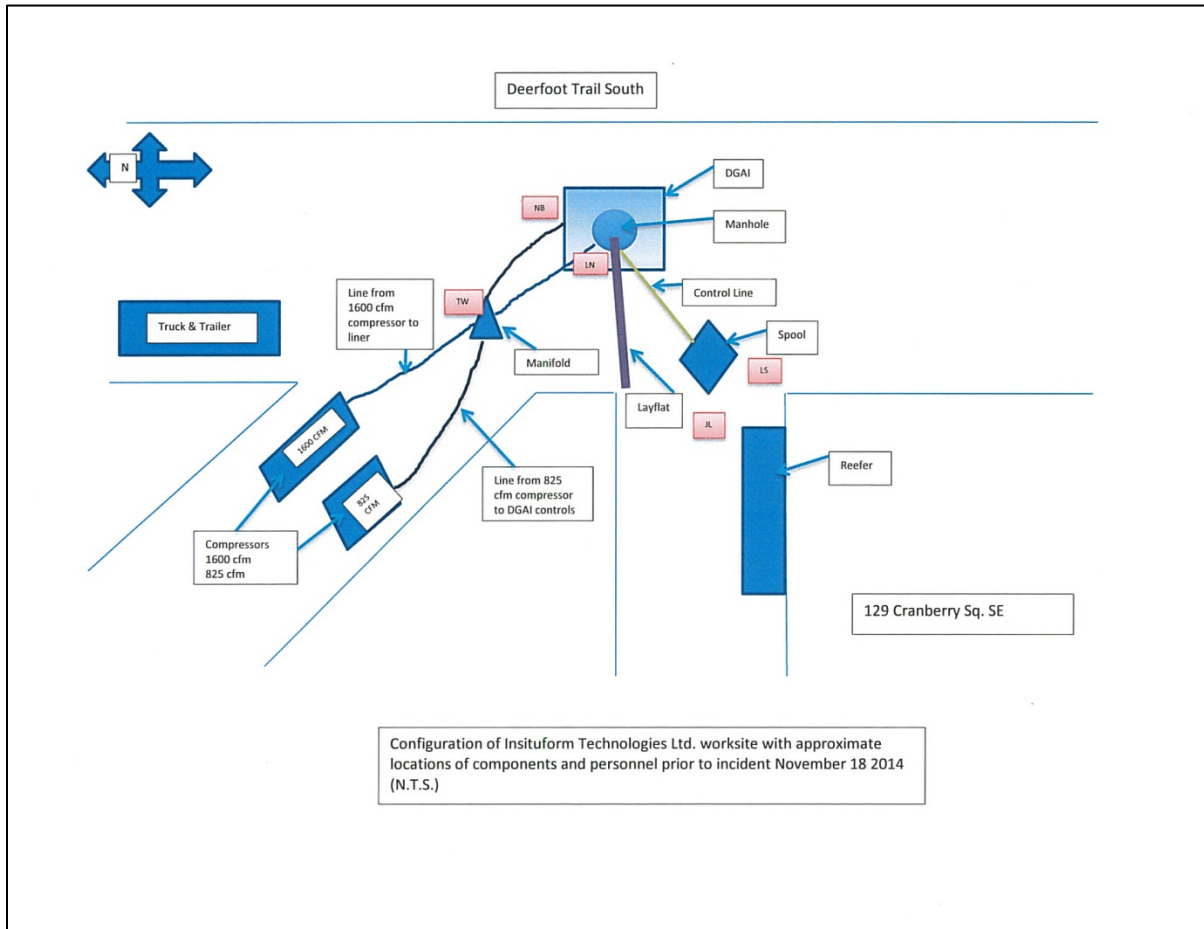
Statements made to Occupational Health and Safety by the Insituform personnel on site indicated that the labourer had been working between the reefer truck and spool of the control line just prior to the incident (Refer to Figure 3).

Figure 3. Site map showing approximate location of workers and equipment just prior to incident November 18, 2014.
