RECAPP Facility Evaluation Report

Alberta Health Services-Calgary

Claresholm Care Centre - Satellite No. 1

B1008B
Claresholm

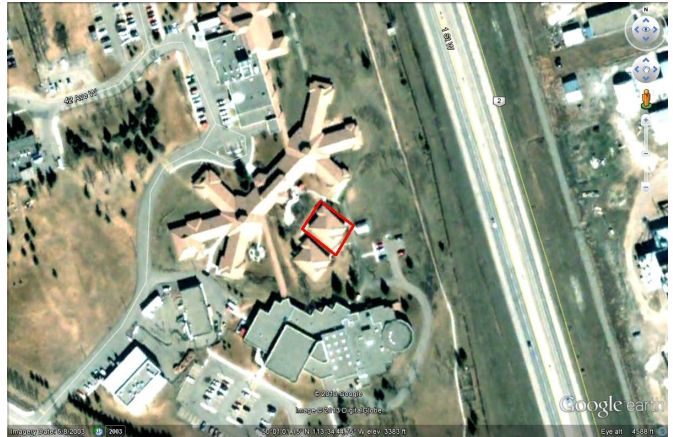
The Site is located in Claresholm, Alberta with access via 43 Ave W and consists of asphalt parking lots, concrete walkways, trees and grass throughout.

General view of the Site.

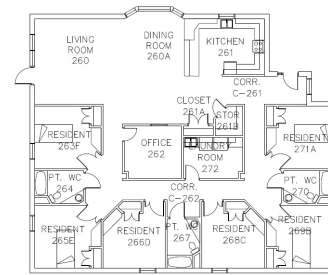
Satellite 1 is a one storey residential building with approximately 279m² total floor area.

Building drawings provided by the Site representative.
