Investigation Report

Worker Fatally Injured After Being Buried by Street Sweepings

April 22, 2015

F-OHS-089427-3A56D

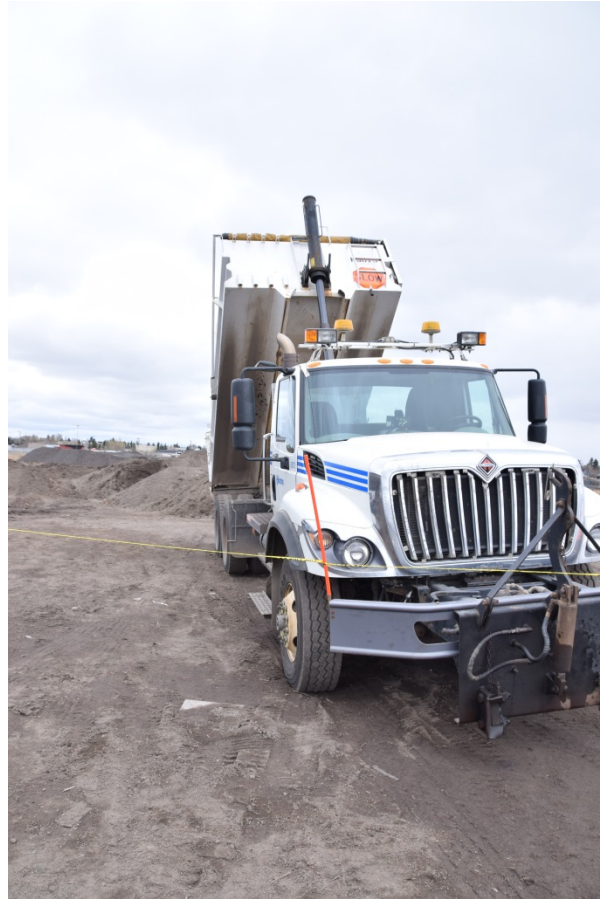
The truck used to collect street sweepings was also used as a sander throughout the winter. Different boxes were installed on the back of the truck for each of these two activities. The truck had recently been converted from the sander box to the dump truck box prior to the incident. The dump truck box was designed and installed by City of Edmonton engineers (Figure 1 and 3).

Two main mechanisms allowed the dump truck to operate. The dump truck bed could be raised using the first mechanism. The second mechanism was a lock that allowed the end gate to open. Two air-operated latches kept the end gate locked closed unless a switch in the cab was activated. Once the switch was activated, the latches would open if the air compressors in the truck were maintaining a pressure of between approximately 80 pounds per square inch (psi) and 120 psi. If the pressure in the truck's air system fell below 60 psi, an audible alarm would sound. Thus, the operator of a truck could press the switch to open the end gate, and, if the pressure in the truck's air system was between 60 psi and approximately 80 psi, the gate would neither open nor would any alarm go off indicating that the gate was not opening due to a lack of pressure. Further, the City of Edmonton had not informed dump truck operators that the end gate latches worked in this fashion.

Upon inspection following the incident, the air compressor system in the truck that the driver was driving was operating within the allowable maintenance limits for the system. However, leaks were present in the air system that may have hampered the truck system's ability to pressure back up after air was used in the operation of the truck. Air pressure may be expended as operators backed up hills to dump their loads as they would normally release air from their air suspensions and might use parts of their braking systems that required air.

Figure 1. Front view of dump truck involved in the incident.

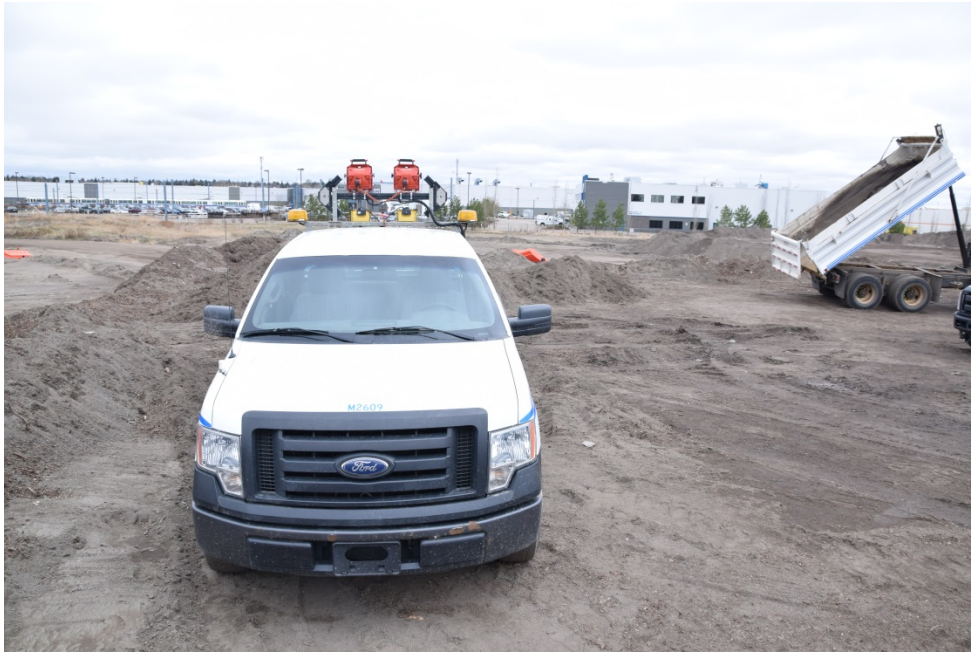
The lighting at the site was provided from two sources. A pickup truck with a portable light stand in the bed shone from the base of the hill to the top (Figure 2). The second source of light was the lights from the front end loader used to move the sweepings.

Figure 2. Truck was used to hold the lighting and generator for the worksite.

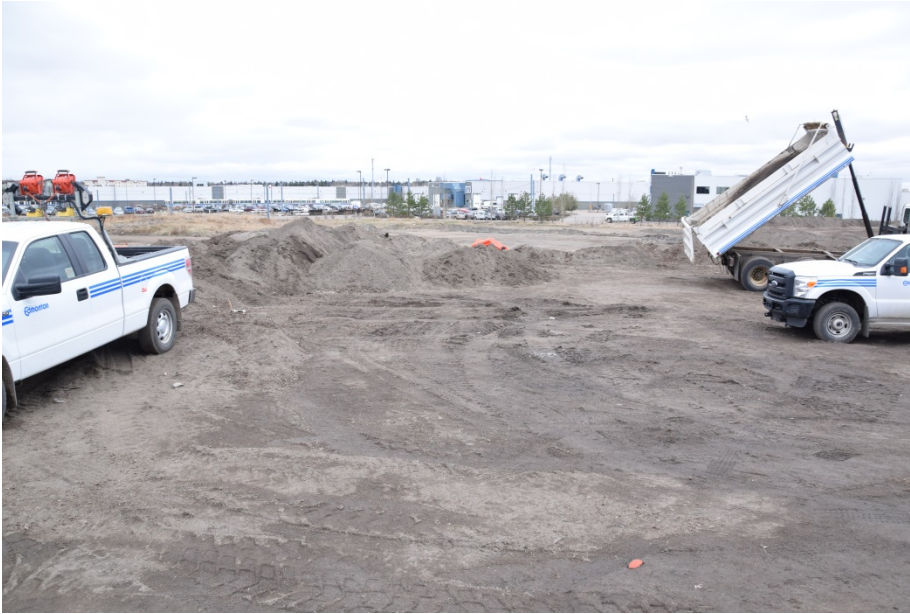
Figure 3. Overall side view of incident scene.
