Investigation Report  
Worker Fatally Injured When Struck by a Tire  
December 28, 2013

## Incident summary

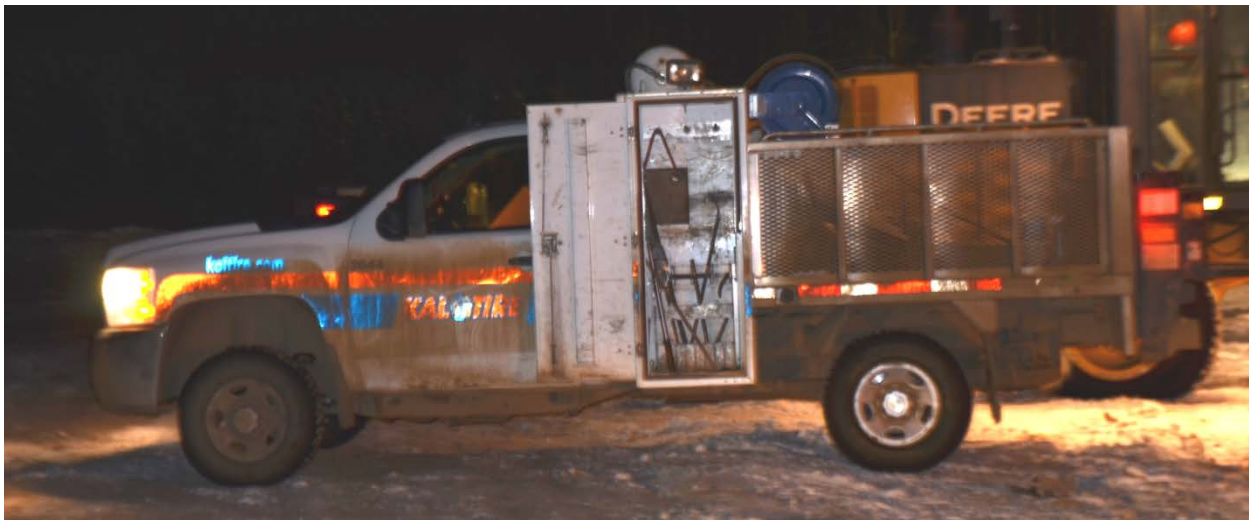
*Figure 2. The Kal Tire service truck in use at the time of the incident.*

The service truck used at the time of the incident was a SILVERADO 2500 4WD Regular Cab (Figure 2). It had a storage compartment on the driver's side and a compressor tank installed in the box. In the engine compartment is an air compression system with a maximum air pressure of approximately 1200 kilopascals (kPa).

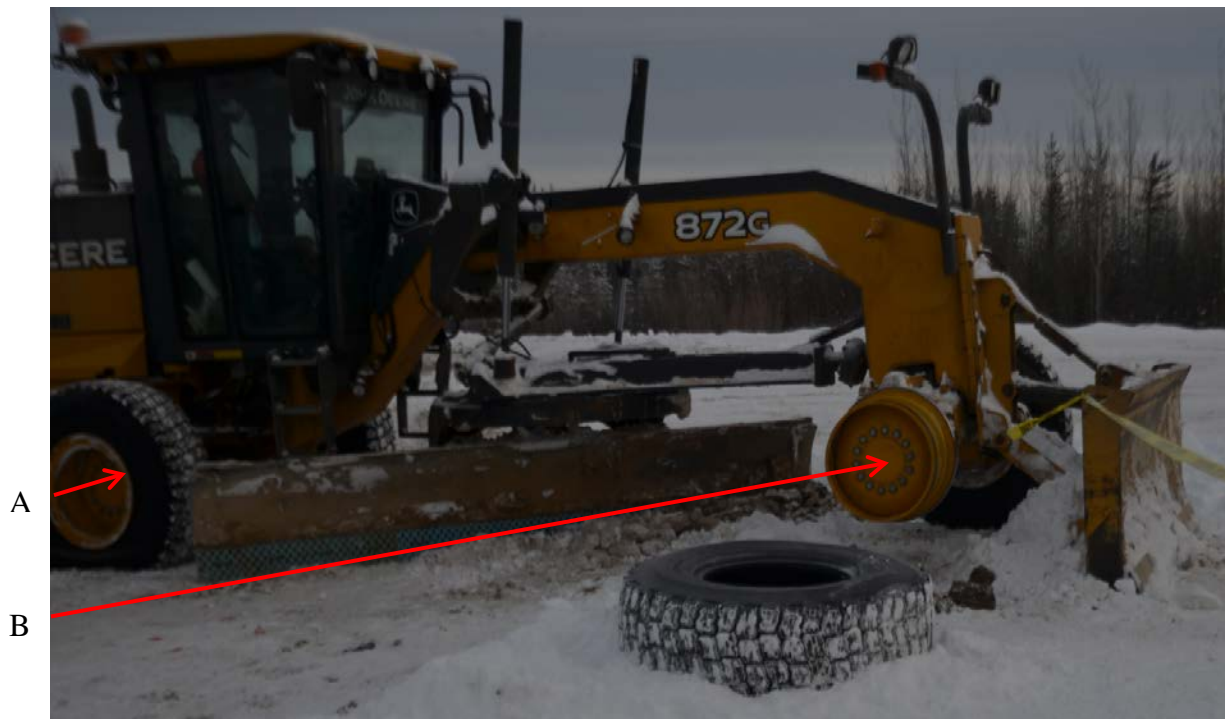
Figure 3. Right side of grader

The tire technician arrived on site at approximately 3:30 p.m. and met with the owner of Sun Trucking to discuss the job. The owner of Sun Trucking identified the two flat tires on the grader. The grader's front right wheel had been elevated with the grader blades and was ready to be fixed. The tire technician suggested that the tires needed new seals and started to work on the front right tire (Figure 3).

*A and B are pointing to the two tires that required fixing at the time of the incident.*

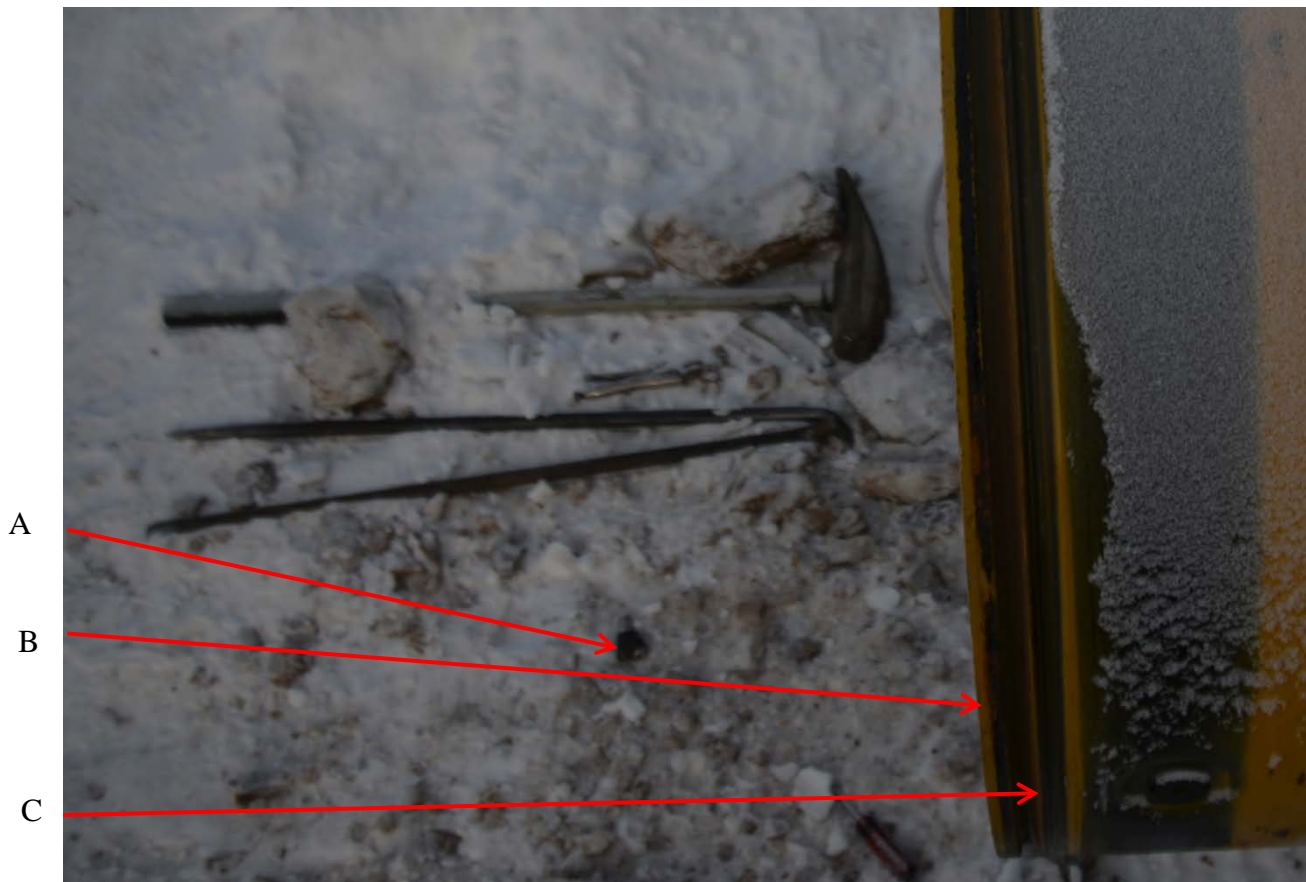
Figure 4. Top view of right front rim.

The tire technician removed the lock ring (a split ring which holds the tire in place by locking the other wheel components together) from the wheel assembly and rested it against the tire. The owner of Sun Trucking received a call and went back to his truck. The tire technician removed the old O-Ring (rubber seal) from the rim and installed a new one (Figure 4).

*A - Air chuck tip*

*B - The lock ring gutter*

*C - The O-ring gutter*

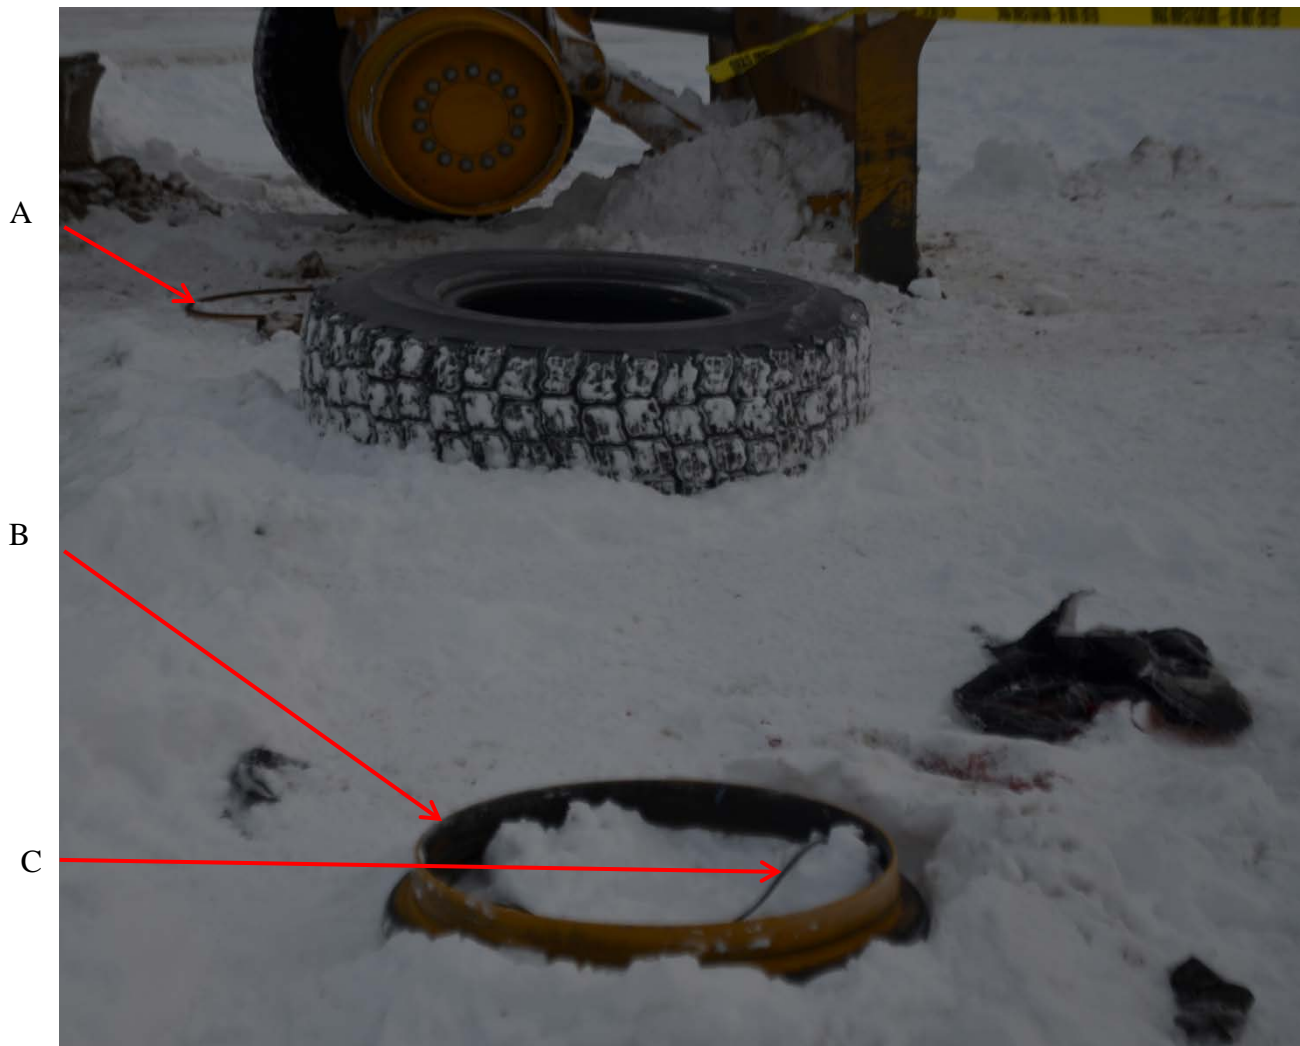
Figure 5. View of front right tire.

The tire technician, in a kneeling position, began to inflate the tire. The lock ring was not installed with the wheel assembly to secure the tire to the rim (Figure 5). At approximately 4:00 p.m., the stored energy in the tire released causing the bead seat band, located behind the O-ring, to contact the tire technician in the head.

- A - The lock ring
- B - The bead seat band
- C - The O-ring
