Explosion resulting in a welder fatality, a welder  
sustaining life altering injuries and multiple worker  
medical aid injuries  
December 27, 2018

# Investigation Report

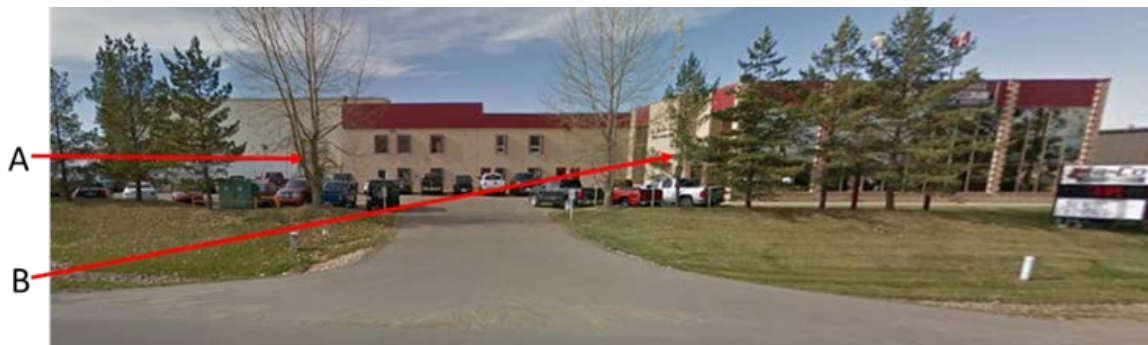
Figure 1. Ja-Co Shop 1 - Street view image obtained by Google Maps.

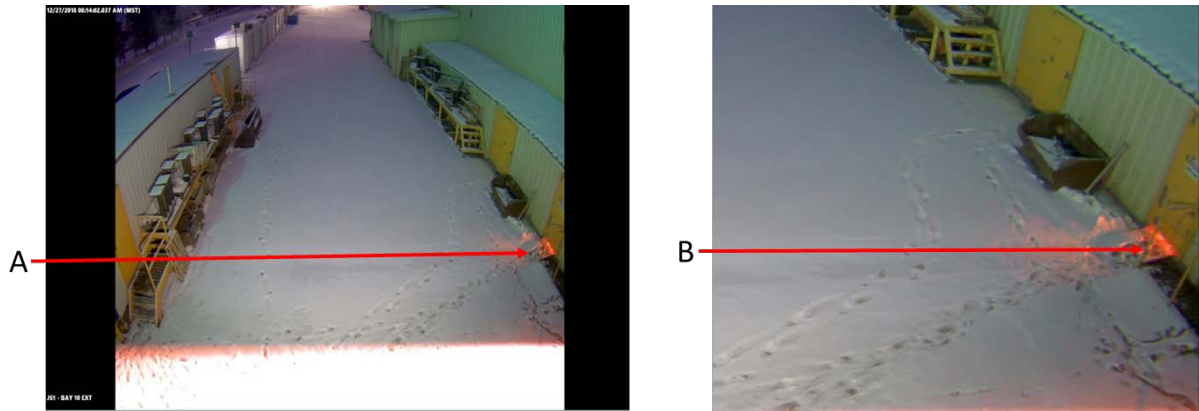
Figure 11. Exterior view of the acetylene storage shack

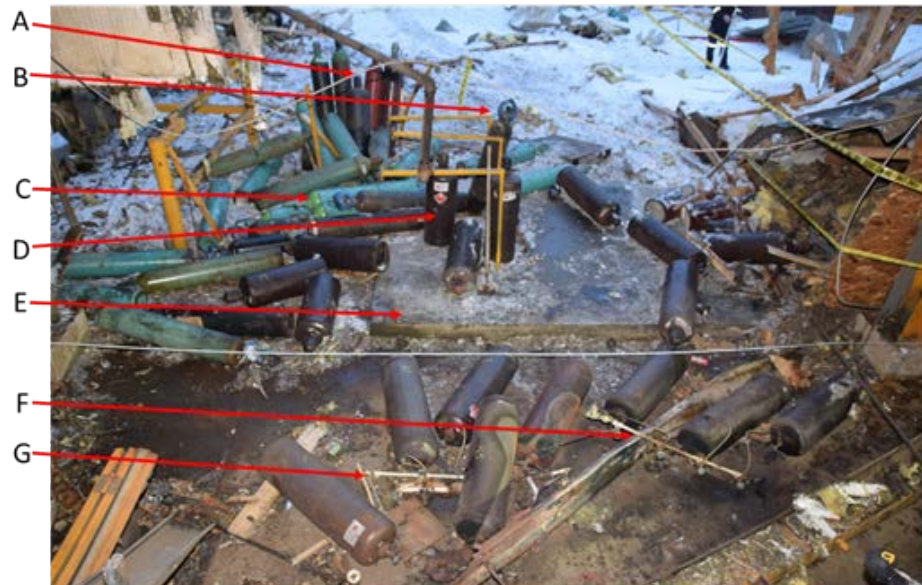
*Figure 16. Acetylene shack post explosion from inside Bay 9 facing east. Mid shot view showing the area where the acetylene shack had been located and attached to Bay 9.*

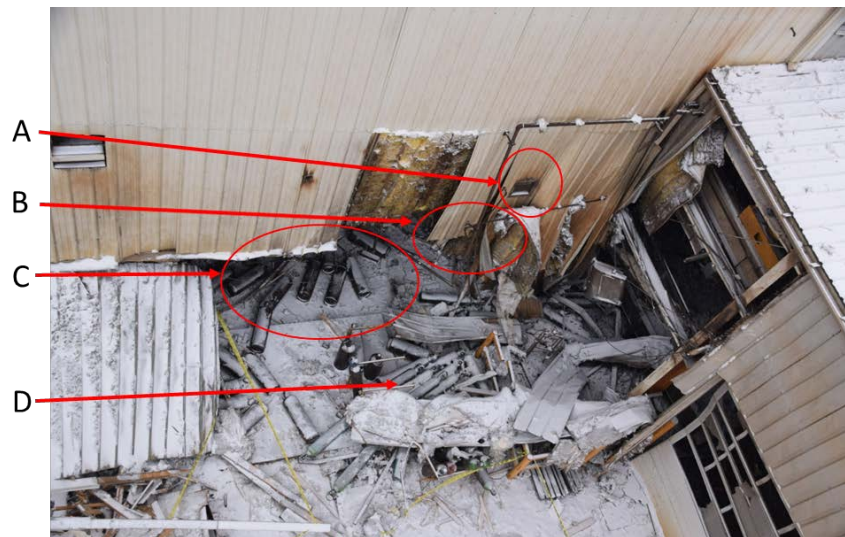
*Figure 17. Acetylene shack post explosion overhead view facing west. Possible acetylene migration routes into Bay 9 in photo:*
