Workplace Health and Safety Fatality Report

WORKER KILLED IN EXPLOSION

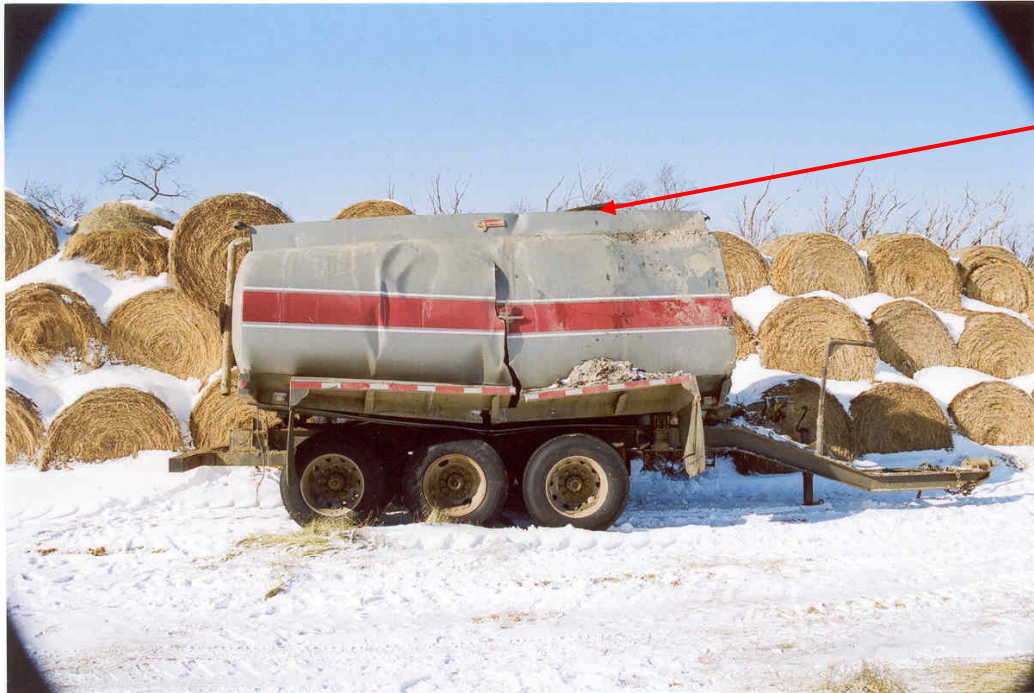
Photograph 2 – Shows the highway transport vessel involved in the incident.

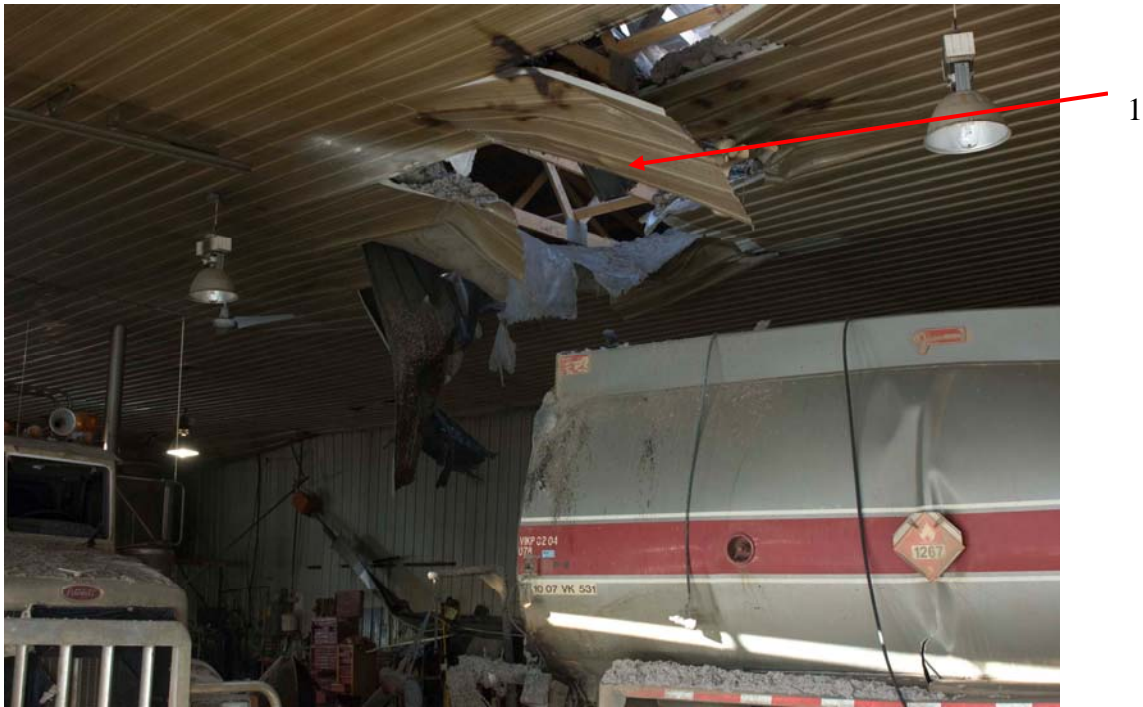
Photograph 6 – Shows the damaged highway transport vessel following the explosion in the building. The picture was taken through a window opening.

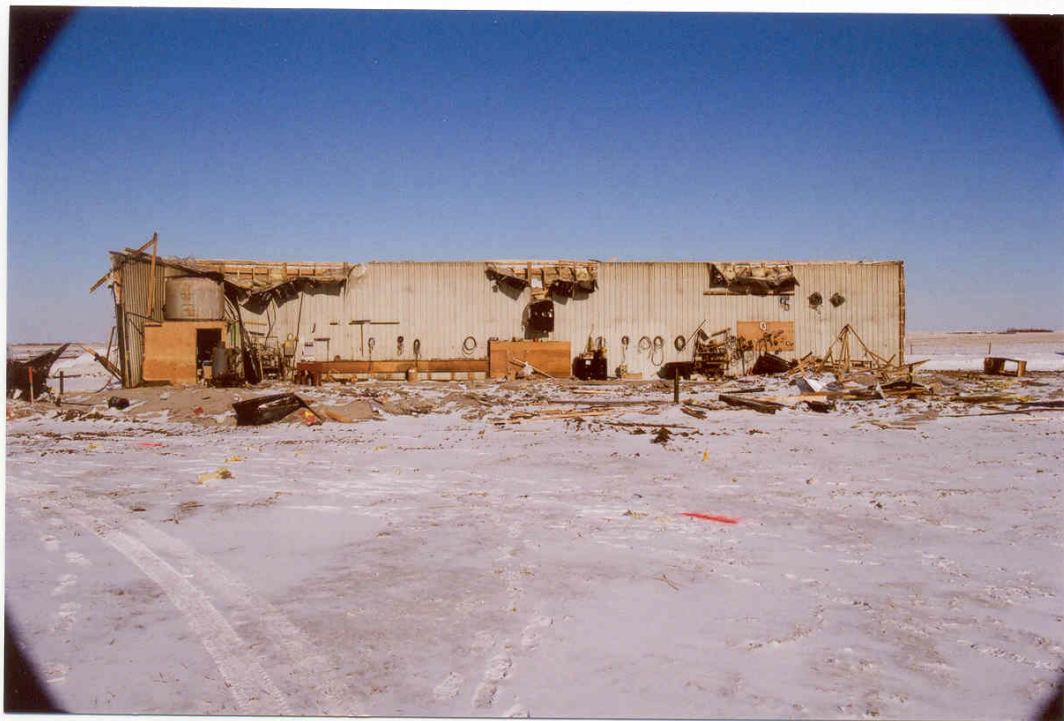
Photograph 7 - Shows the building following demolition.
