Hydrogen Sulphide Fatality

Type of Incident: Fatality

Date of Incident: January 11, 2012

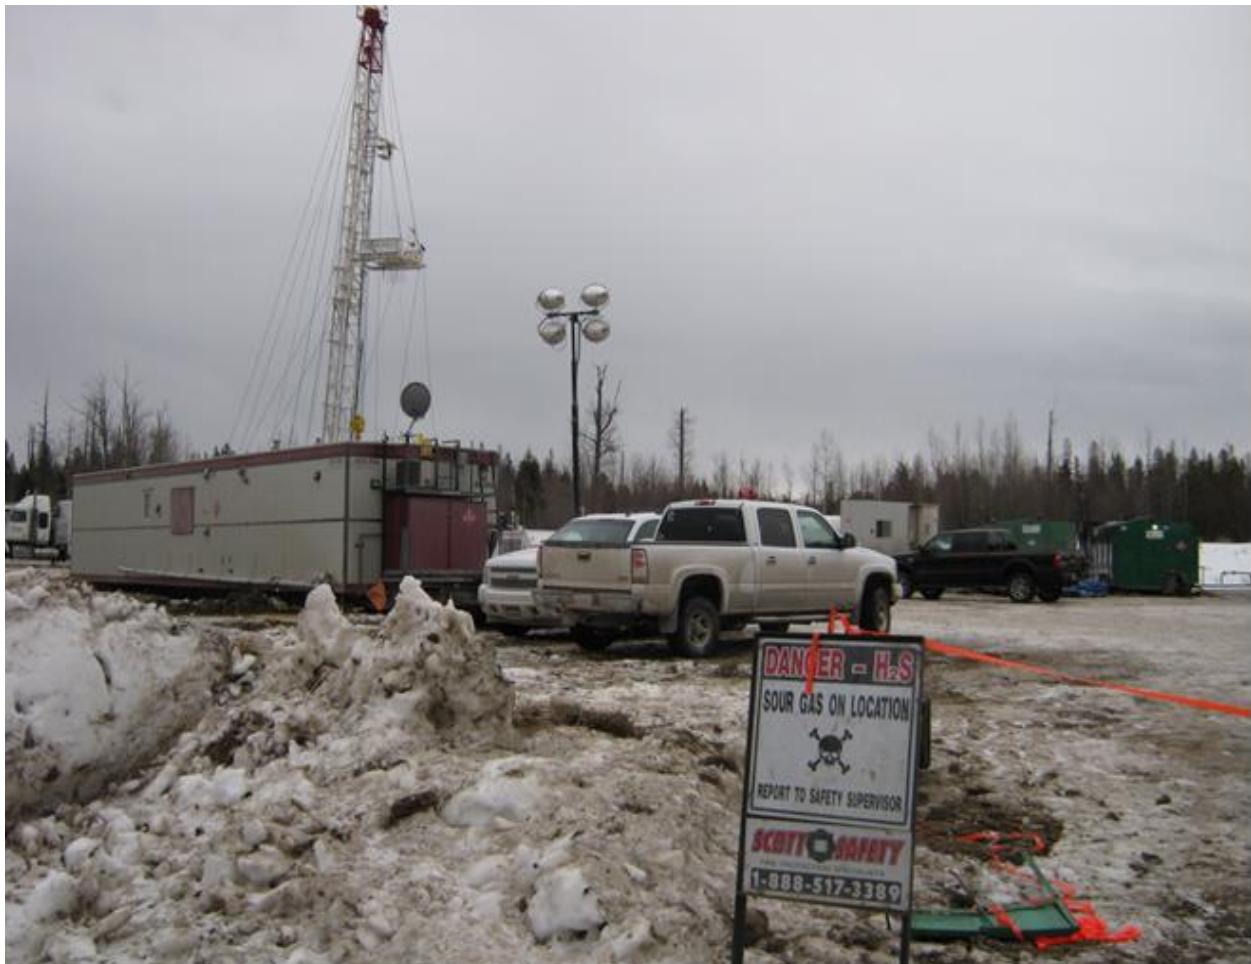
Photograph #1

Photograph showing the position of equipment at the lease site.

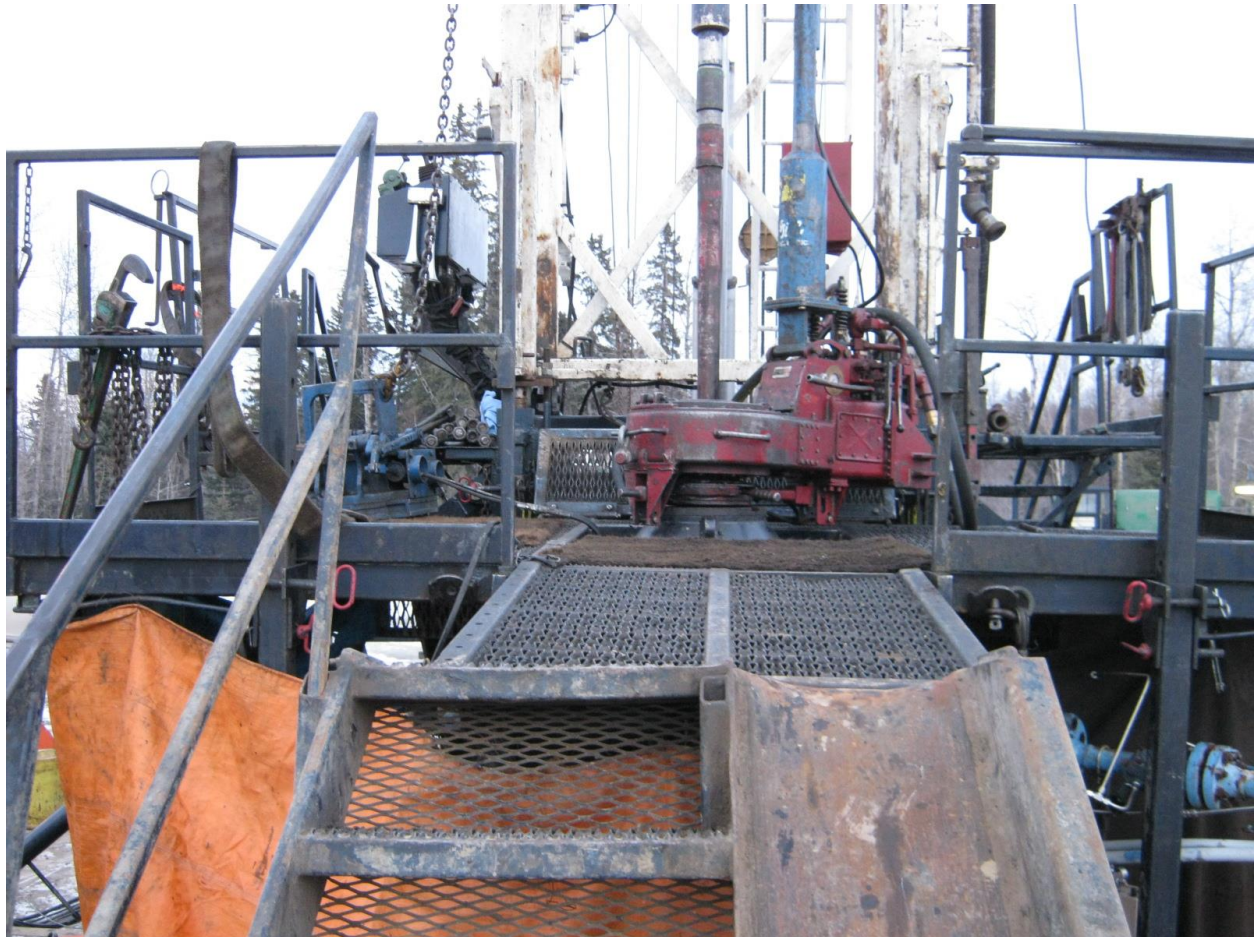
Photograph #2

- 6.9 On the rig floor, the pup joint was being aligned by the floor-hand and snubber. The pup joint went through a seal and there was a smell of something in the air. The floor-hand and snubber tightened the pup joint into the connection by hand. The floor-hand then left the rig floor.

- 6.10 The rig manager exited the rig floor, walked down the stairs past another worker to the end of the catwalk. A short time later, the floor-hand ran down the rig stairs, past another worker, knelt/laid down on the catwalk and then rolled off the side of catwalk onto the ground.

Photograph shows the rig floor where the workers were connecting the pup joint when the incident happened. The steps and V-door in the picture were used by both the rig manager and the fatally injured worker to exit the work area.

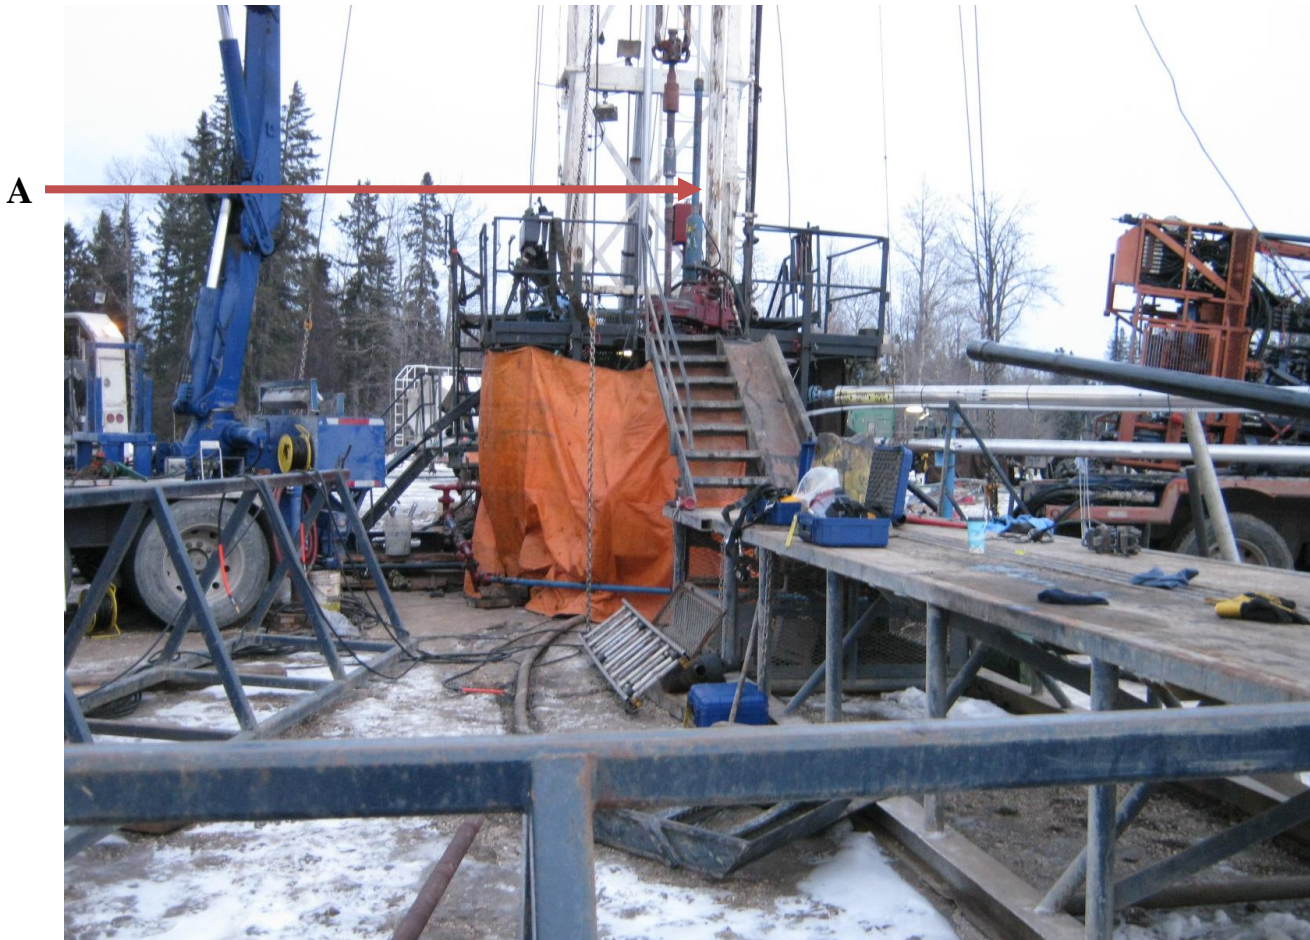
Photograph #3

- 7.1.1 H₂S gas was released from the well when the blind rams on the BOP were opened and the pup joint installed into the tubing hanger.

Rig floor where the workers were working when the incident occurred.
A – pup joint that was being lifted is visible in the center of the rig floor.

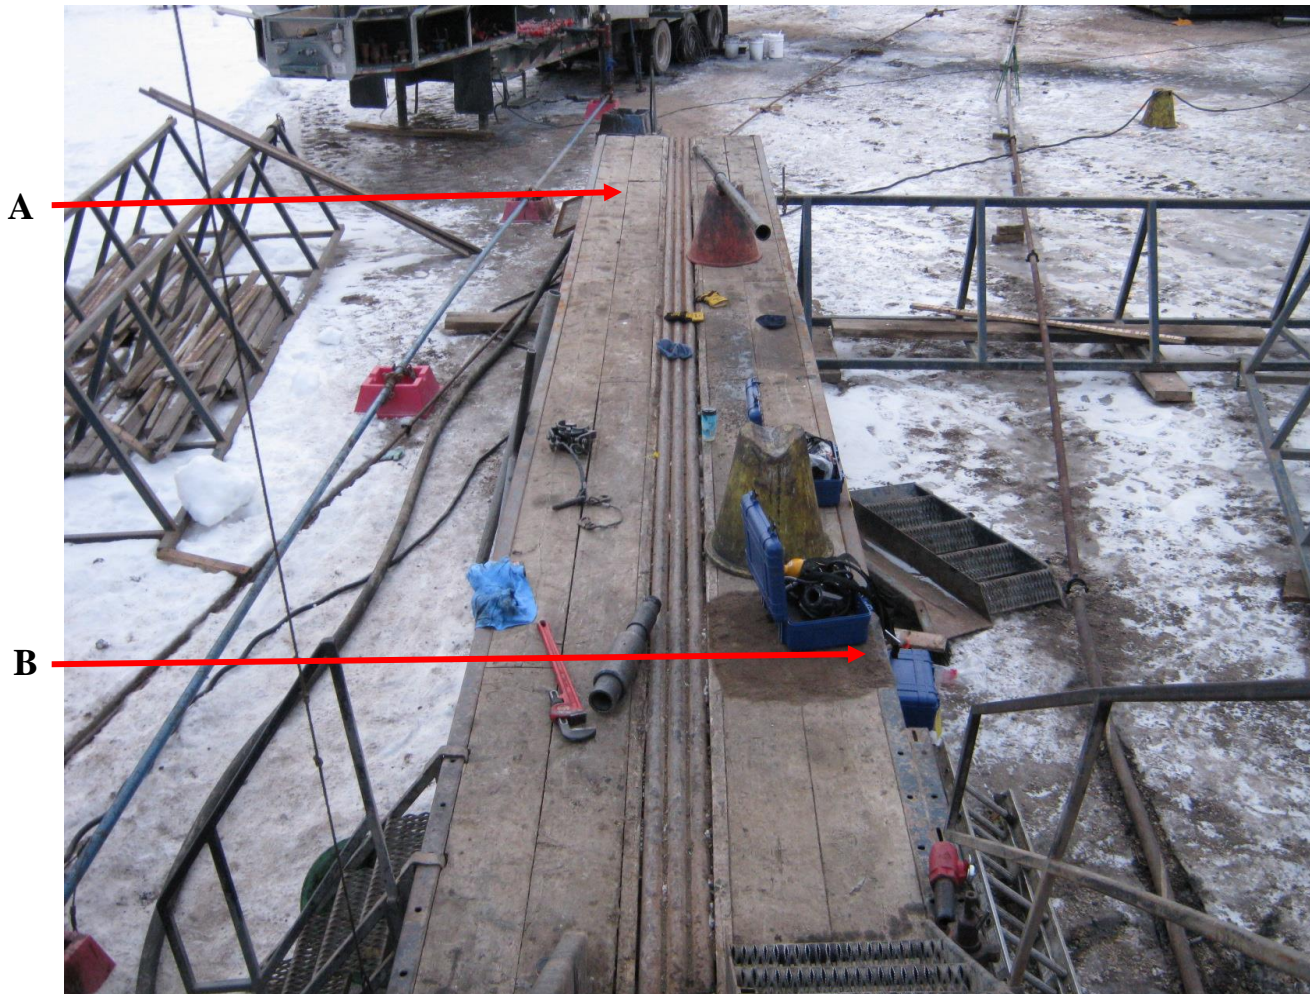
Photograph #4

Catwalk where the rig manager and the fatally injured worker were located immediately after the release of gas. The rig manager ran to the far end of the catwalk. The fatally injured worker stumbled, fell and rolled off the left side of the catwalk.

A – approximate location where floor-hand laid down and fell from catwalk

B – SABA kit

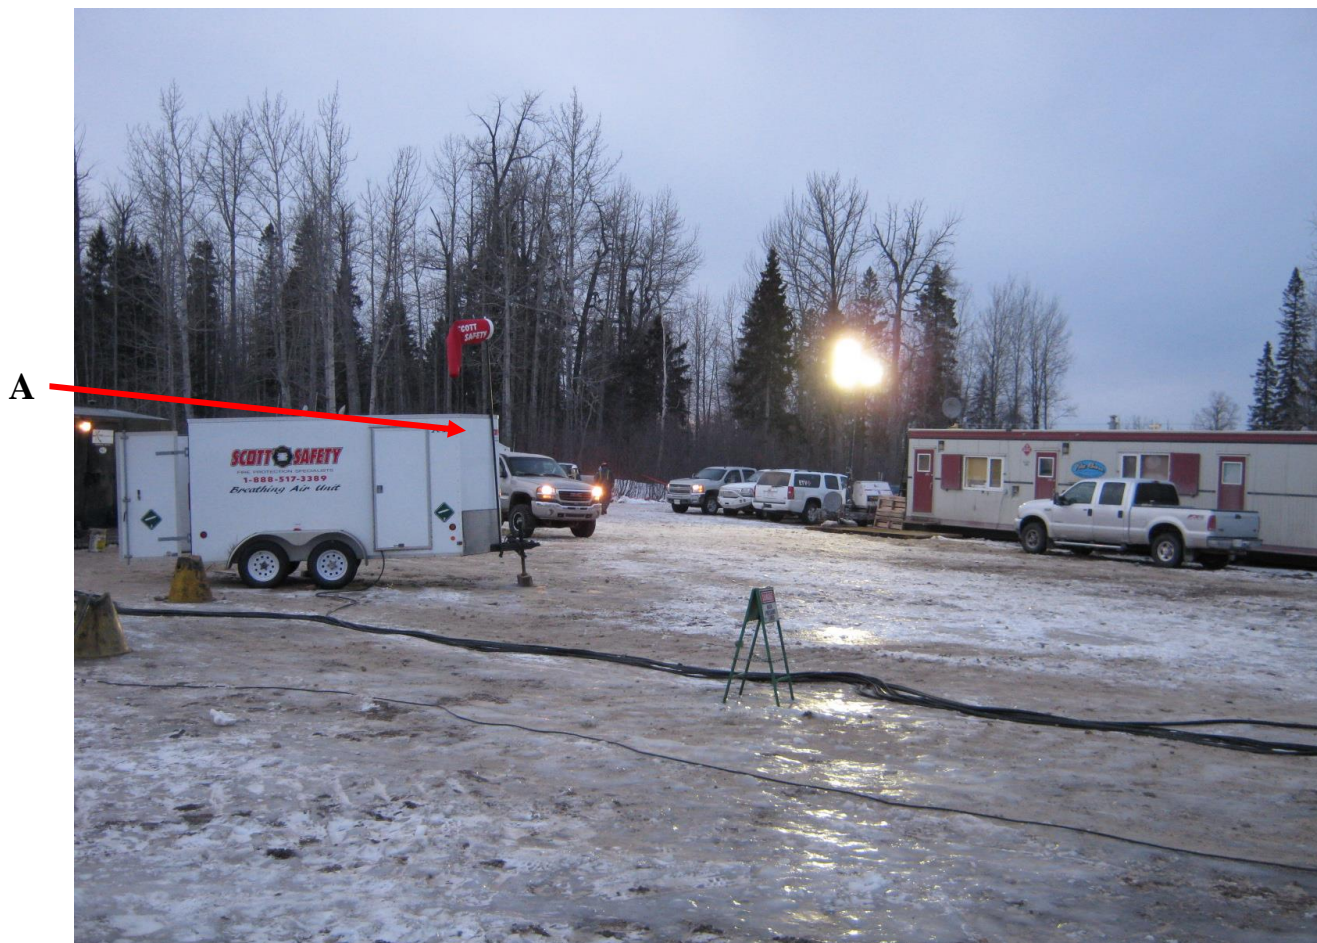
Photograph # 5

- 6.11 The derrick-hand stepped in and used a wrench to tighten the pup joint into the hanger; his gas monitor started to alarm.
- 6.12 At no time during the task were workers using supplied breathing air systems, despite available SABA/SCBA units on site.

Supplied Air Breathing unit trailer (A) available at the worksite
