**CARPENTER WORKER SUFFERS FATAL
HEAD INJURIES IN FALL FROM HEIGHT**

Type of Incident: Fatal Incident

Date of Incident: February 11, 2011

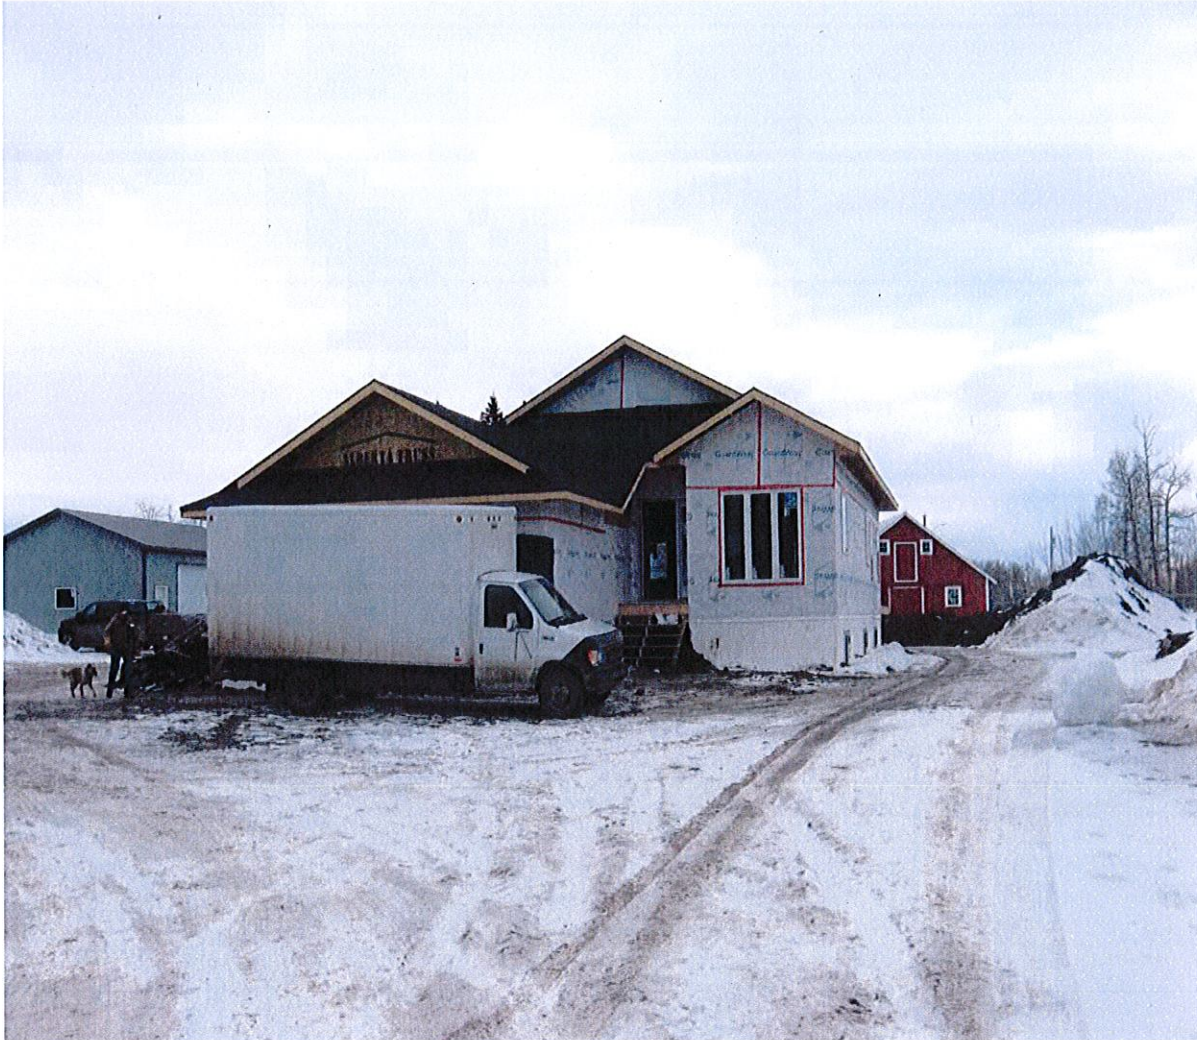
Photograph #3 Shows the house on the property being built looking to the west

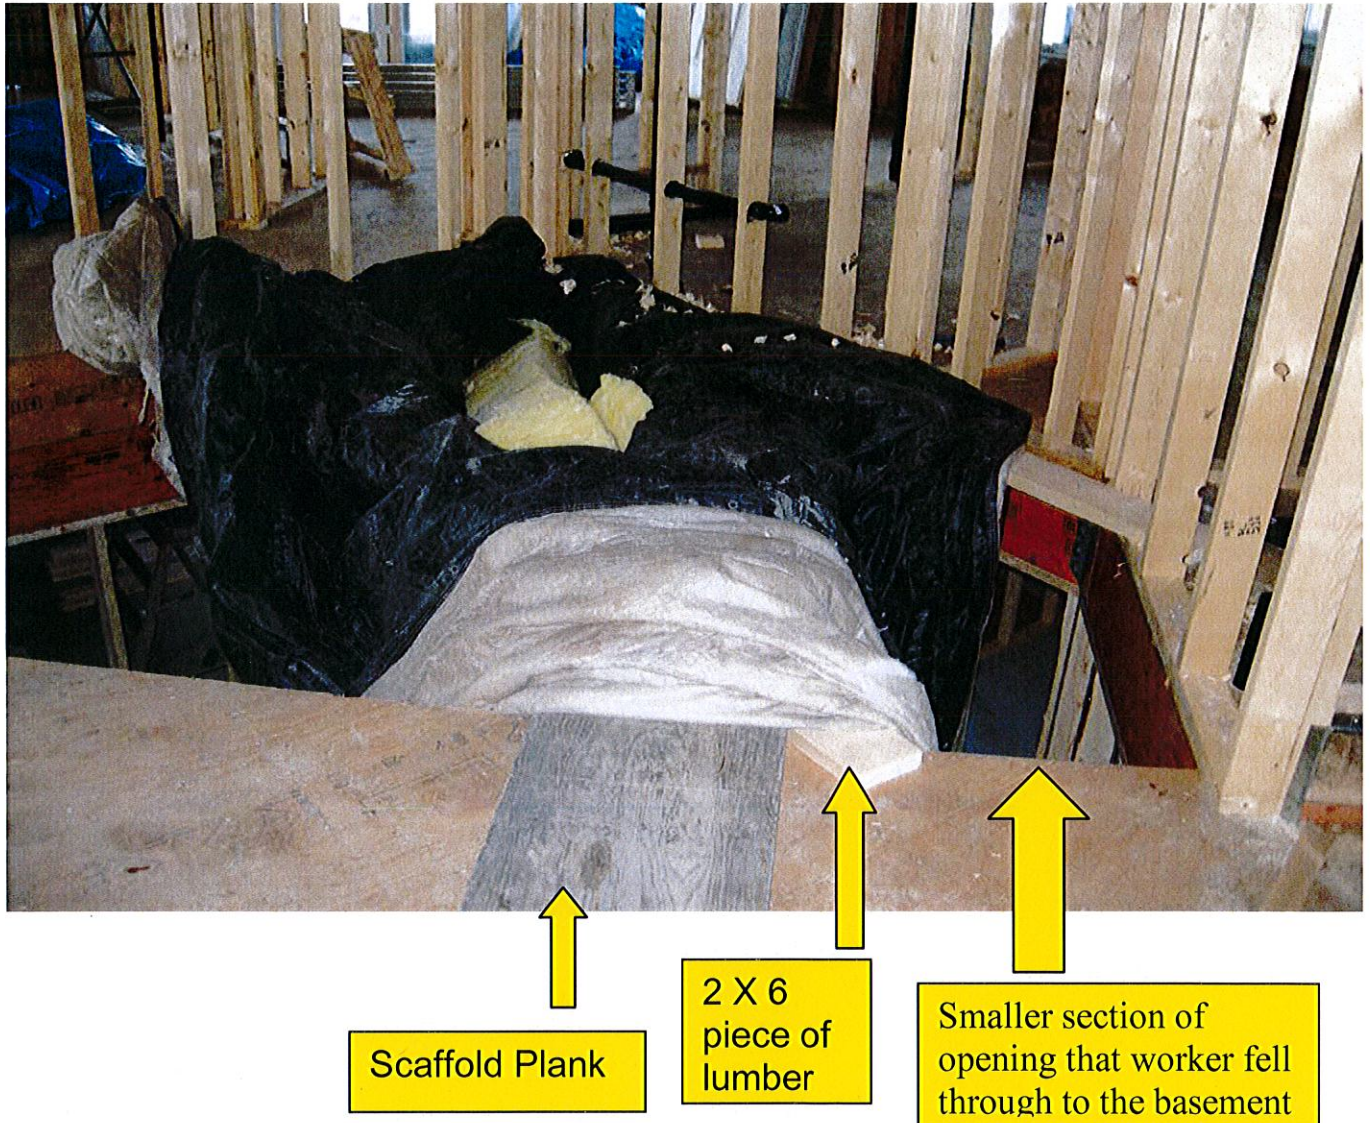
the basement floor below measures 2.97 m. There was no guard rail at the edge of the stairwell opening at the time of the incident.

5.1.2.2 The opening had a scaffold plank laying across it dividing it into a larger and smaller section. The dimensions of the smaller section were .69 m wide, 1.71 m long on one side and .86 m long on the other side. (Refer to Attachment C – Photograph # 4)

Photograph #4 Shows the opening to the basement on the main floor of the house which is divided in half by a scaffold plank laying across it

- A stop work order inside the house was issued and was to remain in effect until fall protection was installed around the edge of the opening to the basement.

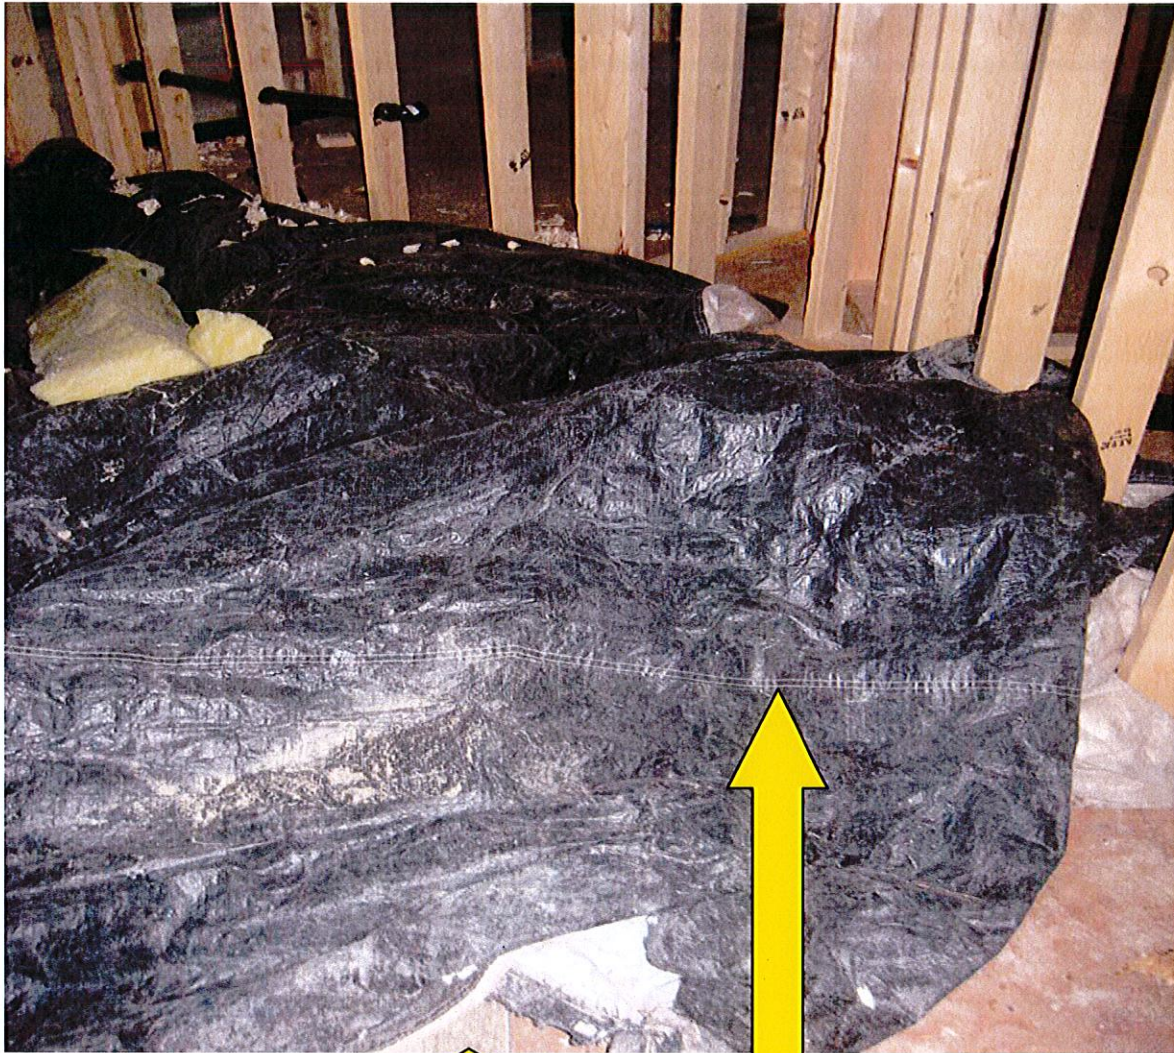
5.1.3.1 A large black vinyl tarp was being used to cover the opening to prevent heat from escaping from the basement.

- 7.2.1 The stairwell opening on the main floor of the house being constructed did not have fall protection in place around the edge to prevent a worker from falling into it.
- 7.2.2 The area where the carpenter fell through had a tarp covering it thereby concealing where the edge of the opening was and tripping hazards underneath it such as the 2 x 6 and scaffold plank (Refer to Attachment C, Photograph # 4 and # 5).
- 7.2.3 Workers at the site were not taking steps to control hazards. The lack of guardrails around the opening had been previously identified and discussed as a hazard but control measures were not taken to eliminate the danger.

Scaffold Plank

Area where worker fell
through the opening

Photograph #5 Shows a re-creation of what the opening would have appeared like with the tarp covering it prior to the worker falling through

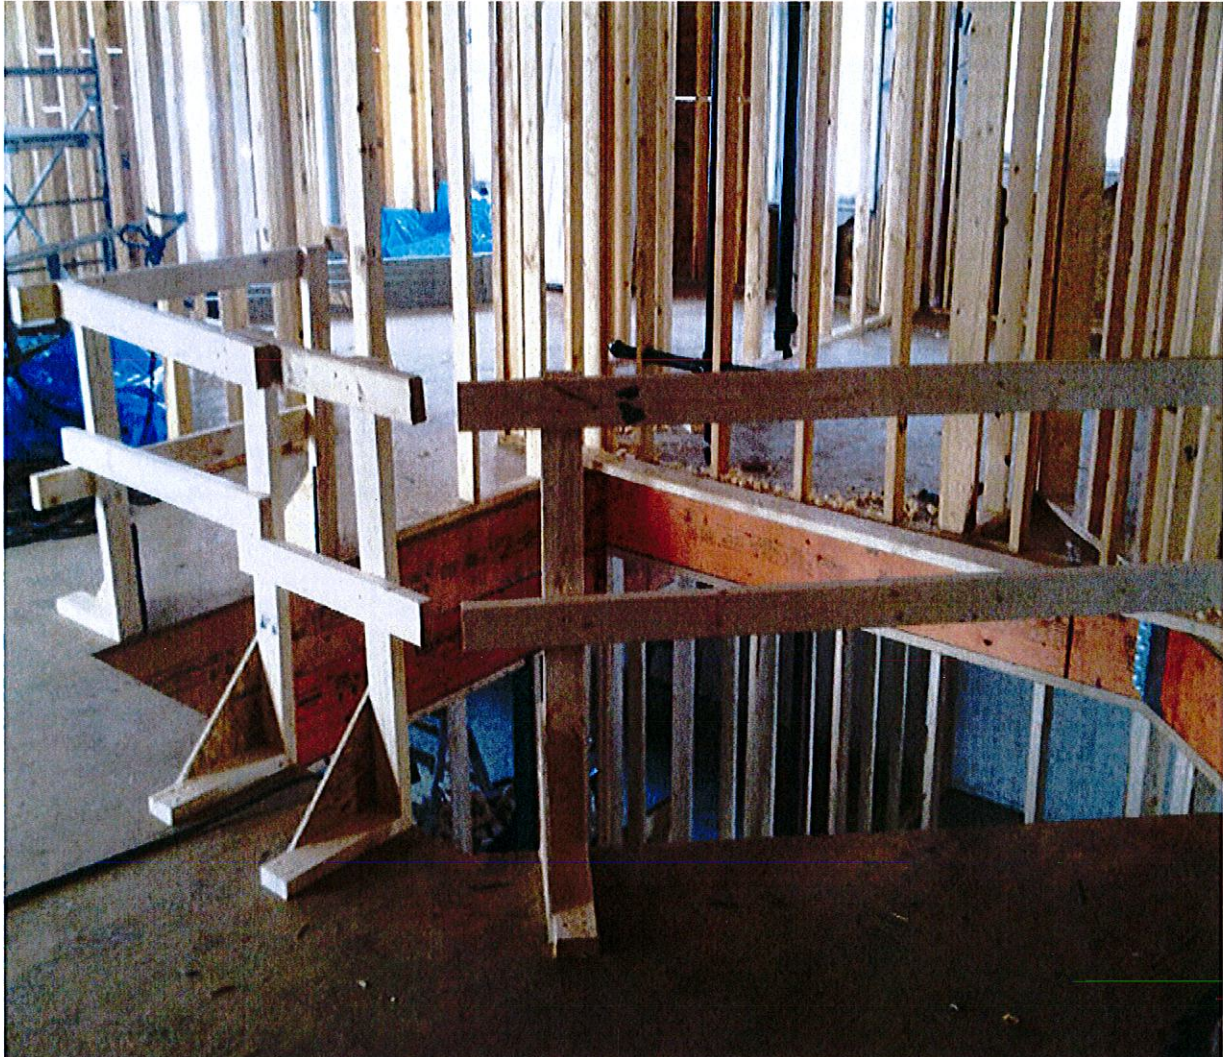
Photograph #6 Shows what the opening looked like after the incident with a proper guardrail in place to protect workers

- 8.1.3 The following orders were written to Buck Mountain Plumbing Ltd.:
- A stop work order was issued for any further plumbing and heating work inside the house until fall protection was installed around the edge of the opening to the basement.
