Abertan Jobs, Skills, Training and Labour

Investigation Report
Worker Fatality – February 21, 2013

Incident summary

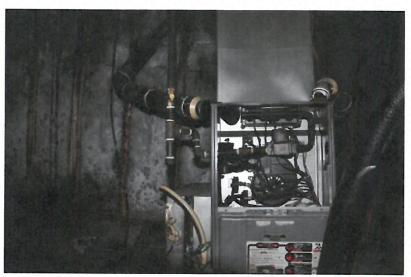
Figure 1

Workers were connecting the permanent natural gas supply line to a RUUD Upflow & Downflow/Horizontal High Efficiency Condensing Gas Furnace (RGRA/RGRB/RGTA/RGTS/RGRT Series) (furnace) that had previously been fuelled by propane using an 80% & 90 Plus Gas Furnaces – Gas Conversion Kit (Fig. 1).

RUUD furnace involved in incident February 21 2013.

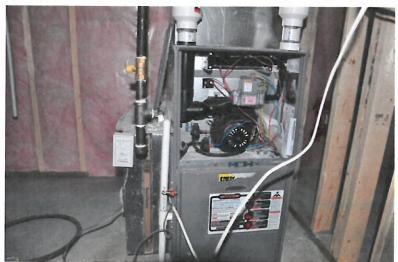
Figure 2

Exemplar of similar RUUD furnace installed in another residence.

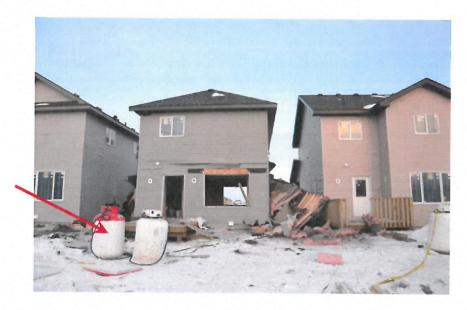
Figure 3.

The furnace had been fuelled by propane from a 1000 lb (450 L) gas cylinder or pig provided by Canwest Propane (Fig. 3). This cylinder was located at the back of 140 Allard Way.

View of back of 140 Allard Way Fort Saskatchewan, Alberta showing the location of the propane cylinders for the temporary heating arrangement. Arrow indicates propane cylinder used to supply 140 Allard Way prior to the incident.

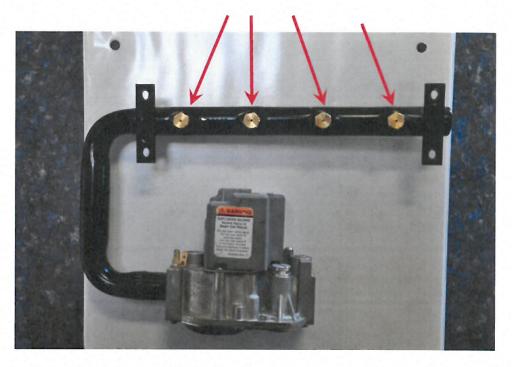
Figure 4.

Photograph of the orifices in the RUUD Furnace. Arrows indicate the components (orifices and springs) that were replaced as part of the furnace conversion from propane to natural gas. A spring in the valve was also replaced.

Rigorous converted the furnace back to natural gas by shutting the propane tank off, disconnecting the propane hose at the furnace, and re-installing orifices appropriate for natural gas. The propane hose was left in the basement at 140 Allard Way.
