# **RECAPP Facility Evaluation Report**

**Alberta Health Services-South**

**Medicine Hat Regional Hospital**

B1126A  
Medicine Hat

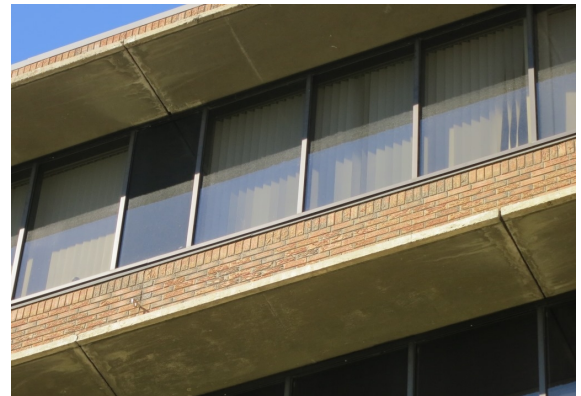
Floor slab projections at the south wall of the RRS Wing are cracked and spalling; water penetration is evident on the interior.

Potential for water penetration and danger of portions of slab falling off the building.

Concrete sun shades on south elevation.

Repair top of slabs, apply roofing membrane and wall flashing. Clean underside of slabs, remove spalling and patch any damage.
