RECAPP Facility Evaluation Report

Aspen Regional Health Authority

Hinton General Hospital

Evaluation Company: KOLIGER SCHMIDT architect-engineer
Evaluation Date: November 27 2008
Evaluator Name: Steve Horvath

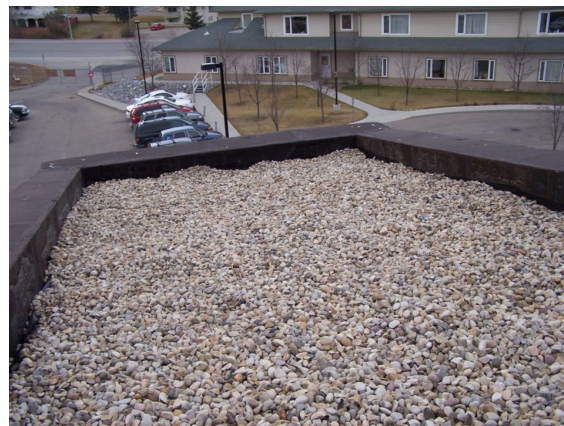
No capping on parapet walls

<u>Type</u>	<u>Year</u>	<u>Cost</u>	<u>Priority</u>
Repair	2010	\$25,800	High

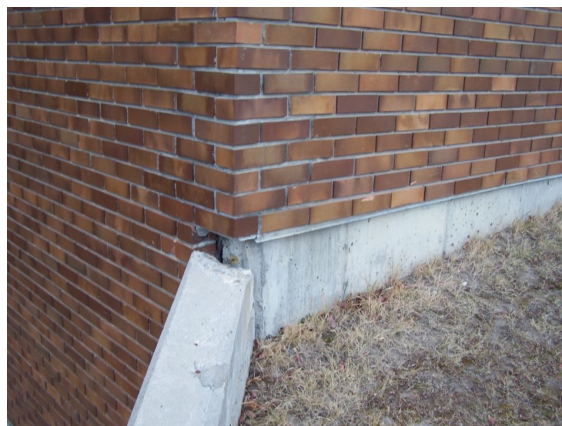
Concrete retaining wall attached to the building foundation at back of building.

Retaining wall pulling away from building

Replace or stabilize retaining wall. Further investigation is recommended.

<u>Type</u>	<u>Year</u>	<u>Cost</u>	<u>Priority</u>
Failure Replacement	2010	\$37,700	High

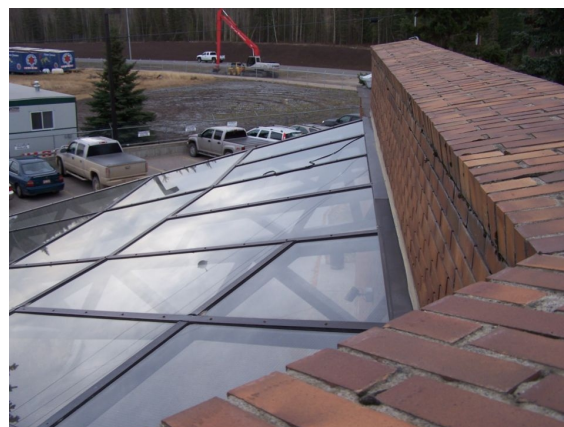
Three insulated glass panels have seals broken and are to be replaced, also flashing missing.

Leaking may occur and also loss of energy. Plus poor aesthetics for fogged glass panels.

Caulk and sealing strips pulling away from glass panes

Replace glazing panels and install proper flashings

<u>Type</u>	<u>Year</u>	<u>Cost</u>	<u>Priority</u>
Repair	2010	\$23,000	High

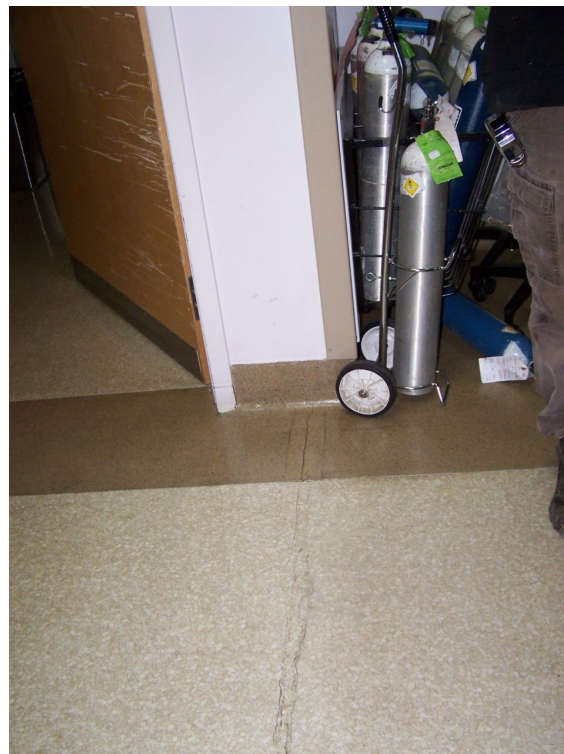
The control joint in the floor has failed.

Failed control joint in floor

Replace control joint

<u>Type</u>	<u>Year</u>	<u>Cost</u>	<u>Priority</u>
Failure Replacement	2010	\$3,800	Medium

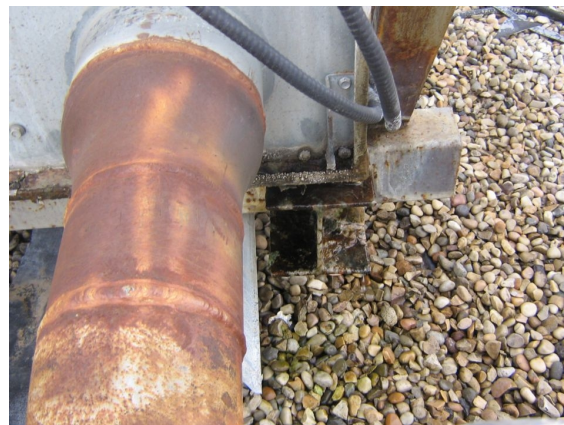
Loss of cooling to the hospital.

Corner that appeared to be leaking.

<u>Type</u>	<u>Year</u>	<u>Cost</u>	<u>Priority</u>
Failure Replacement	2010	\$450,000	Medium

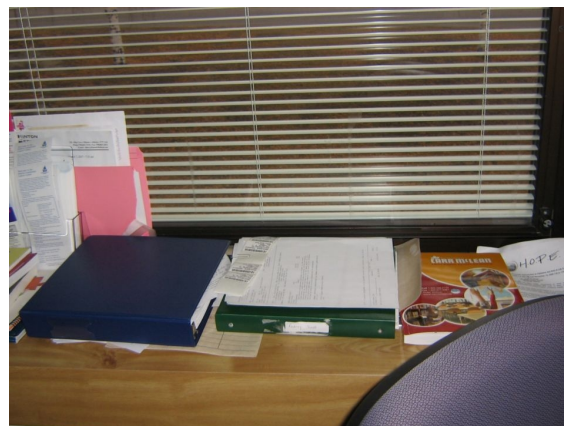
Grille is located under the books and files.

<u>Type</u>	<u>Year</u>	<u>Cost</u>	<u>Priority</u>
Preventative Maintenance	2010	\$1,000	Medium

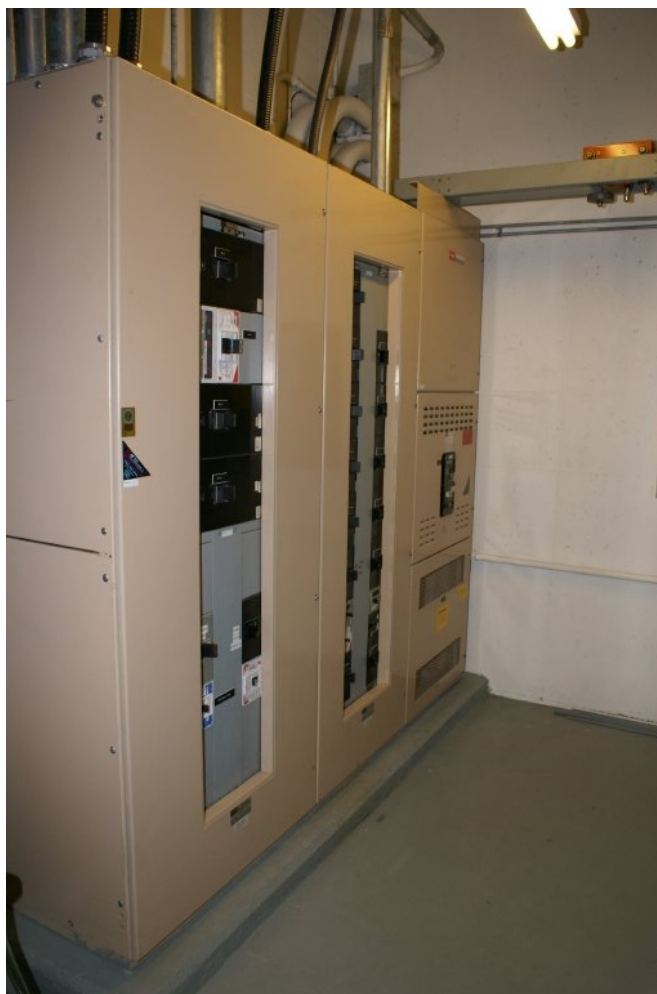
The main distribution is 1600A 347/600V 3ph 4w. The distribution panel is manufactured by Federal Pioneer and is located in the main electrical room on the lower floor, north corner. The main cell consists of a 1600A-3P main breaker and c/t p/t compartment. The c/t p/t compartment is no longer used as the utility meter has been removed and is now located directly on the Utility Padmount transformer. Users report that the Main Breaker is easily tripped by slight vibrations, and disconnects frequently. There are two (2) distribution cells on the MDP, both are rated for 1600A. There are five (5) spaces for future.

<u>Rating</u>	<u>Installed</u>	<u>Design Life</u>	<u>Updated</u>
3 - Marginal	1979	40	MAR-10

Main distribution panel

Event: Replace Main Distribution Breaker

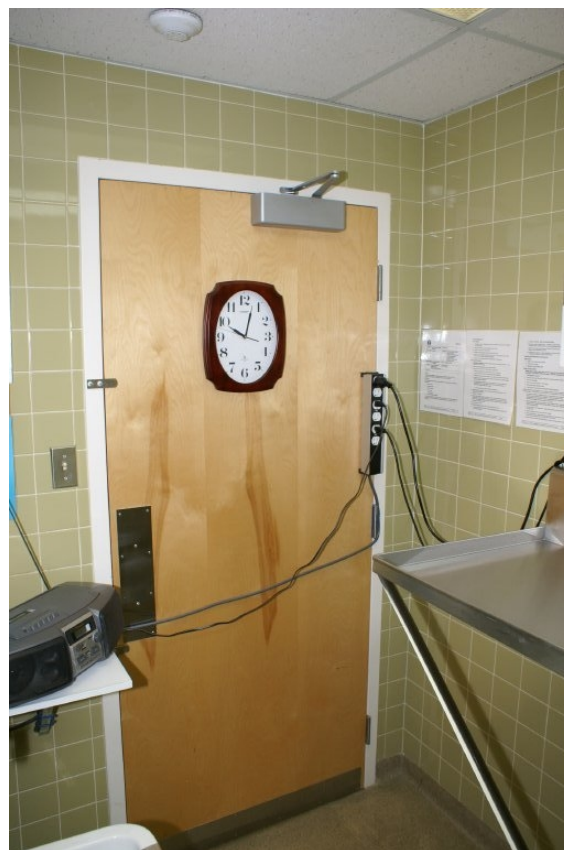
Power cords stretched across room - Endoscopy wash area

<u>Type</u>	<u>Year</u>	<u>Cost</u>	<u>Priority</u>
Program Functional Upgrade	2010	\$3,750	High

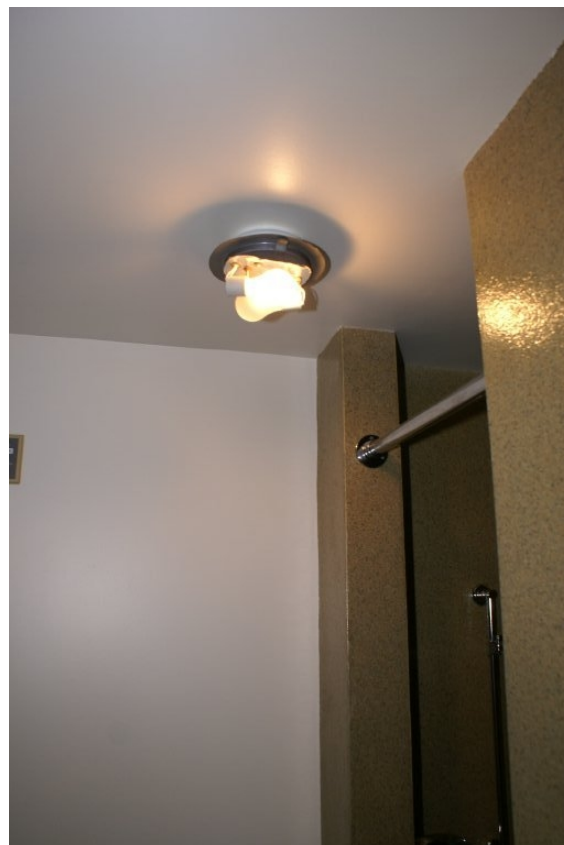
Incandescent dome light w/ missing lens

<u>Type</u>	<u>Year</u>	<u>Cost</u>	<u>Priority</u>
Failure Replacement	2010	\$2,200	Low

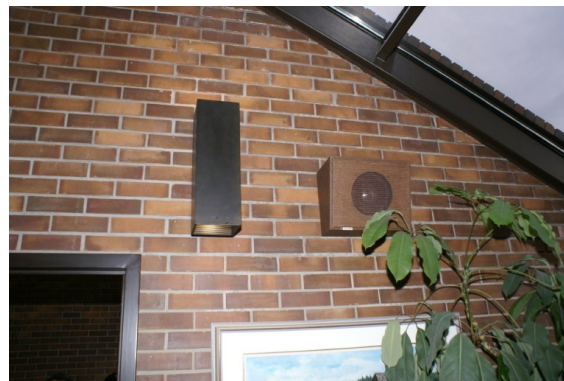
Minimal light levels in the stairwell is a safety hazard as users are not able to see the stairs. Chances of incidents are greatly increased in the current condition.

Existing main stairwell lighting

Event: Replace existing wall sconce fixtures with new fixtures

<u>Type</u>	<u>Year</u>	<u>Cost</u>	<u>Priority</u>
Program Functional Upgrade	2010	\$3,300	High

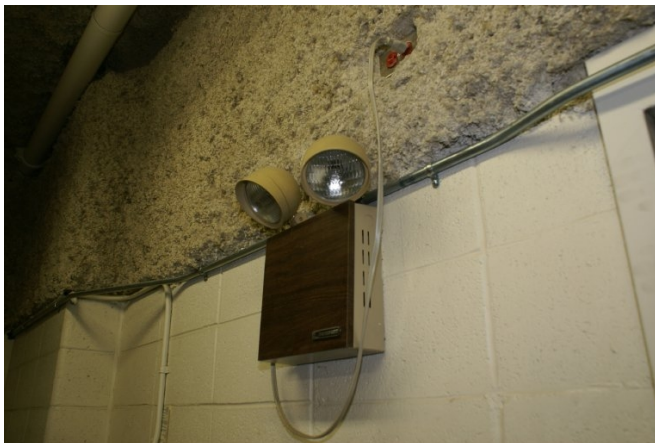
The majority of emergency lighting throughout the building is via emergency generator power to various lights. The lower floor main corridor has approximately three combination exit signs with emergency heads/battery packs. The installation dates within the last ten (10) years. One (1) emergency battery pack is located in the generator room. The unit dates from the original 1979 construction and has surpassed the rated life cycle.

<u>Rating</u>	<u>Installed</u>	<u>Design Life</u>	<u>Updated</u>
3 - Marginal	1998	20	MAR-10

Emergency lighting battery pack in the generator room.

Event: Replace 3 Emergency Lighting Battery Packs

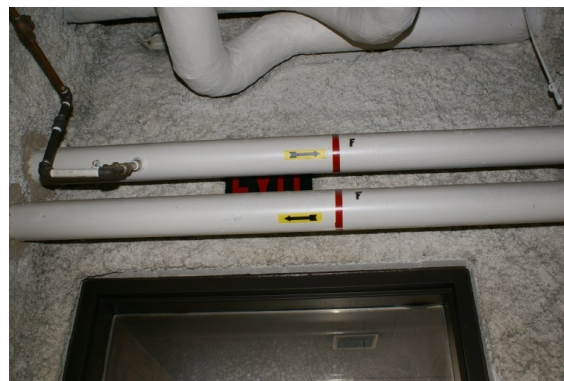
Currently the exit sign is not visible. During emergency situations, the pathway of egress is not visible.

Exit sign blocked by mechanical piping.

Event: Relocate Exit Sign

<u>Type</u>	<u>Year</u>	<u>Cost</u>	<u>Priority</u>
Code Upgrade	2010	\$1,000	High

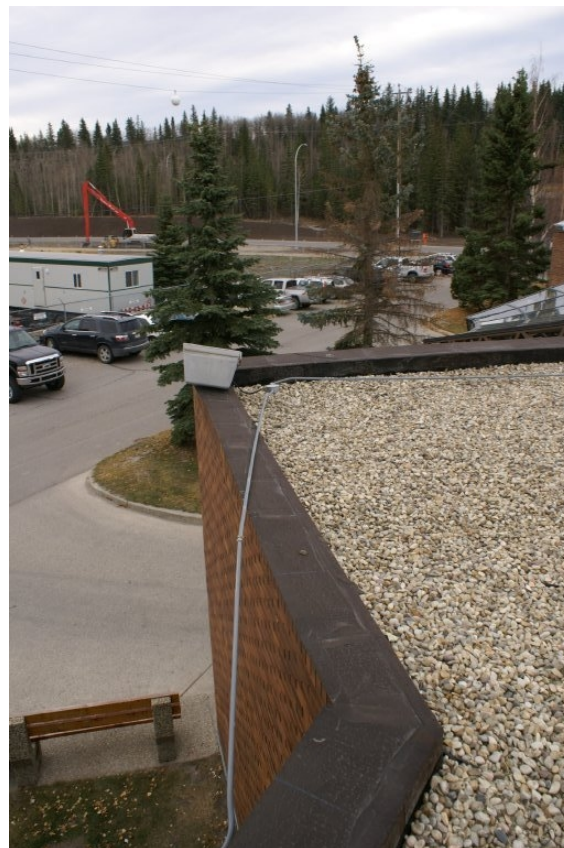
Exterior HPS flood light and damaged conduit

Event: Repair Exterior H.P. Sodium Fixtures

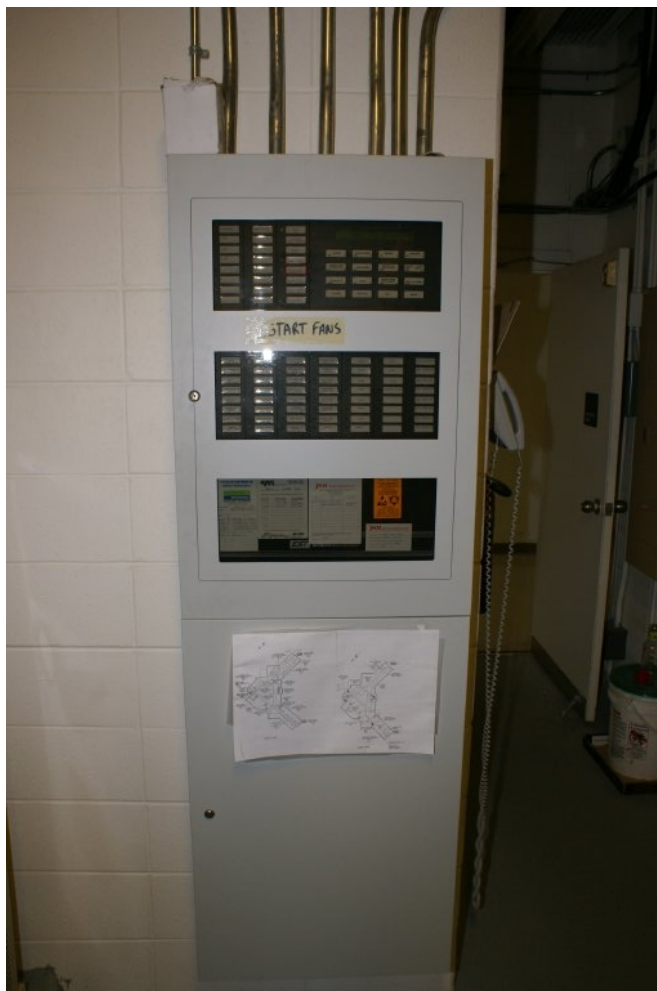
<u>Rating</u>	<u>Installed</u>	<u>Design Life</u>	<u>Updated</u>
2 - Poor	1979	25	MAR-10

Edwards ESA2000 fire alarm control panel

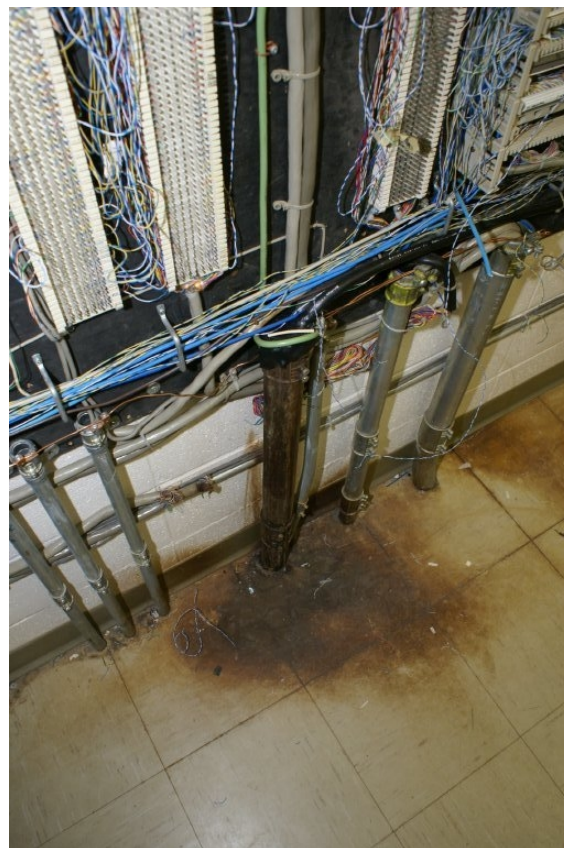
Telephone service entry w/ water damage

Event: Repair Telephone Systems

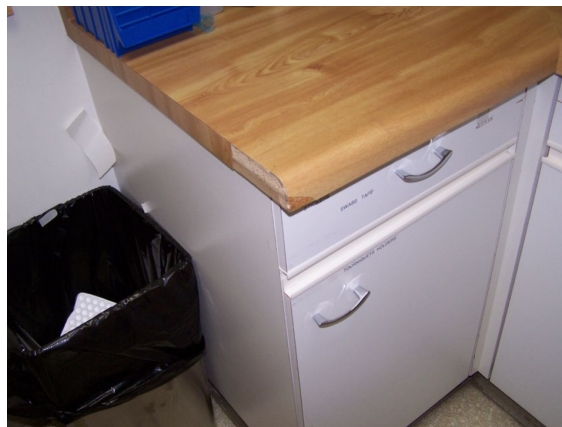
Laminate missing for counter top

Event: Replace ~170m Fixed Casework
