Workplace Health and Safety Fatality Report

WORKER FALLS FROM A LADDER

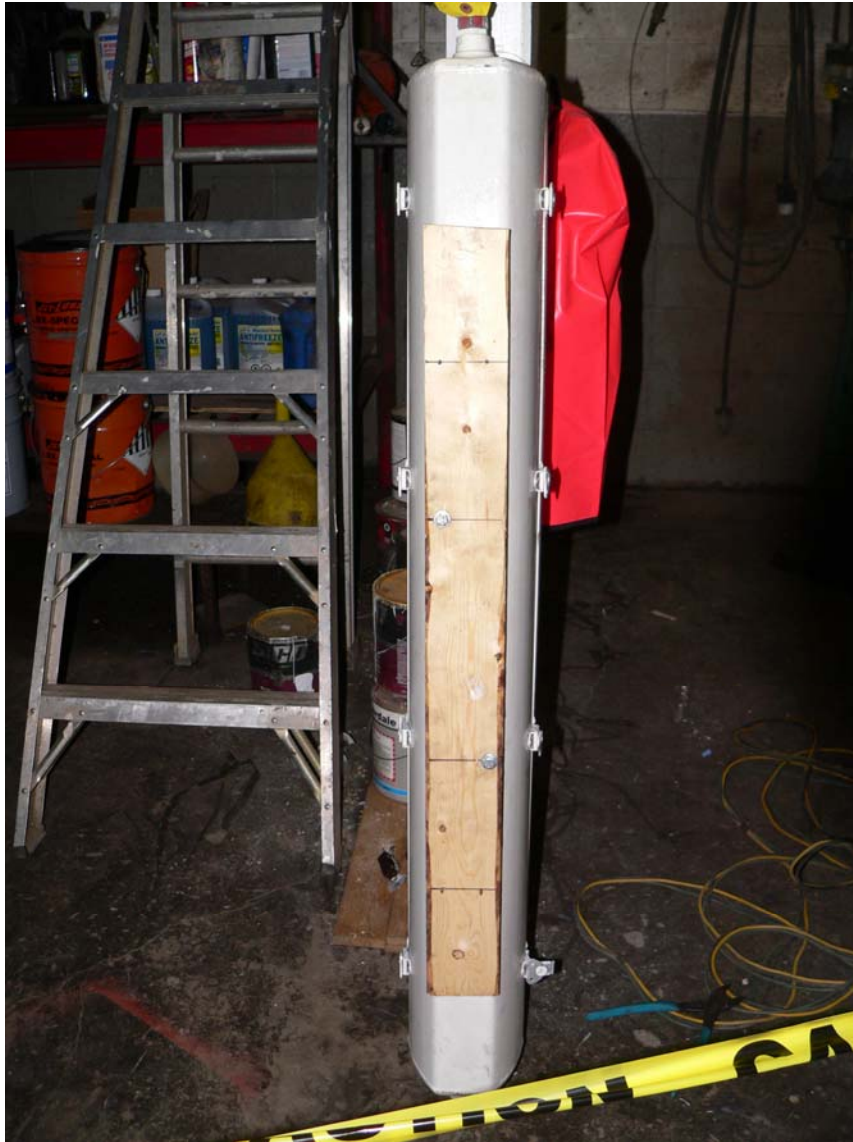
Photograph #3 Shows the barrel that was moved away from the injured worker and the wooden bin to provide space to provide first aid.

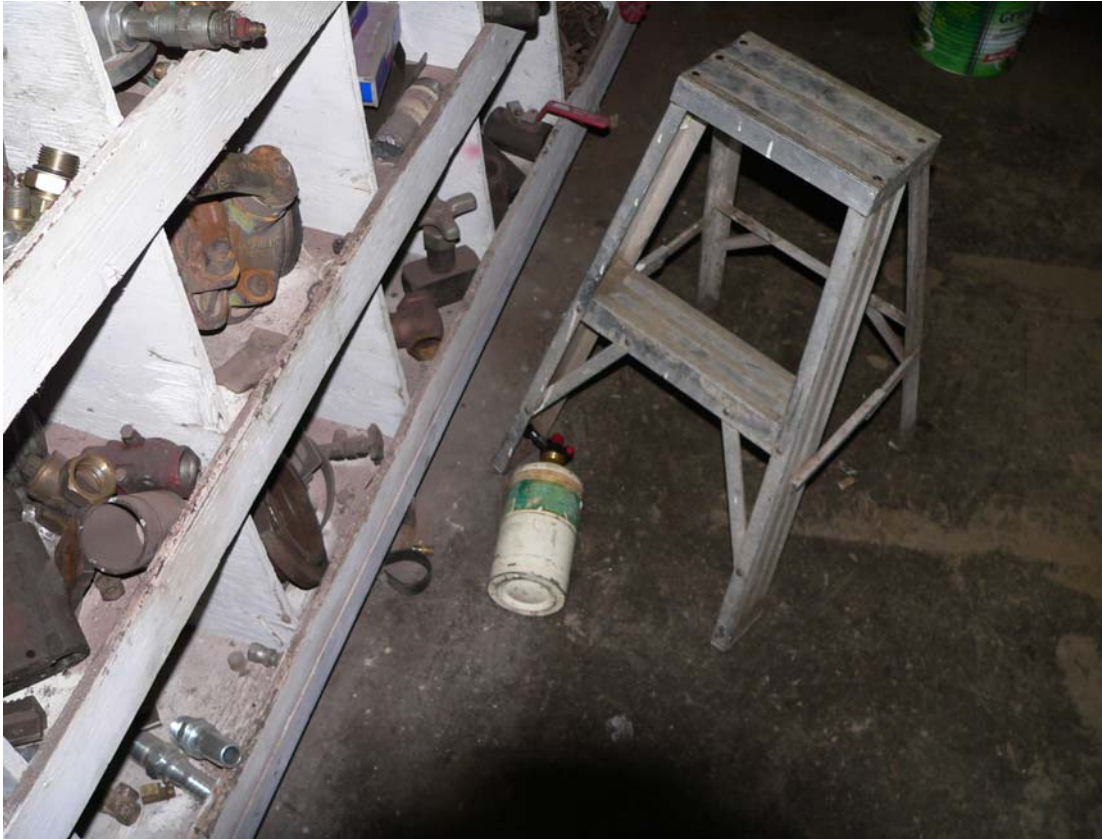
Photograph #5 Shows a 465 g propane cylinder that was found on the floor to the left of the injured worker.

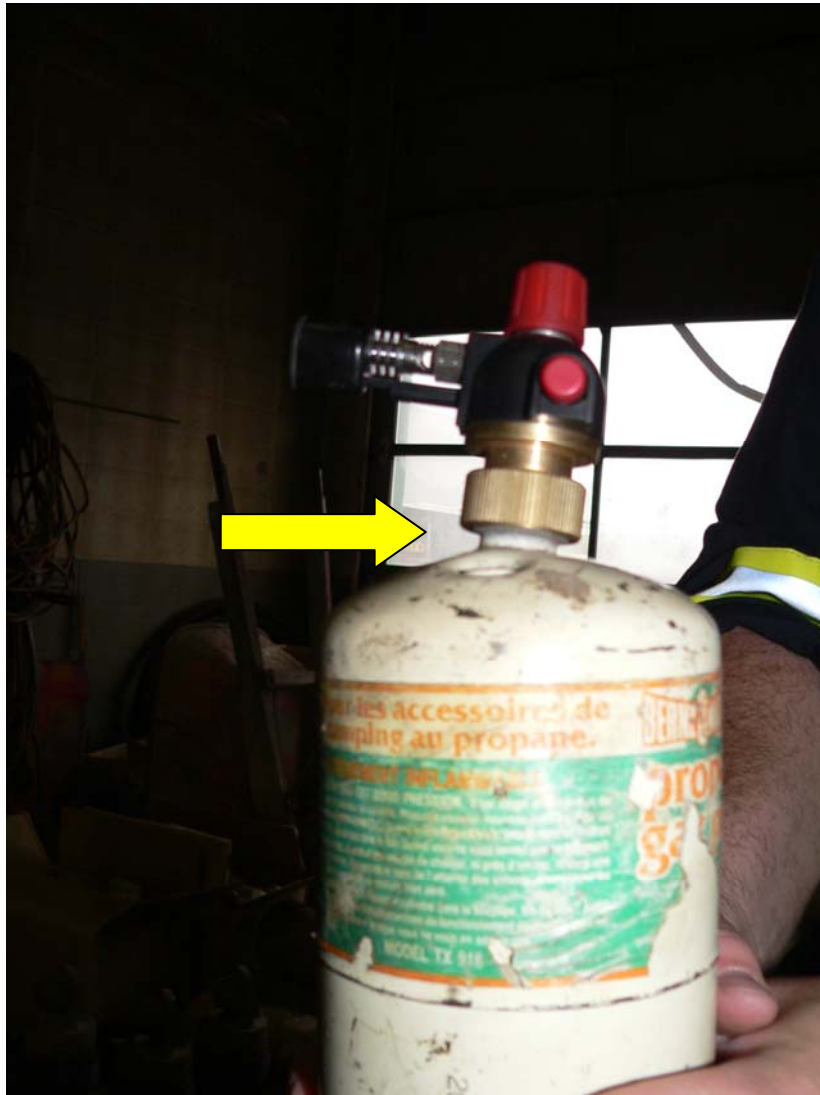
Photograph #6 Illustrates the deformed neck of the 465 g propane cylinder. The yellow arrow shows where the propane cylinder was damaged.

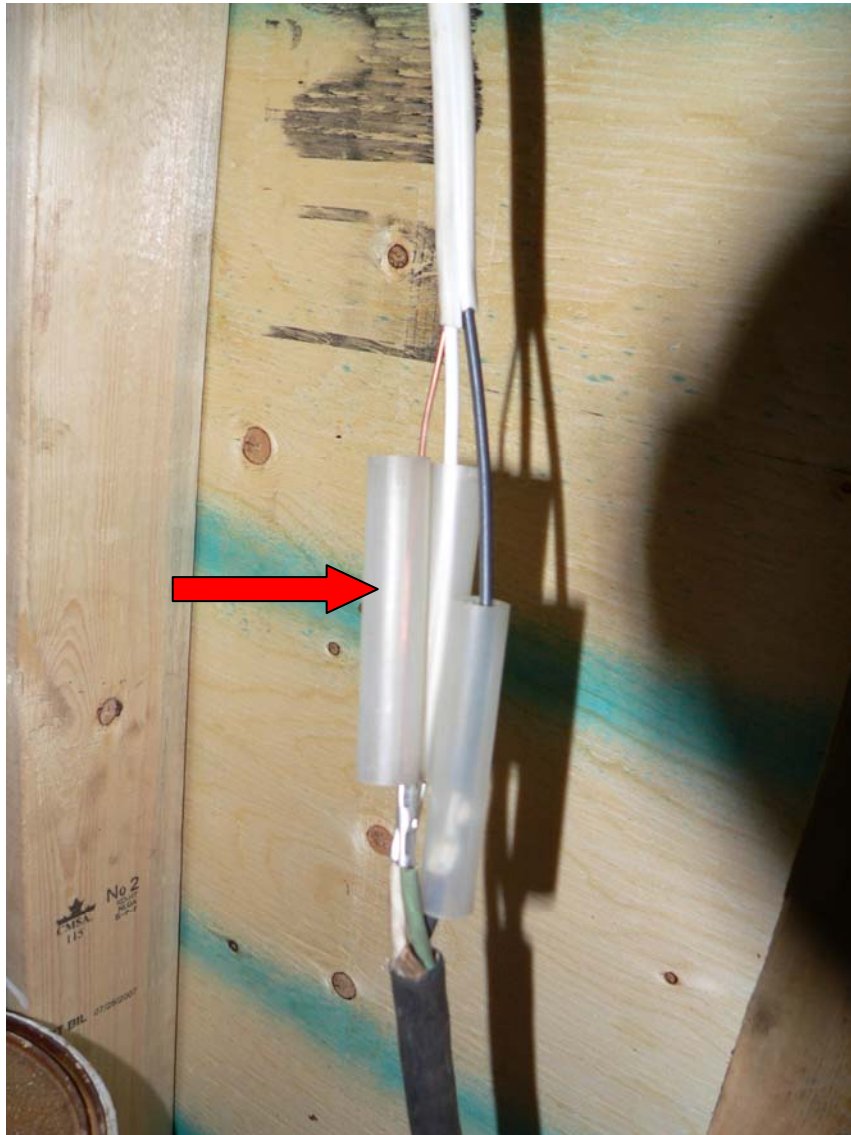
Photograph #7 Shows a connection to the light box with the heat shrink tubing identified by the red arrow. This connection was approximately 1.8 m above the concrete surface.
